Bridge Number : 55C0181  
Facility Carried: SILVERADO CANYON RD.  
Location : 3.1 MI E/O SANTIAGO ROAD  
City :  
Inspection Date : 12/15/2017

# Bridge Inspection Report

**STRUCTURE NAME:** SILVERADO CANYON CREEK

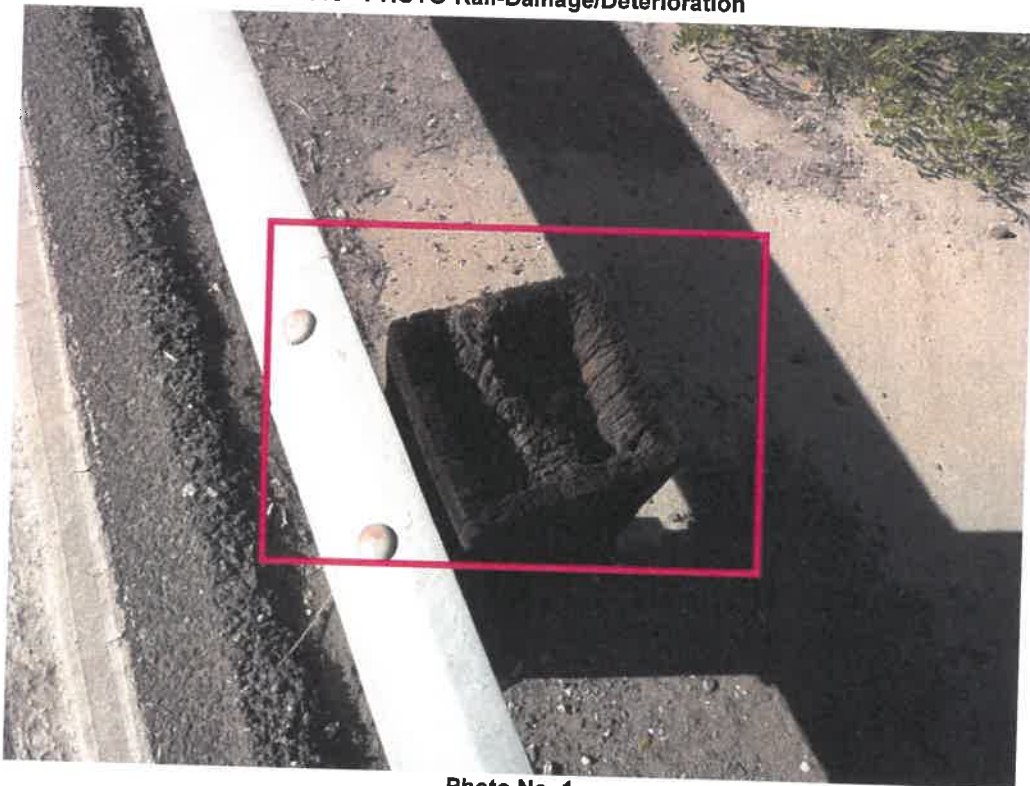
**Photo No. 1**

Post #8 (counting from west) was decayed and has section loss at the south rail.

At the north rail, posts #3, #4, #6 and #7 (counting from west) are decayed from to the top. (see the attached photo no. 1)

At the north rail, posts #3, #4, #6 and #7 are decayed from to the top.

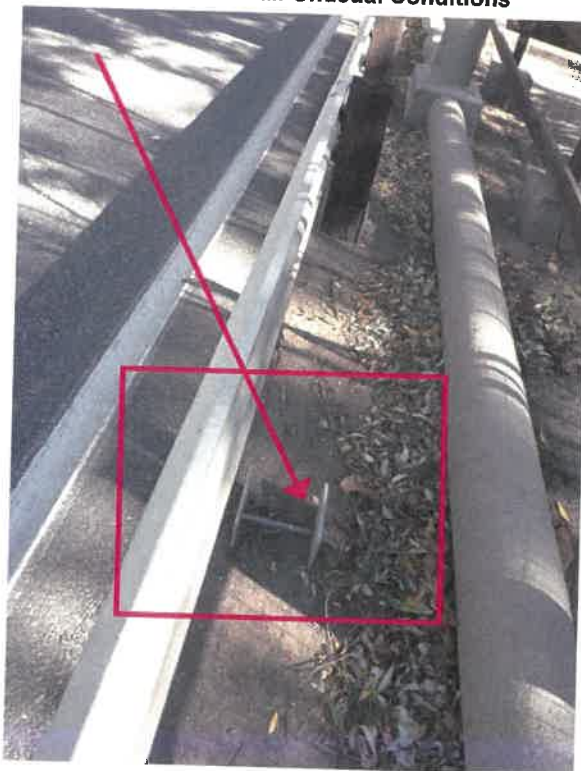
**Photo No. 2**

South rail has two missing timber posts #3 and #7 (counting from west), and the metal beam is bent between posts 6 and 8. (see the attached photo no. 2)

South rail has two missing timber posts #3 and #7 (counting from west).

Replace the missing two missing timber posts #3 and #7 (counting from west) at the south rail.

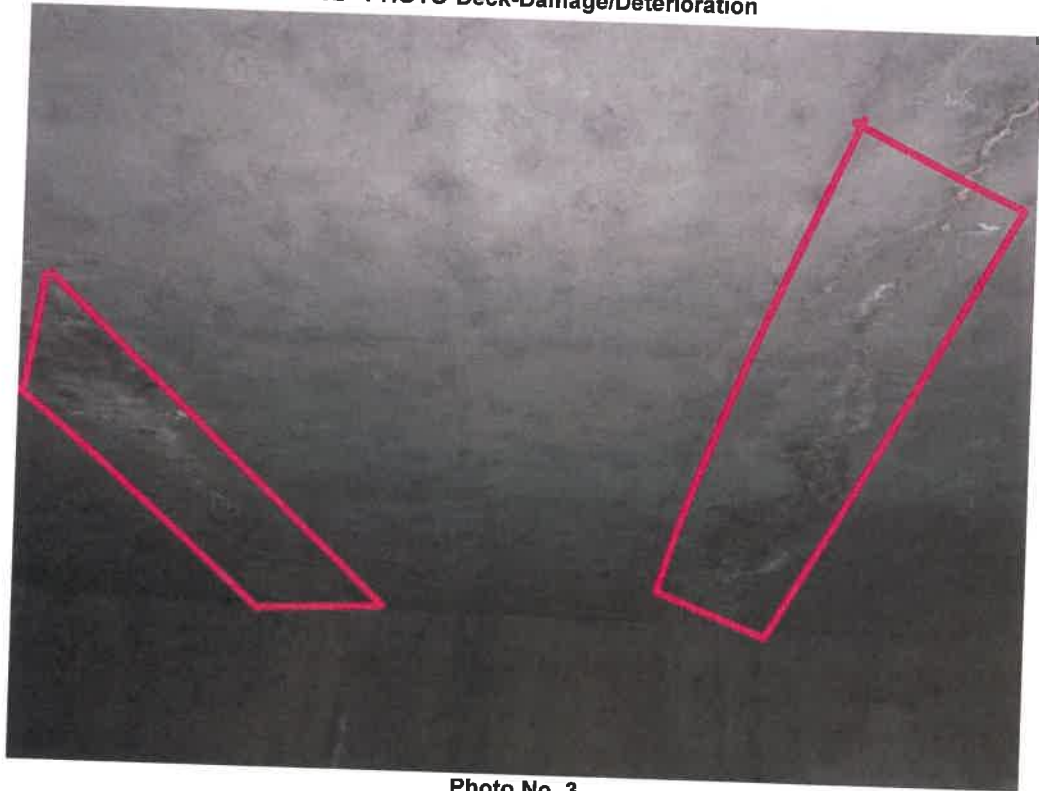
Photo No. 3

| Elem No. | Defect /Prot | Defect | Element Description | Env | Total Qty | Units | Qty in each Condition State | St. 1 | St. 2 | St. 3 | St. 4 |
|---|---|---|---|---|---|---|---|---|---|---|---|
| The soffit exhibits five full length longitudinal cracks from abutment to abutment with white and brown efflorescence. (see the attached photo no. 3) | | | | | | | | | | | |

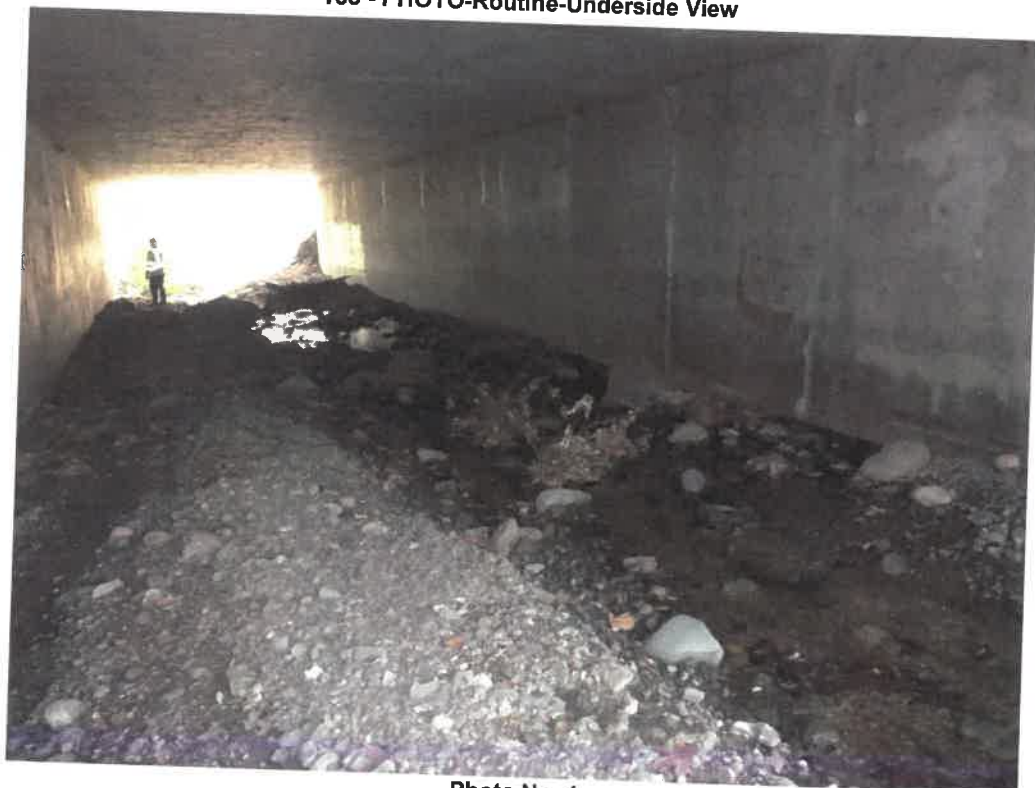
Photo No. 4

Ten year routine underside photograph was taken during this inspection and is included with this report. (see the attached photo no. 4)

Underside view looking South.
