Bridge Report Transmittal Sheet**Batch 41392****County of Orange**

Bridge Number : 55C0182
Facility Carried: SILVERADO CANYON RD.
Location : 3.6 MI. E/O SANTIAGO ROA
City :
Inspection Date : 12/15/2017

Bridge Inspection Report

STRUCTURE NAME: SILVERADO CANYON CREEK

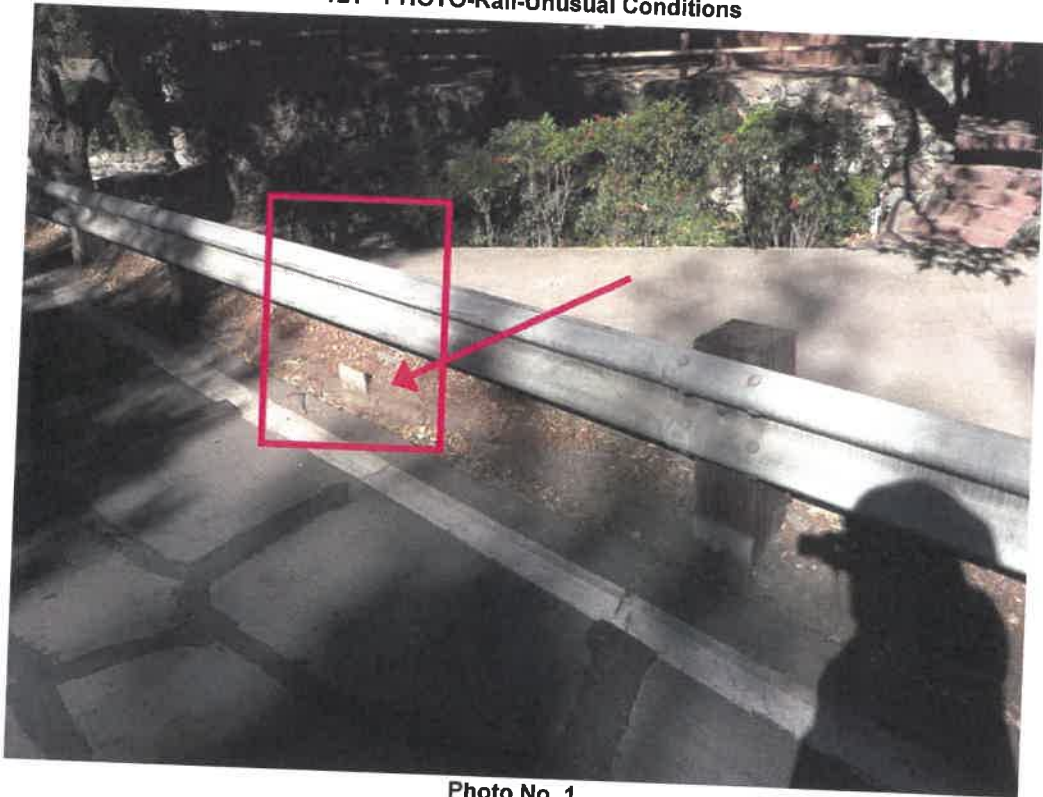
Photo No. 1

The north rail exhibits:

- * timber post #4 (counting from west) is missing; (see the attached photo no. 1)
- * post #8 is missing a nut; and
- * post #10 is missing bolt and nut.

The north rail has timber post #4 (counting from west) is missing.

Replace the missing timber post #4 (counting from west); Post #8 is missing a nut; and post #10 is missing bolt and nut at the north rail.

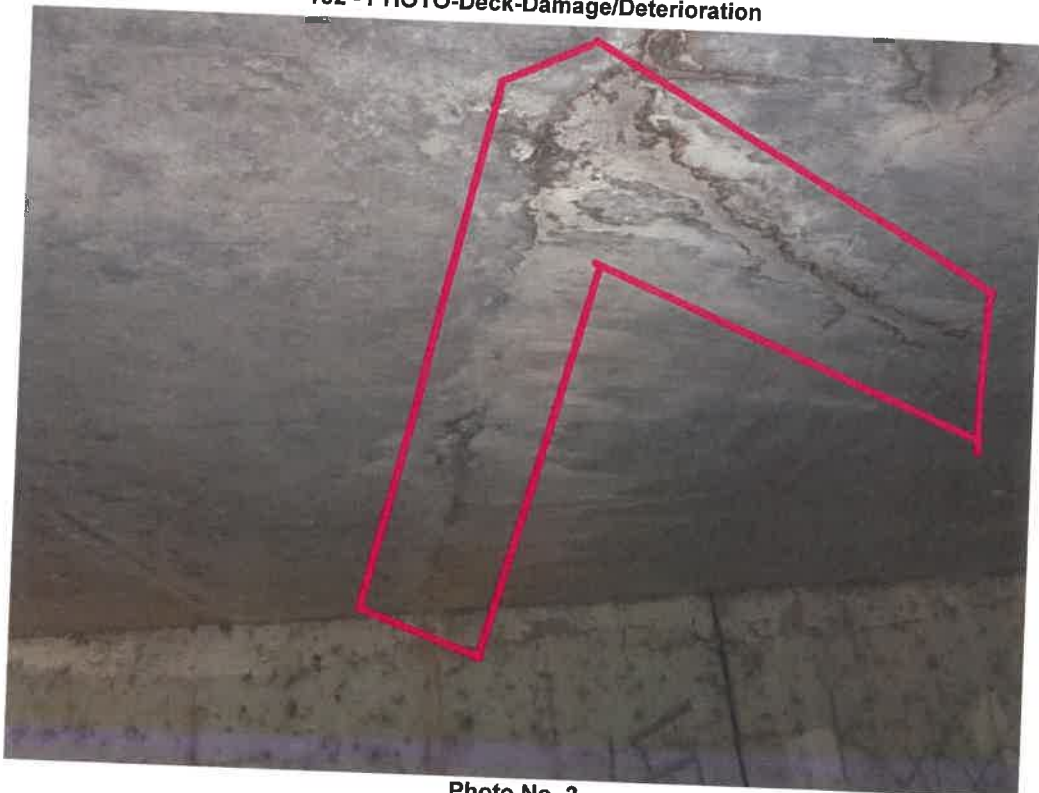
Photo No. 2

The soffit exhibits two full length longitudinal cracks, 0.05 inches wide with light brown efflorescence; and a crack 8 feet long with white efflorescence. (see the attached photo no. 2)

The soffit has few longitudinal cracks, 0.05 inches wide with light brown efflorescence.
