Bridge Report Transmittal Sheet**Batch** **45045****County of Orange**

Bridge Number : 55C0188
Facility Carried: THISA WAY
Location : 200' S/O SILVERADO CYN R
City :
Inspection Date : 12/15/2017

Bridge Inspection Report

STRUCTURE NAME: SILVERADO CANYON CREEK

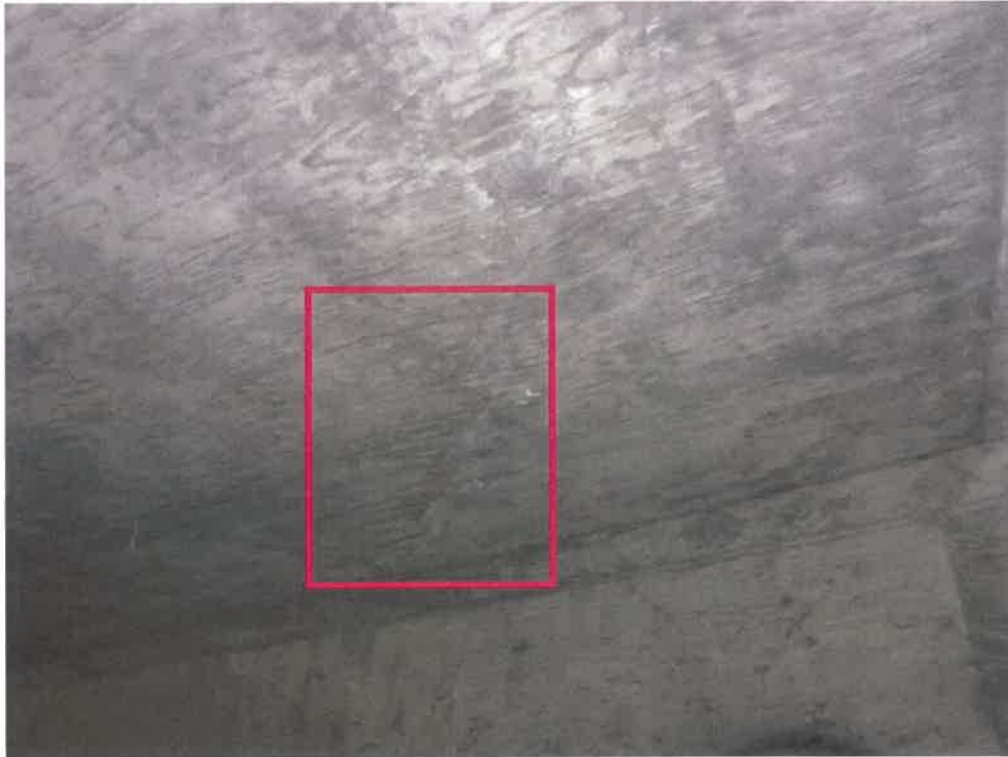
Photo No. 1

Diagonal and longitudinal cracks with white and brown efflorescence.
