March 23, 2020

Bridge Inspection Report

STRUCTURE NAME: SANTA ANA DELHI CHANNEL

55C0205

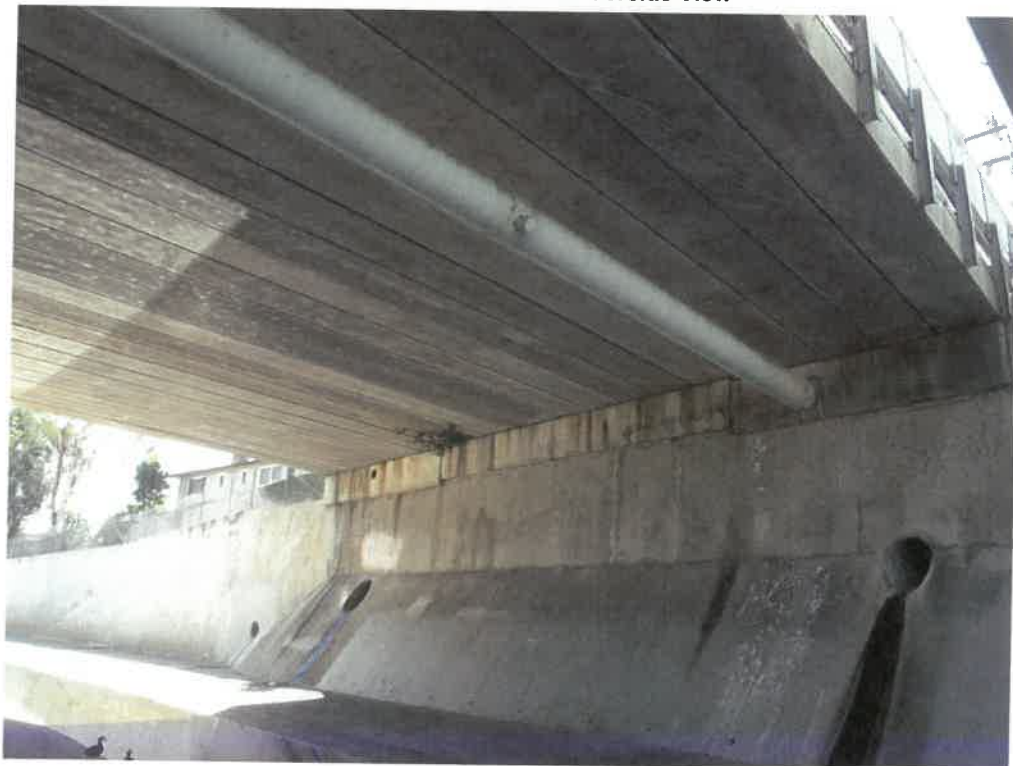
Photo No. 2

There is a tree growing at the seat of Abutment 1 under the PC/PS concrete box girder unit 15 counting from the west side (Photo Number 2).

UNDER VIEW TOWARD ABUTMENT 1 AT SOUTHEASTERN SIDE

RecDate: 02/07/2018 Action : Super-Patch spalls Work By: LOCAL AGENCY Status : PROPOSED	EstCost: StrTarget: 2 YEARS DistTarget: EA:	Patch the side spall at the western exterior PS concrete box beam section, located near the middle of the structure.
RecDate: 02/07/2018 Action : Appr. Roadway-Repair Work By: LOCAL AGENCY Status : PROPOSED	EstCost: StrTarget: 2 YEARS DistTarget: EA:	Seal the AC pavement cracks on the structural surface, especially near both abutments with asphalt slurry.
RecDate: 06/08/2011 Action : Sub-Misc. Work By: LOCAL AGENCY Status : PROPOSED	EstCost: StrTarget: 2 YEARS DistTarget: EA:	Remove the small tree growing in Abutment 1 seat beneath the PS concrete box beam section.

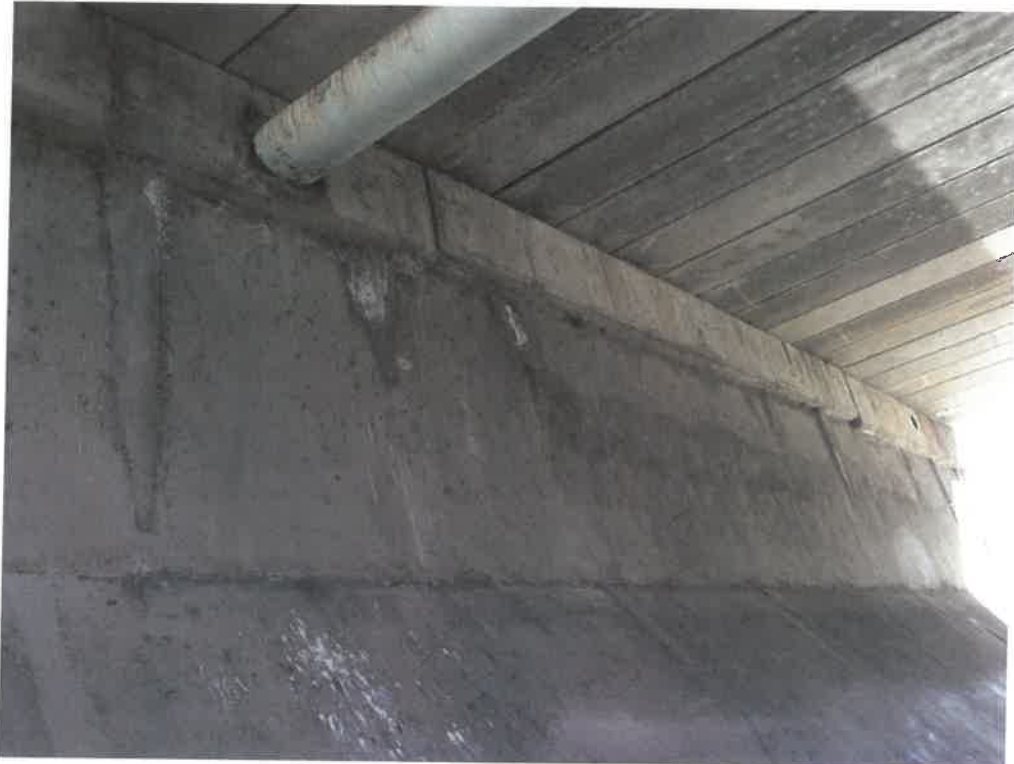
Photo No. 3

(220)									
There were no significant defects noted.									
251		Pile-CISS	2	12	ea.	10	2	0	0
1000		Corrosion	2	2		0	2	0	0
(251)									
Up to 12 concrete pile steel shell top portions are partially exposed beyond the faces of the abutment walls, 3 at Abutment 1 and 9 at Abutment 2 (Photo Number 3, 4, 6).

UNDER VIEW TOWARD ABUTMENT 2 AT NORTHEASTERN SIDE

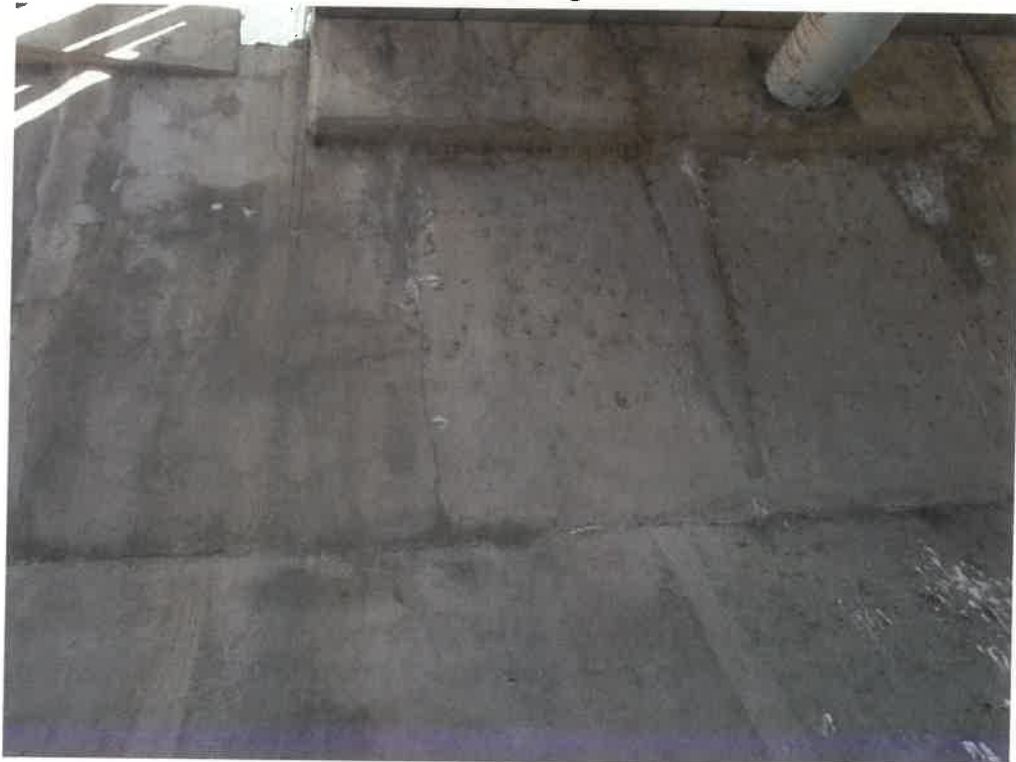
Photo No. 4

(215)									
Monolithic wingwalls (with the RC bent cap) are included in the total quantity.									
(215-1130)									
There is a vertical crack on the north abutment wall at the western side, up to 0.05 inch wide (Photo Number 4).									
220		Pile Cap/Footing-RC	2	40	m	40	0	0	0

TYPICAL ABUTMENT WALL VERTICAL CRACKS

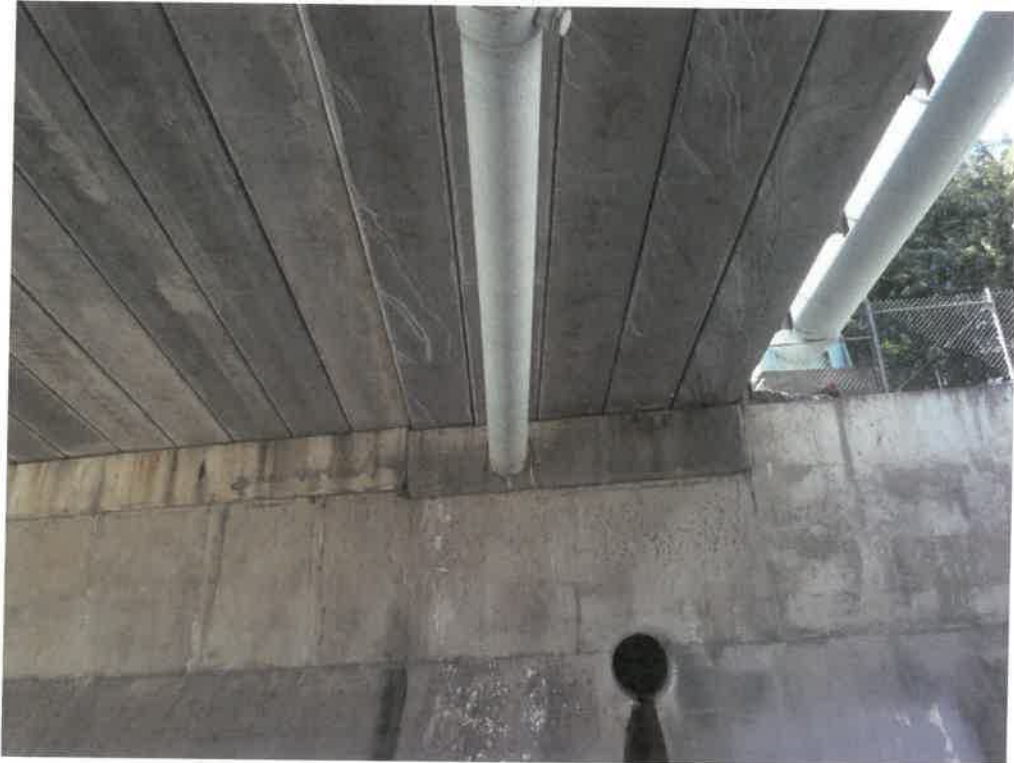
Photo No. 5

UNDER VIEW TOWARD ABUTMENT 1, NOTE THE UTILITY PIPE

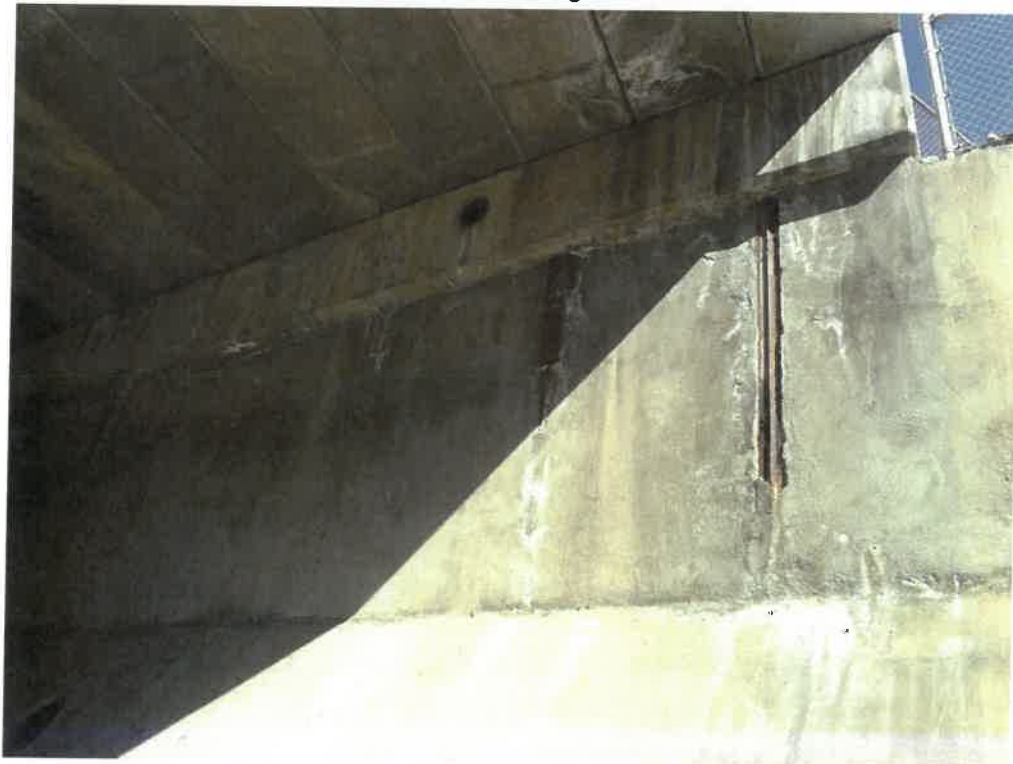
Photo No. 6

Elem No.	Defect /Prot	Element Description	Env Qty	Total Qty	Units	Qty in each Condition State			
						St. 1	St. 2	St. 3	St. 4
(251-1000)									
Two exposed steel shells at the eastern side of Abutment 2 are rusted (Photo Number 6).									
330		Railing-Metal	2	33	m	33	0	0	0
(330)									
There were no significant defects noted.

THE EXPOSED CONCRETE PILE STEEL CASING AT EASTERN SIDE OF ABUTMENT 2
