**DEPARTMENT OF TRANSPORTATION**  
Structure Maintenance & Investigations

Bridge Number : 55C0205  
Facility Carried: SANTA ANA AVENUE  
Location : 0.1 MI S/O BRISTOL STREE  
City :  
Inspection Date : 01/27/2017  
Inspection Type  
Routine FC Underwater Special Other  
☒

## Bridge Inspection Report

**STRUCTURE NAME:** SANTA ANA-DELHI CHANNEL

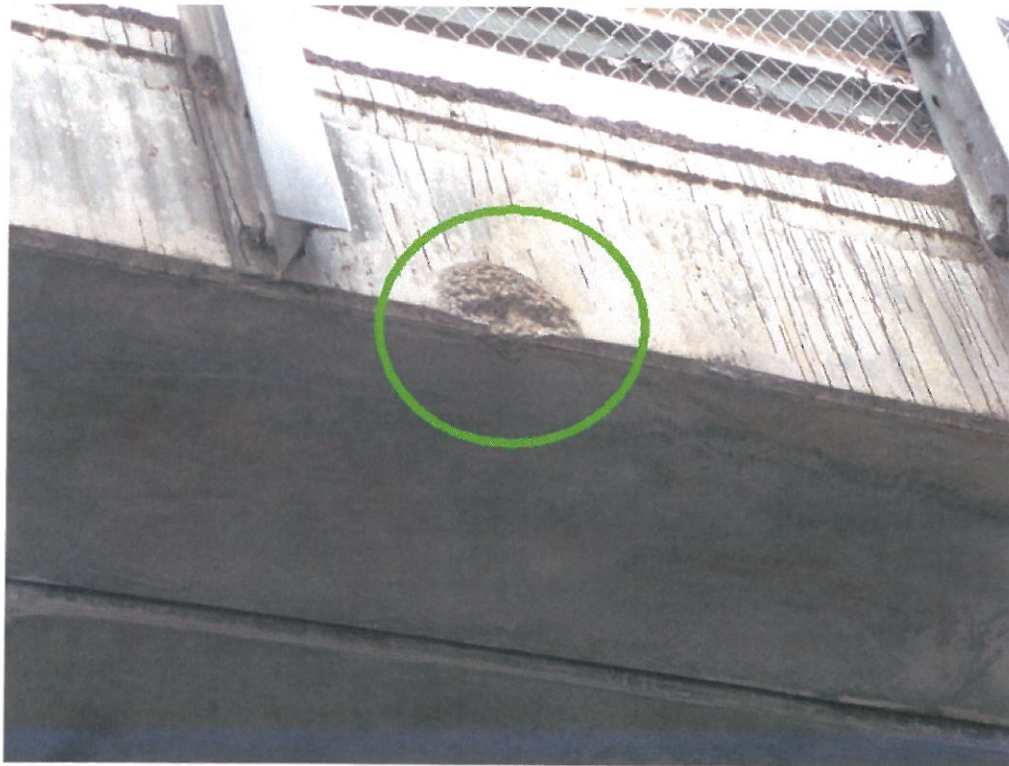
Photo No. 4

| ELEMENT INSPECTION RATINGS AND NOTES | | | | | | | | | | |
|---|---|---|---|---|---|---|---|---|---|---|
| The westerly face of the westerly box girder unit exhibits a spall 12 inches X 8 inches X 1.5 inch at | | | | | | | | | | |

| Elem No. | Defect /Prot | Element Description | Env | Total Qty | Units | Qty in each Condition State | | | |
|---|---|---|---|---|---|---|---|---|---|
| the mid-span. (see the attached photos 4 & 5) | | | | | | | | | |

Spall 12" X8" X 1.5 at teh west face of the bog girder at mid-span.
