Bridge Number : 55C0344  
Facility Carried: ADAMS AVENUE  
Location : 0.5 MI E/O BROOKHURST ST  
City :  
Inspection Date : 01/27/2017

**Bridge Inspection Report**

**STRUCTURE NAME:** SANTA ANA RIVER (ADAMS AVE)

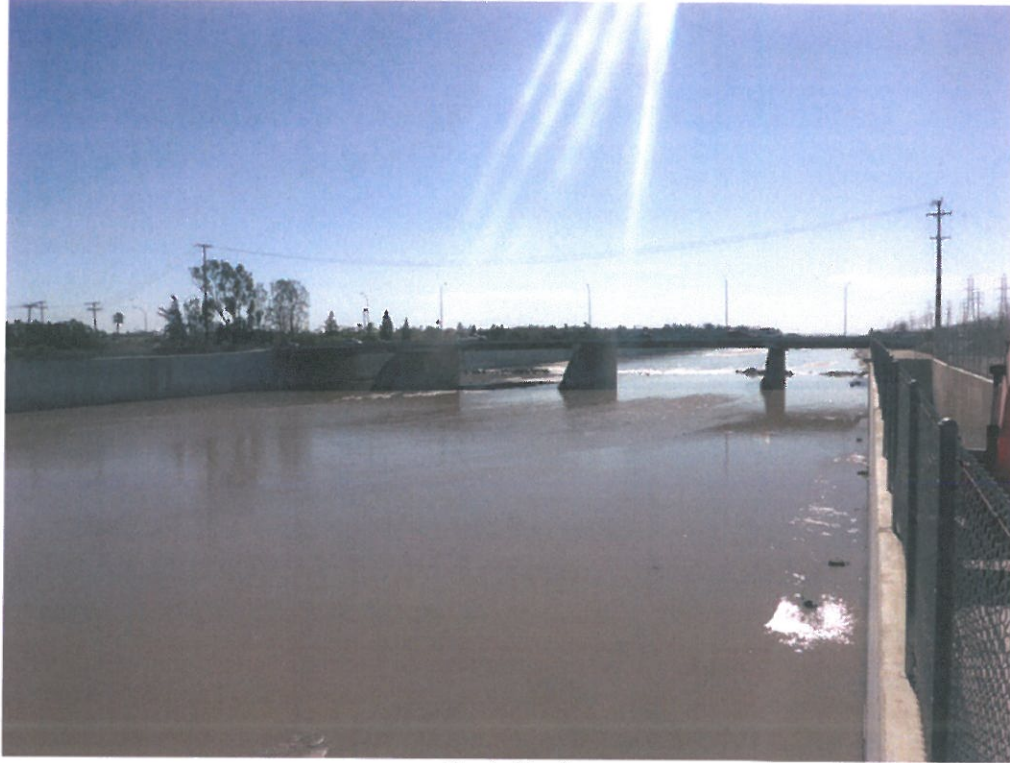
Photo No. 1

Elevation View looking South

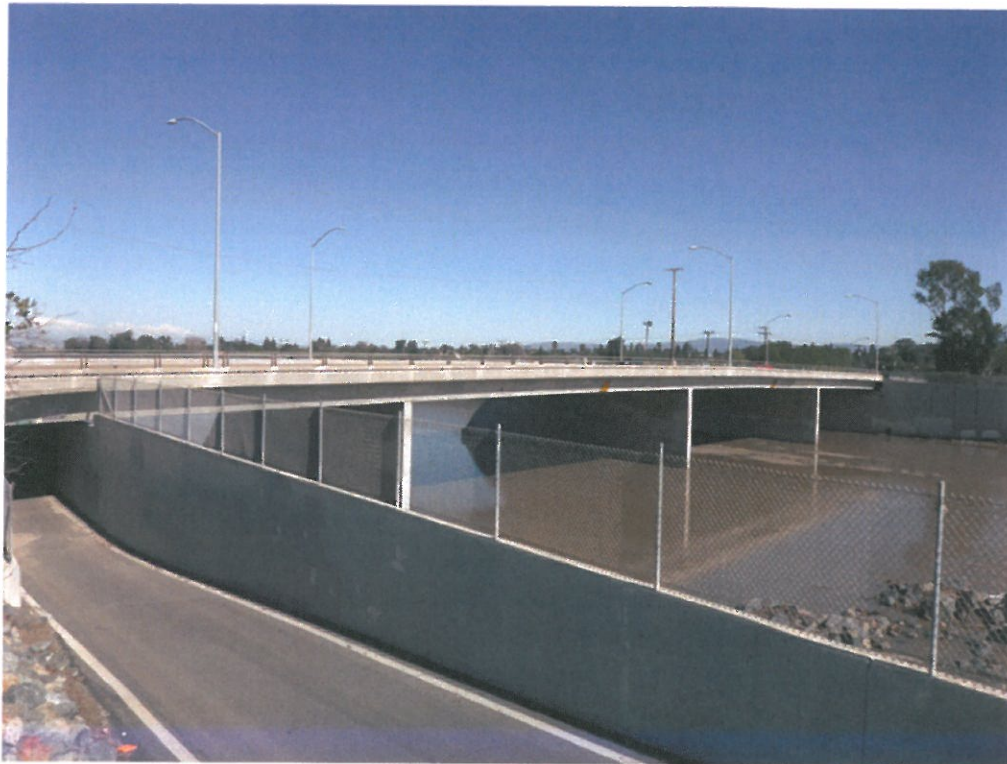
Photo No. 2

Elevation View looking North-East

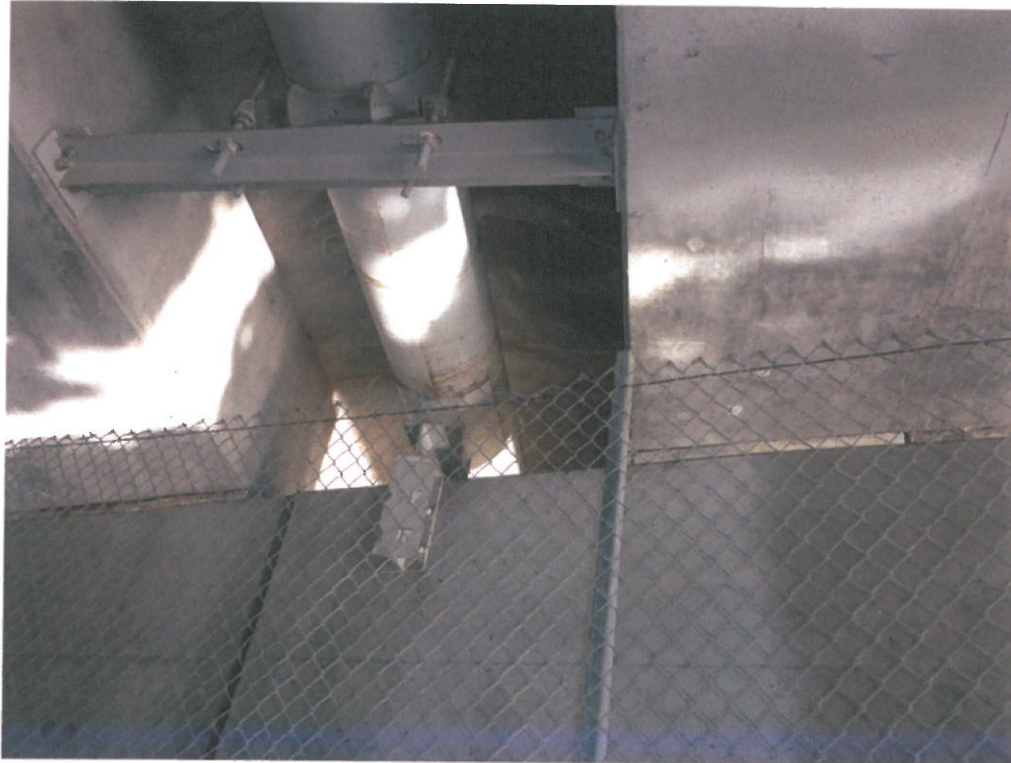
Photo No. 8

The soffit at the closure pour between the two box girders exhibits few transverse cracks with white efflorescence at span 4.

Soffit between the 2 box girders has transvrs cracks with white efflorescence at span 4.

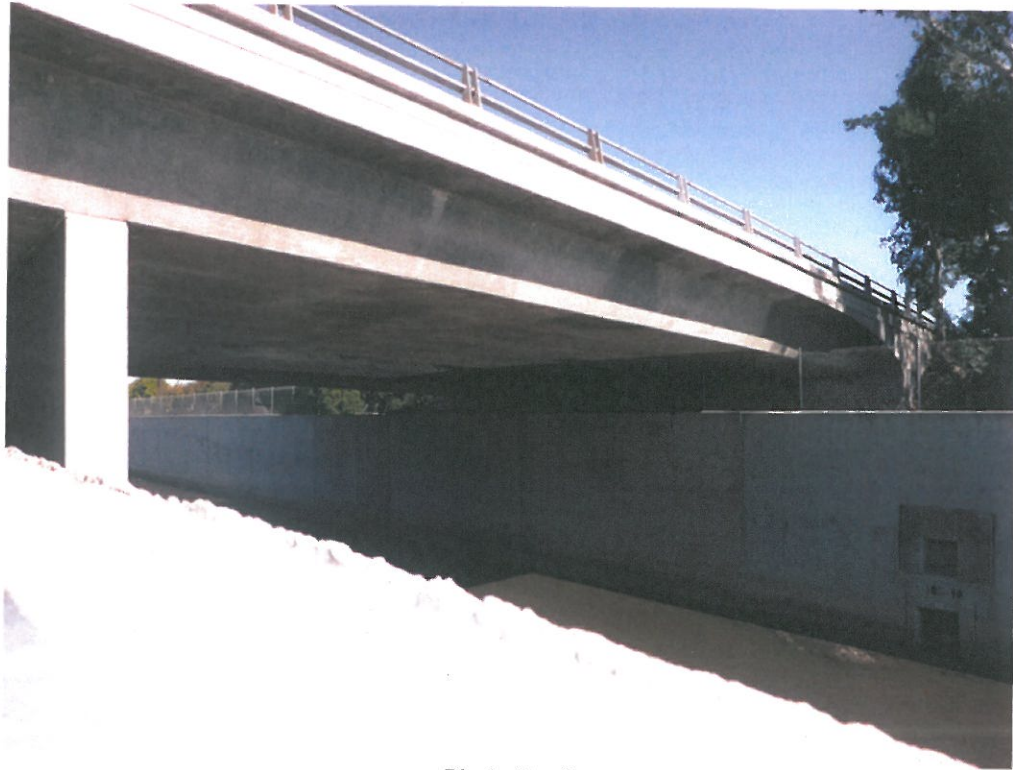
Photo No. 9

Underside View looking East
