DEPARTMENT OF TRANSPORTATION
Structure Maintenance & Investigations

Bridge Number : 55C0371
Facility Carried: SEGERSTROM-SLATER
Location : 0.3 MI. W/O HARBOR BLVD.
City :
Inspection Date : 06/28/2017

Bridge Inspection Report

STRUCTURE NAME: SANTA ANA RIVER CHANNEL (SEGERSTROM-SLATER)

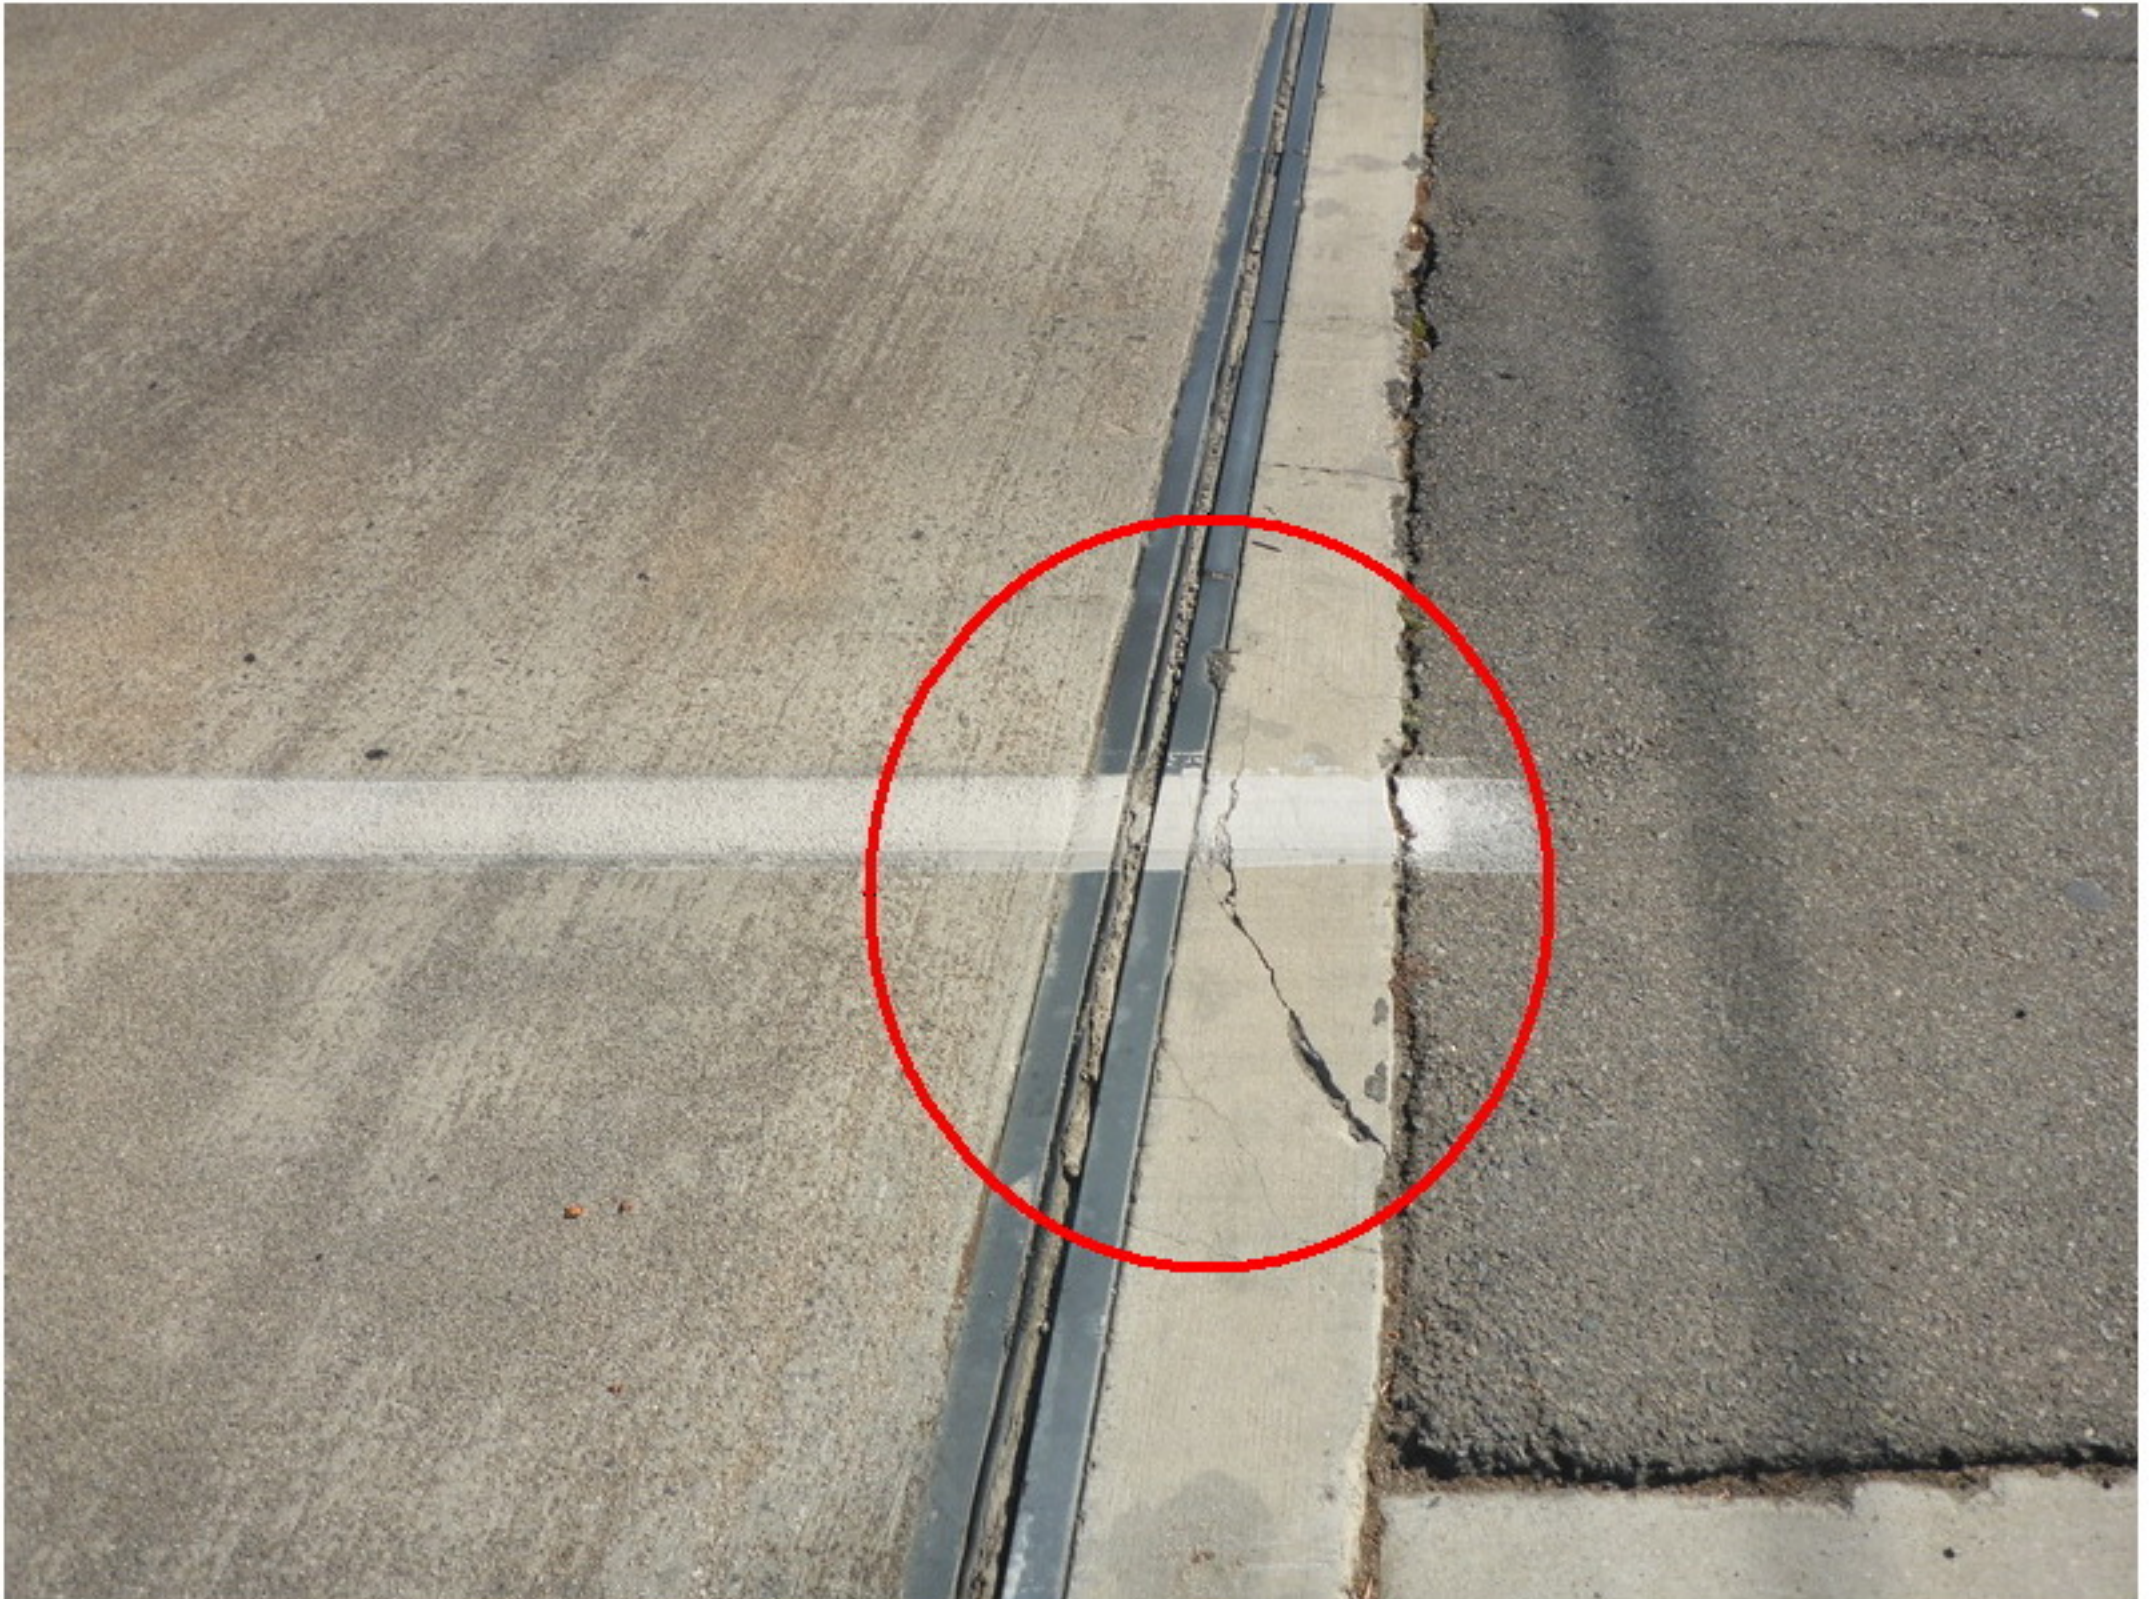
Photo No. 1

The header of the east joint has a crack 3 feet long at south end. (see the attached photo no. 1)

Header joint crack 3 feet long at east Abutment.

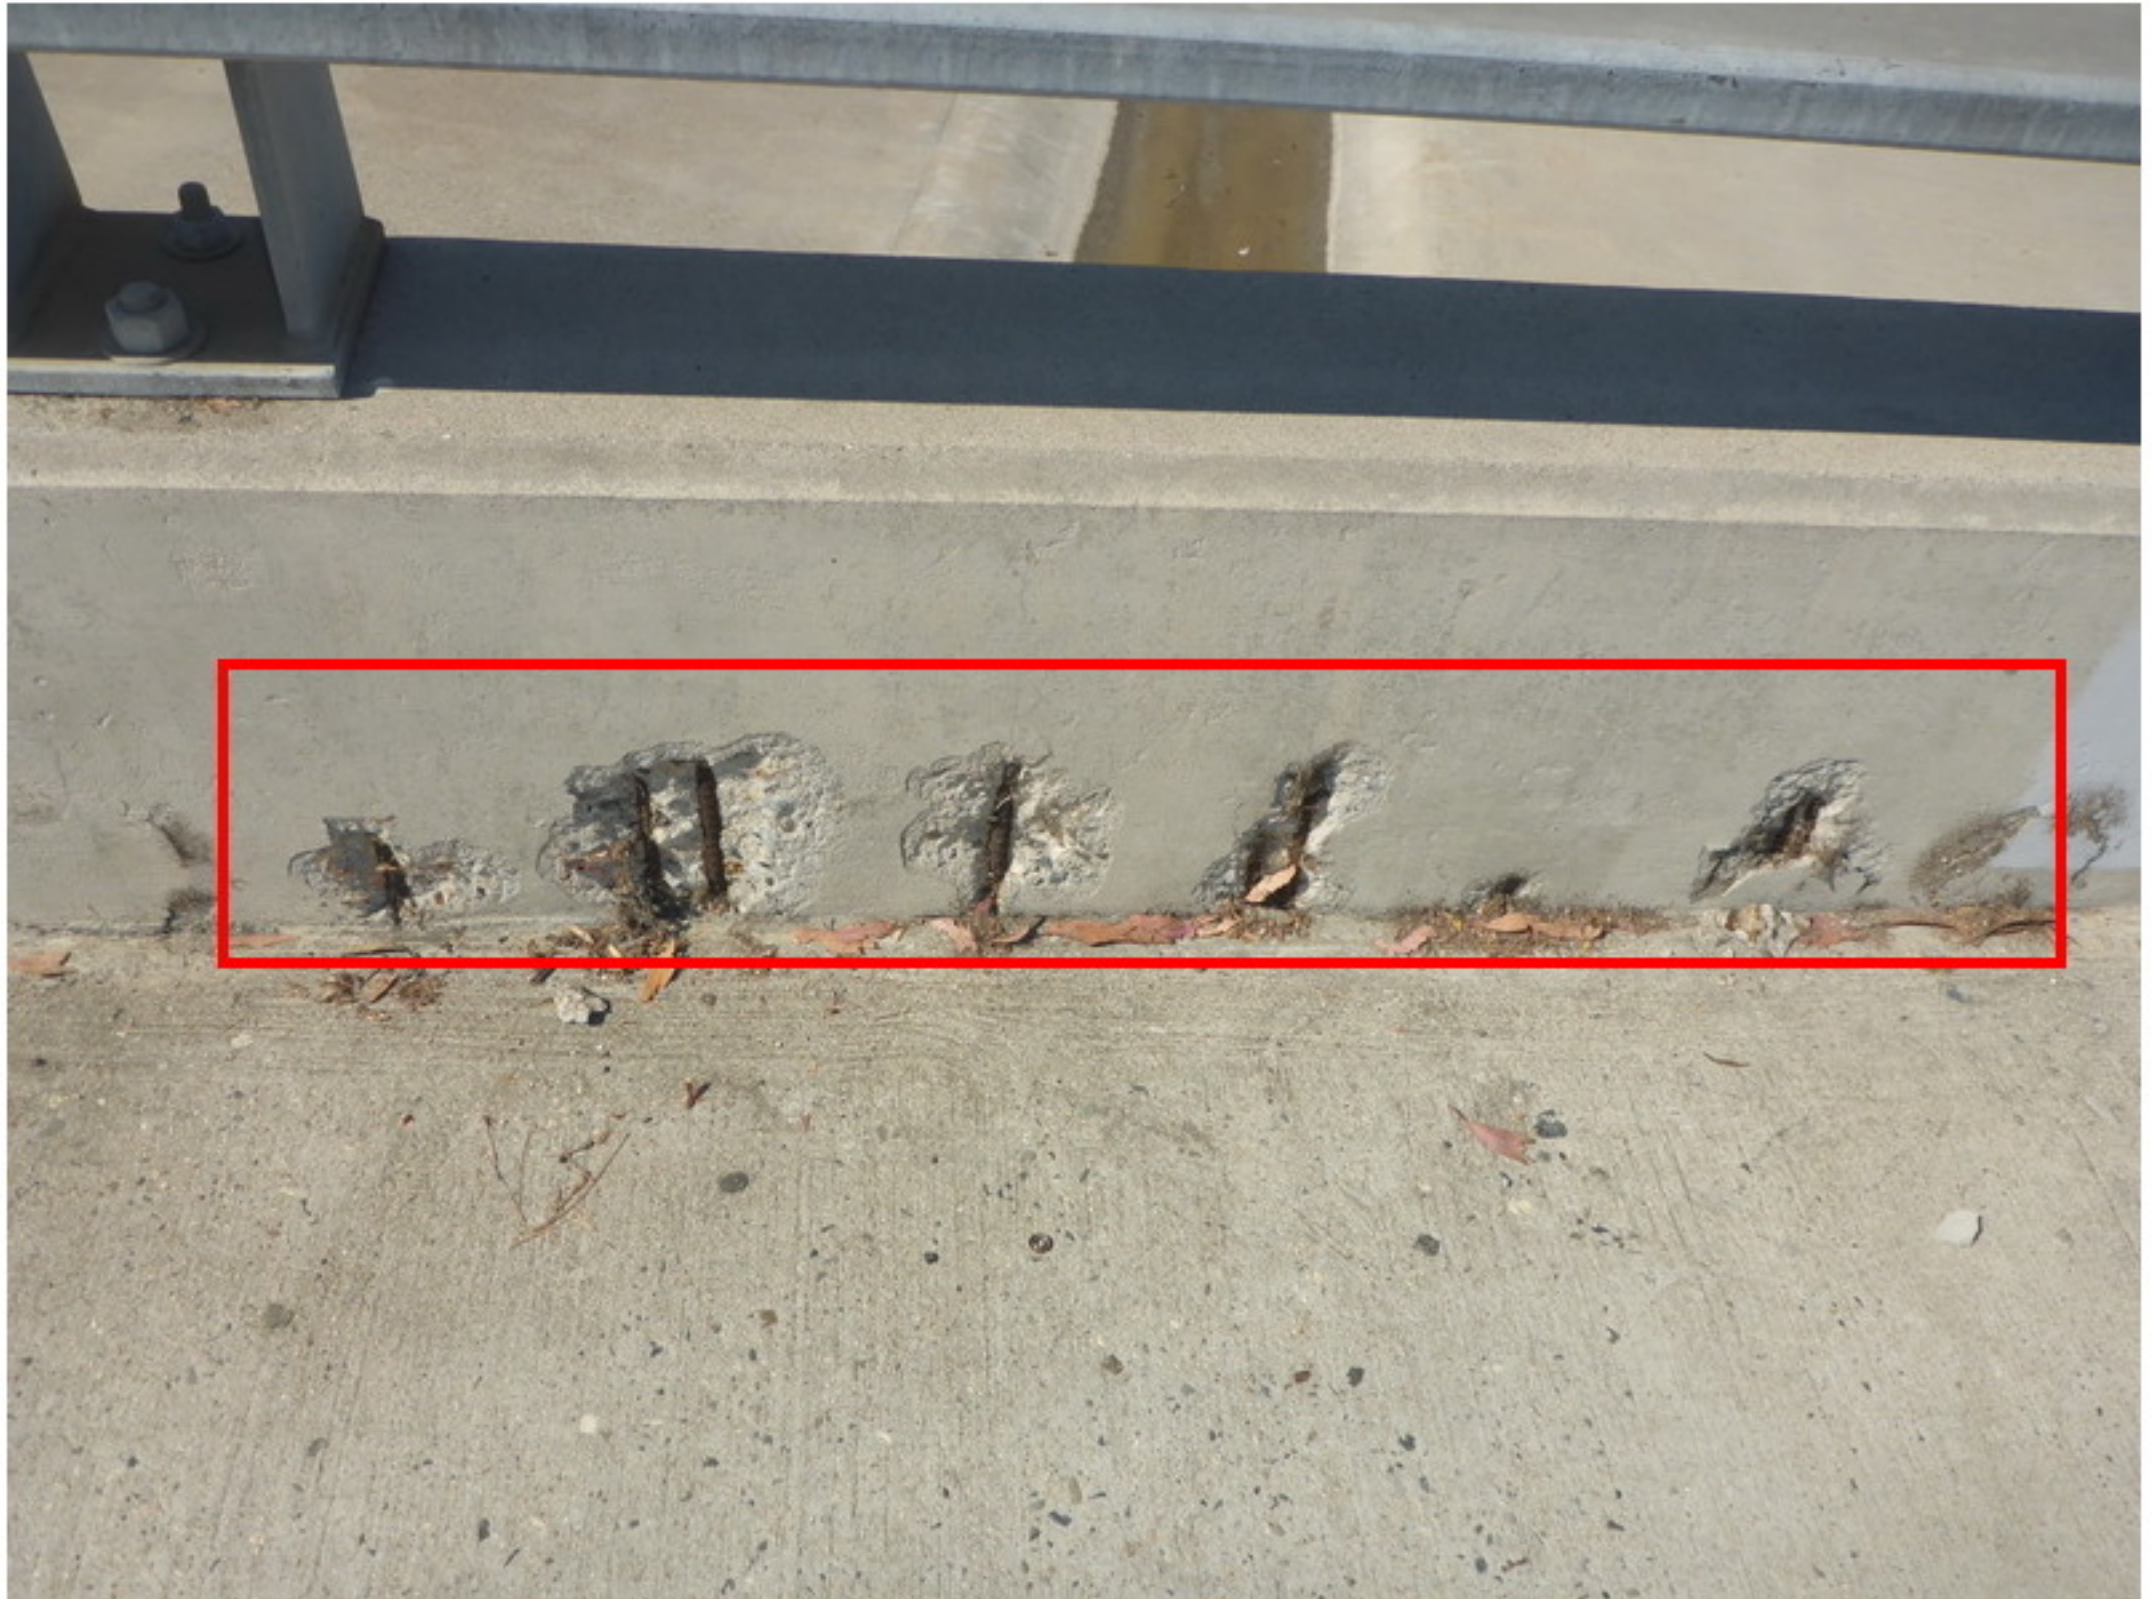
Photo No. 2

There are two spalls 15 inches X 5 inches X 1.5 inches with exposed rebars at the inside face of the south rail at 50 and 70 feet from west end; and many spalls +/- 6 inches X 4 inches X 1 inch with rebar exposed and rusted at many locations of the inside face of both rails. (see the attached photos no. 2, 3 & 5)

Several spall w/rebar exposed at both rails.

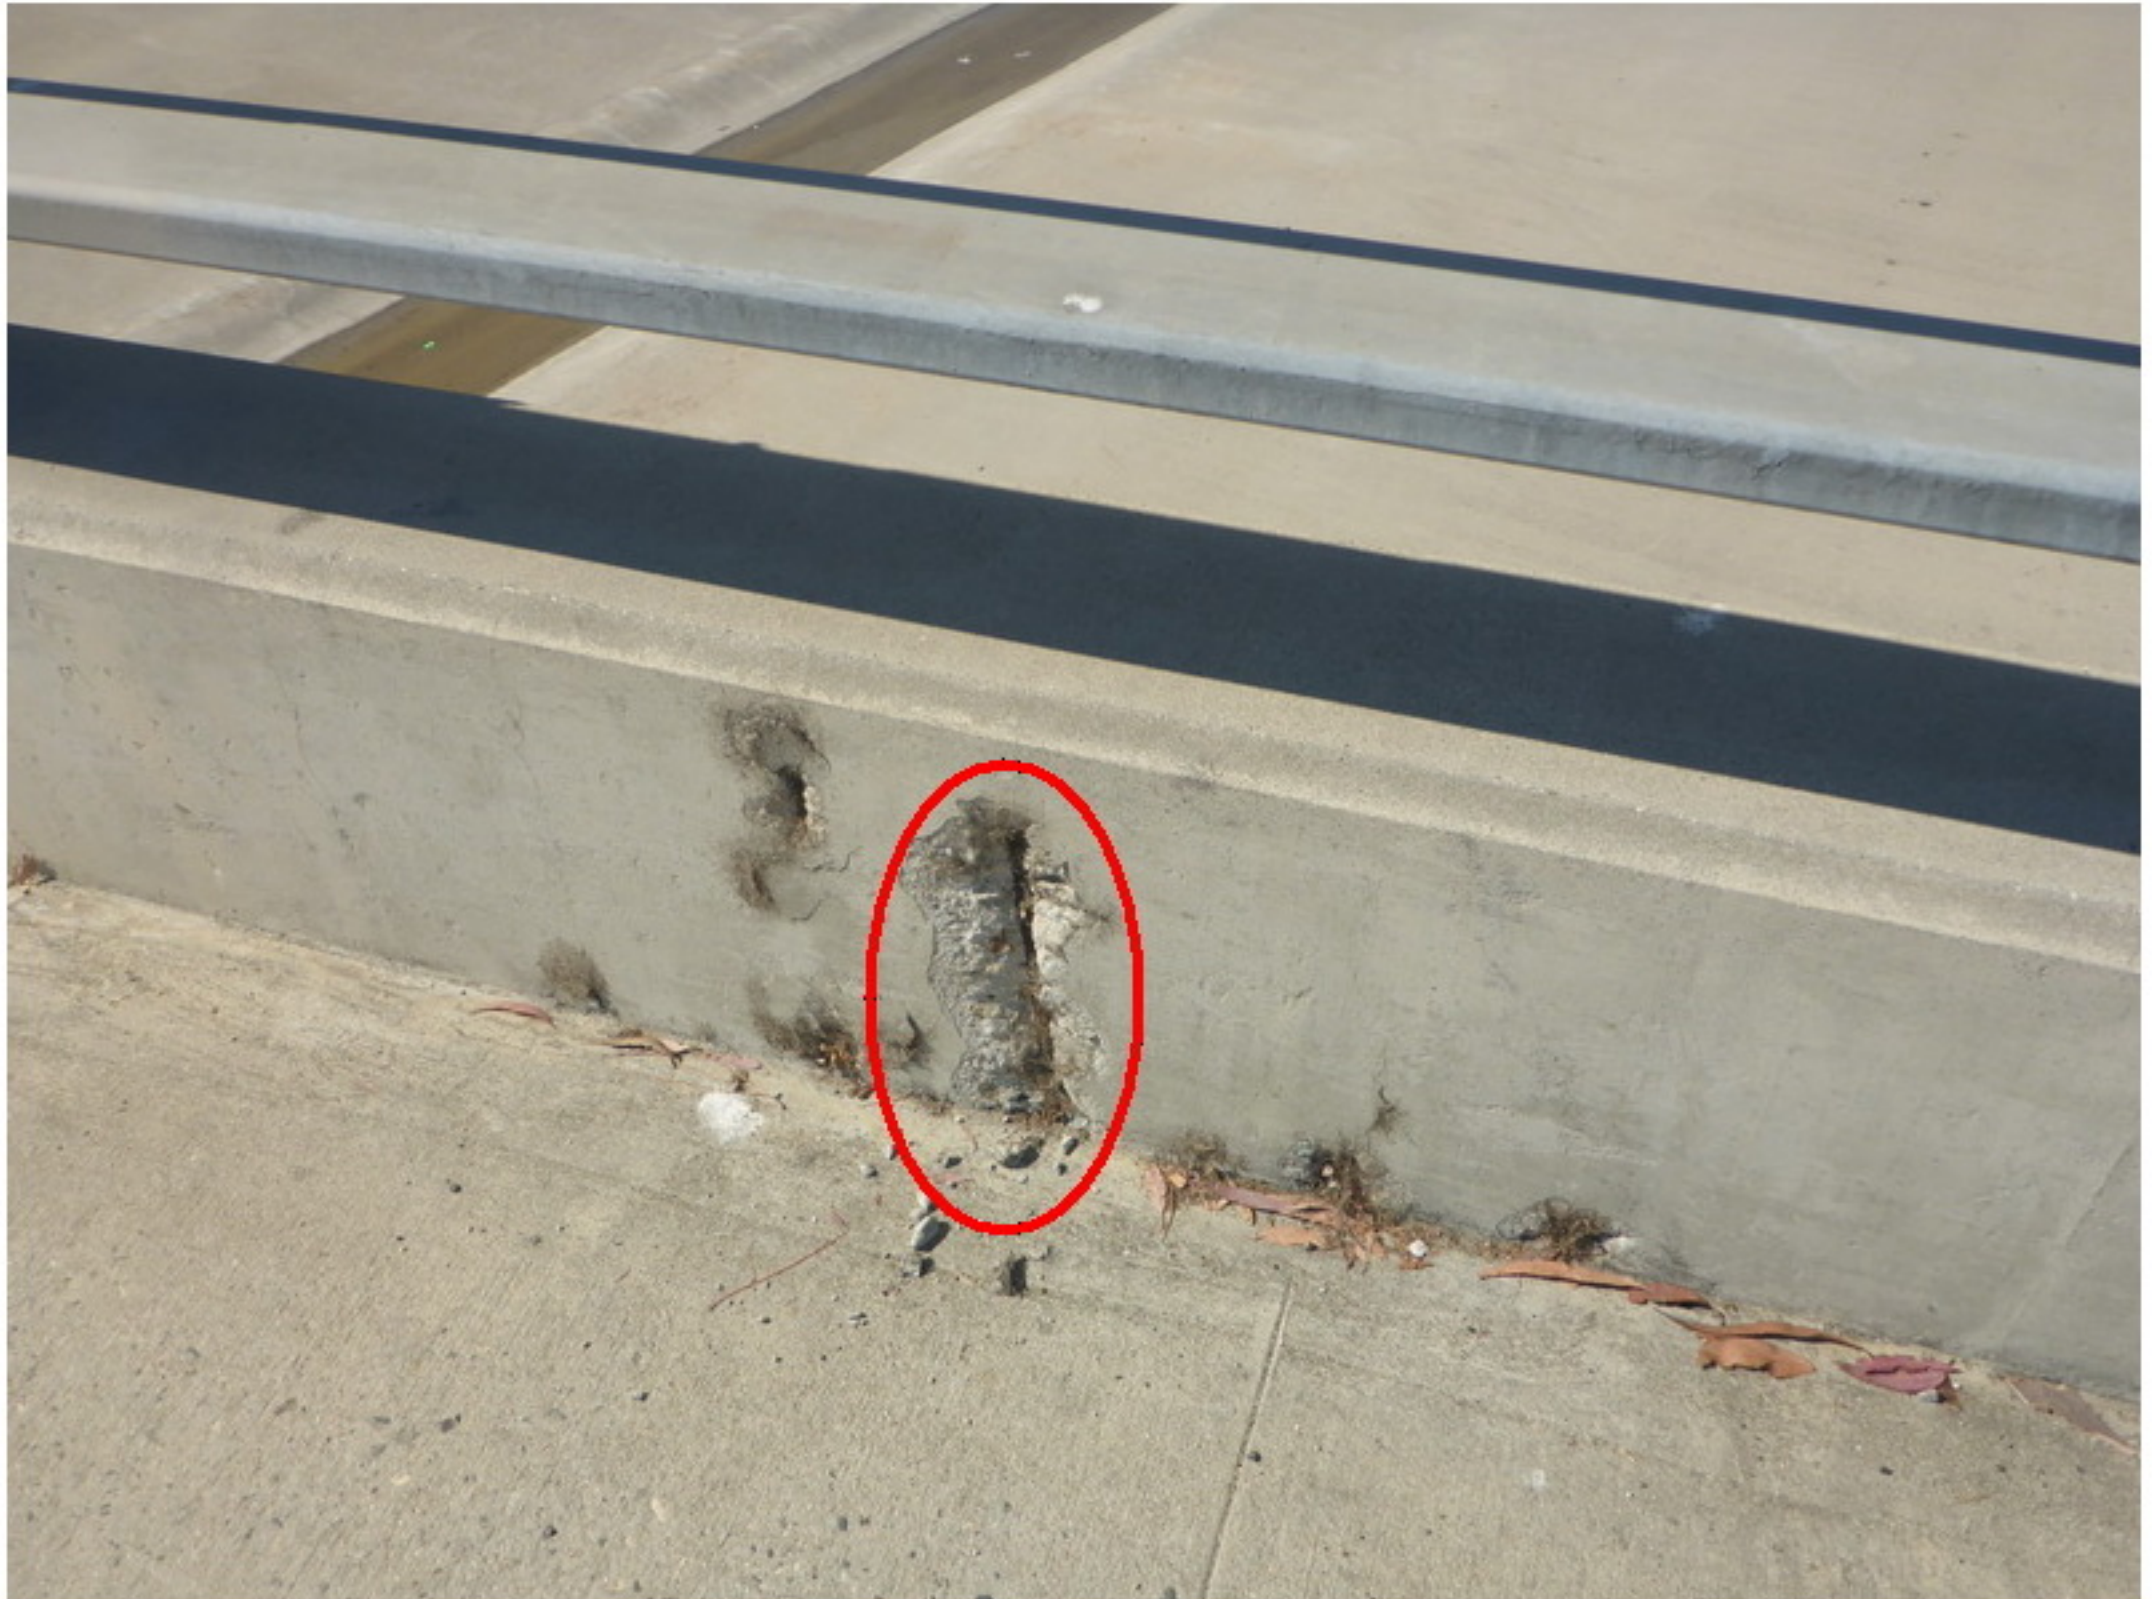
Photo No. 3

A spall 15 " X 5" X 1.5 at the interior face of the south rail.

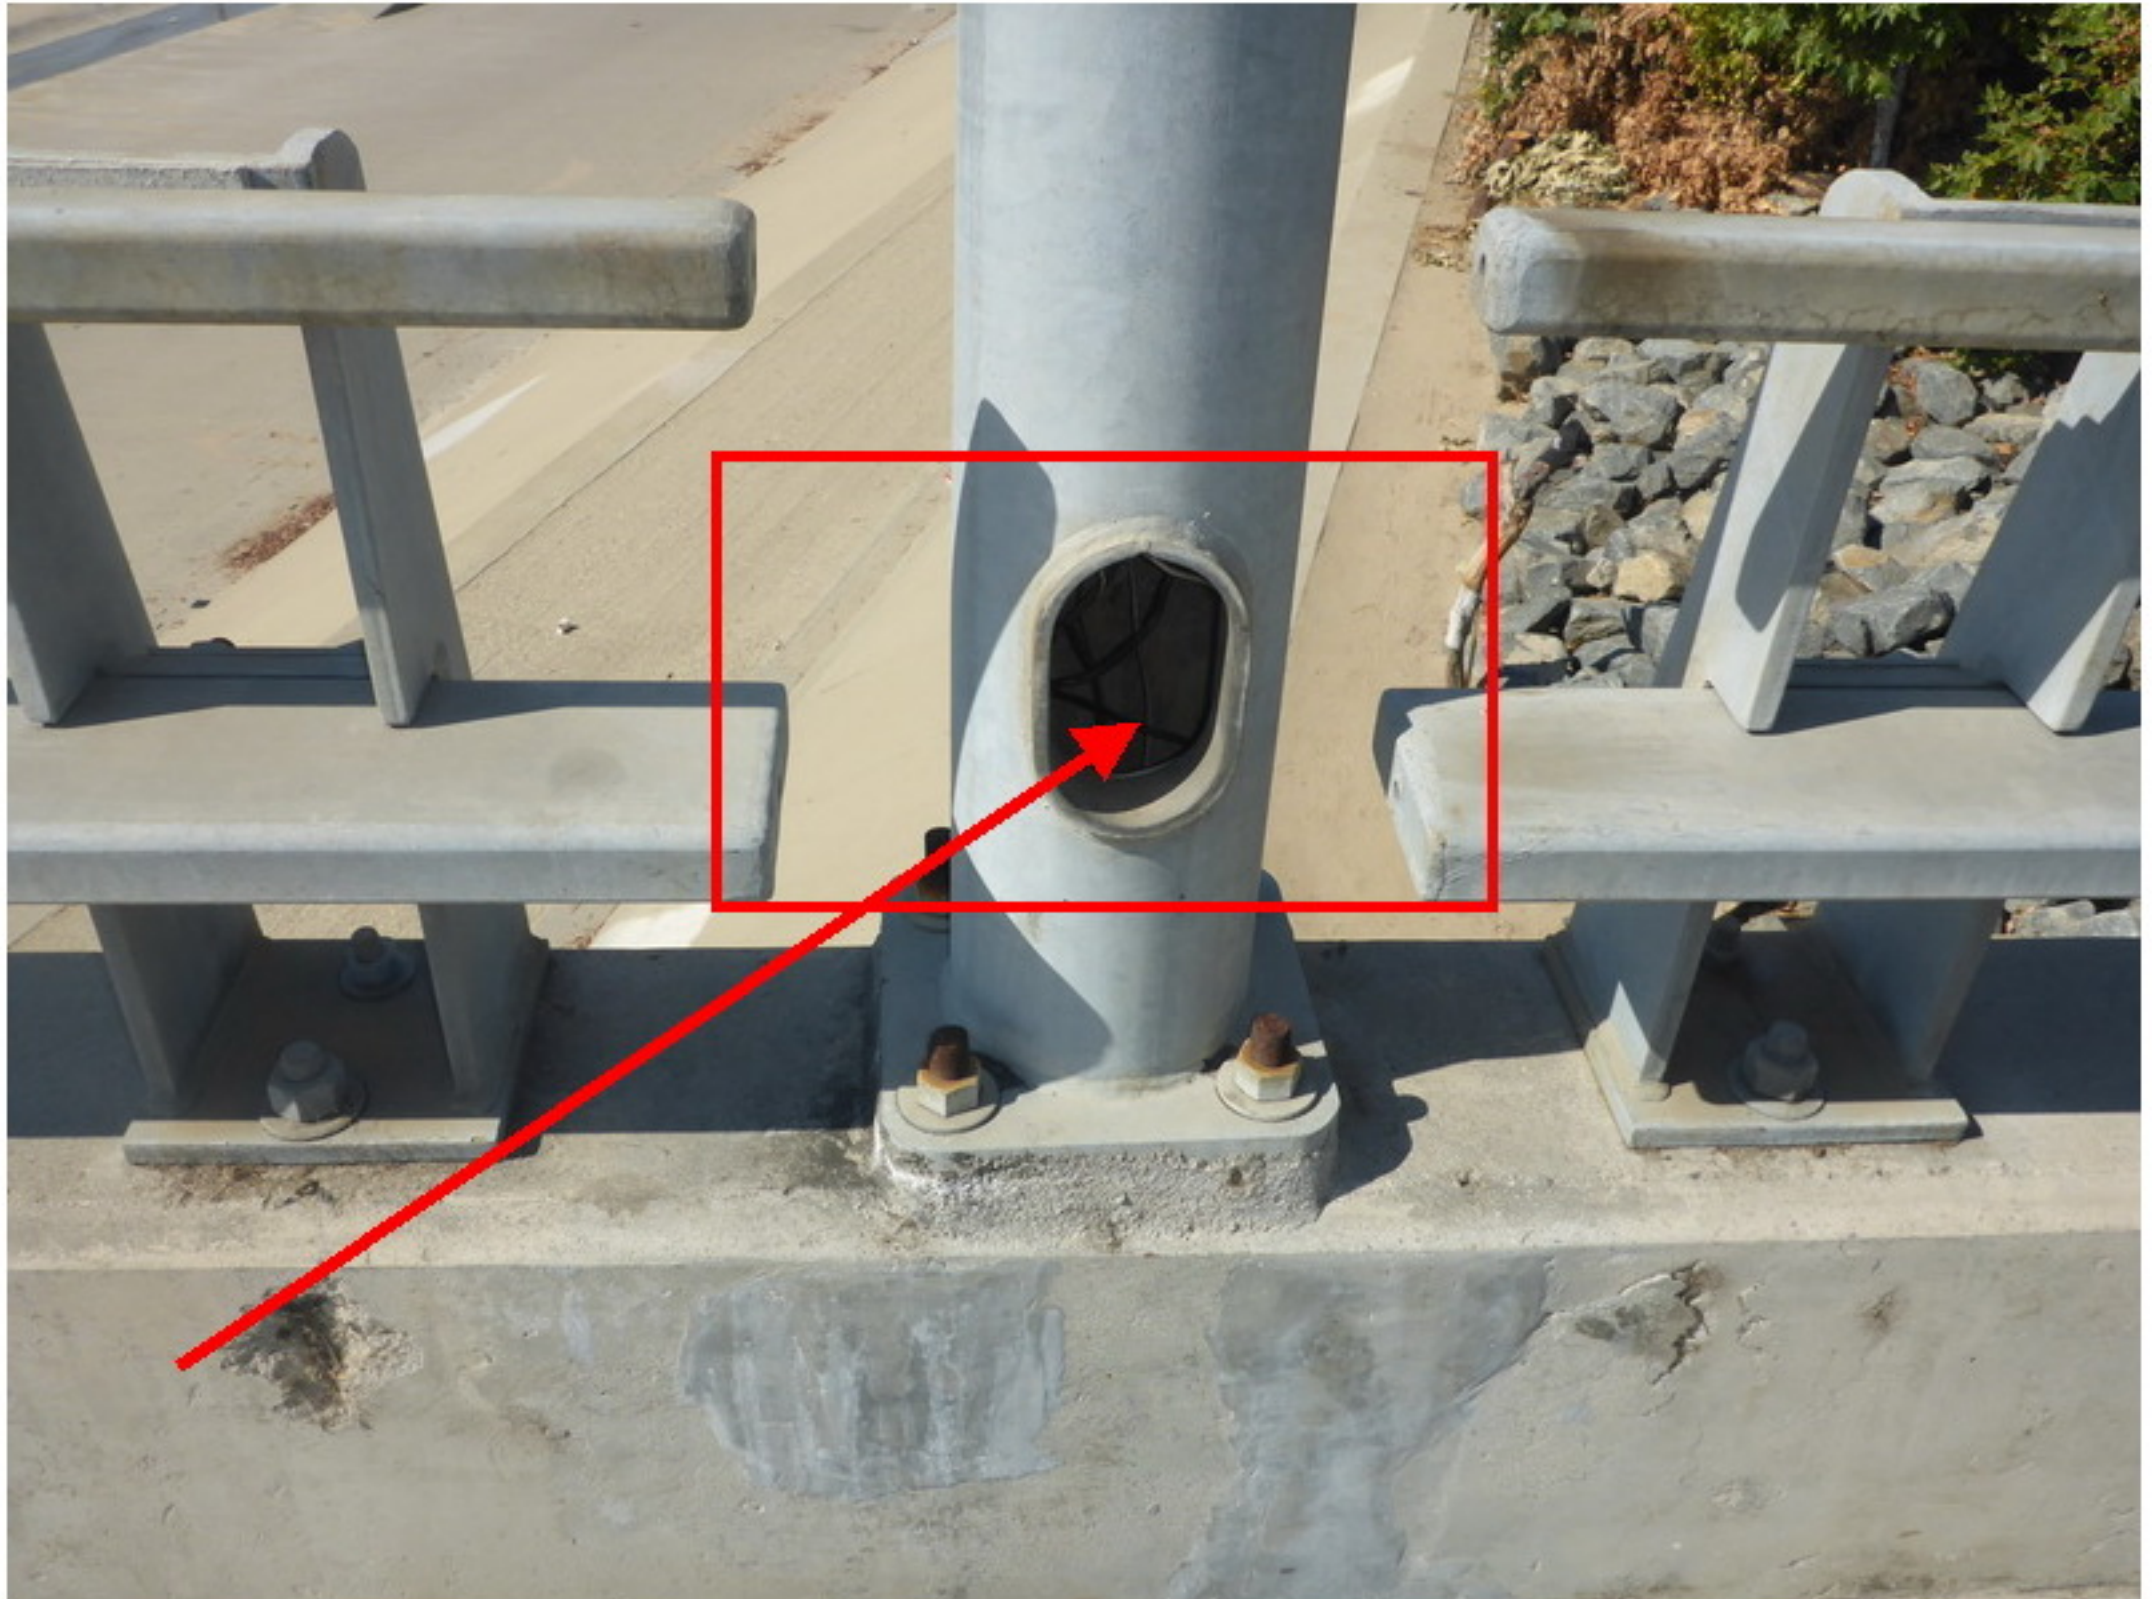
Photo No. 4

An electric cover is missing at the light pole above span 1 at the south side. (see the attached photo no. 4)

Electric cover is missing at span 1 southerly side.

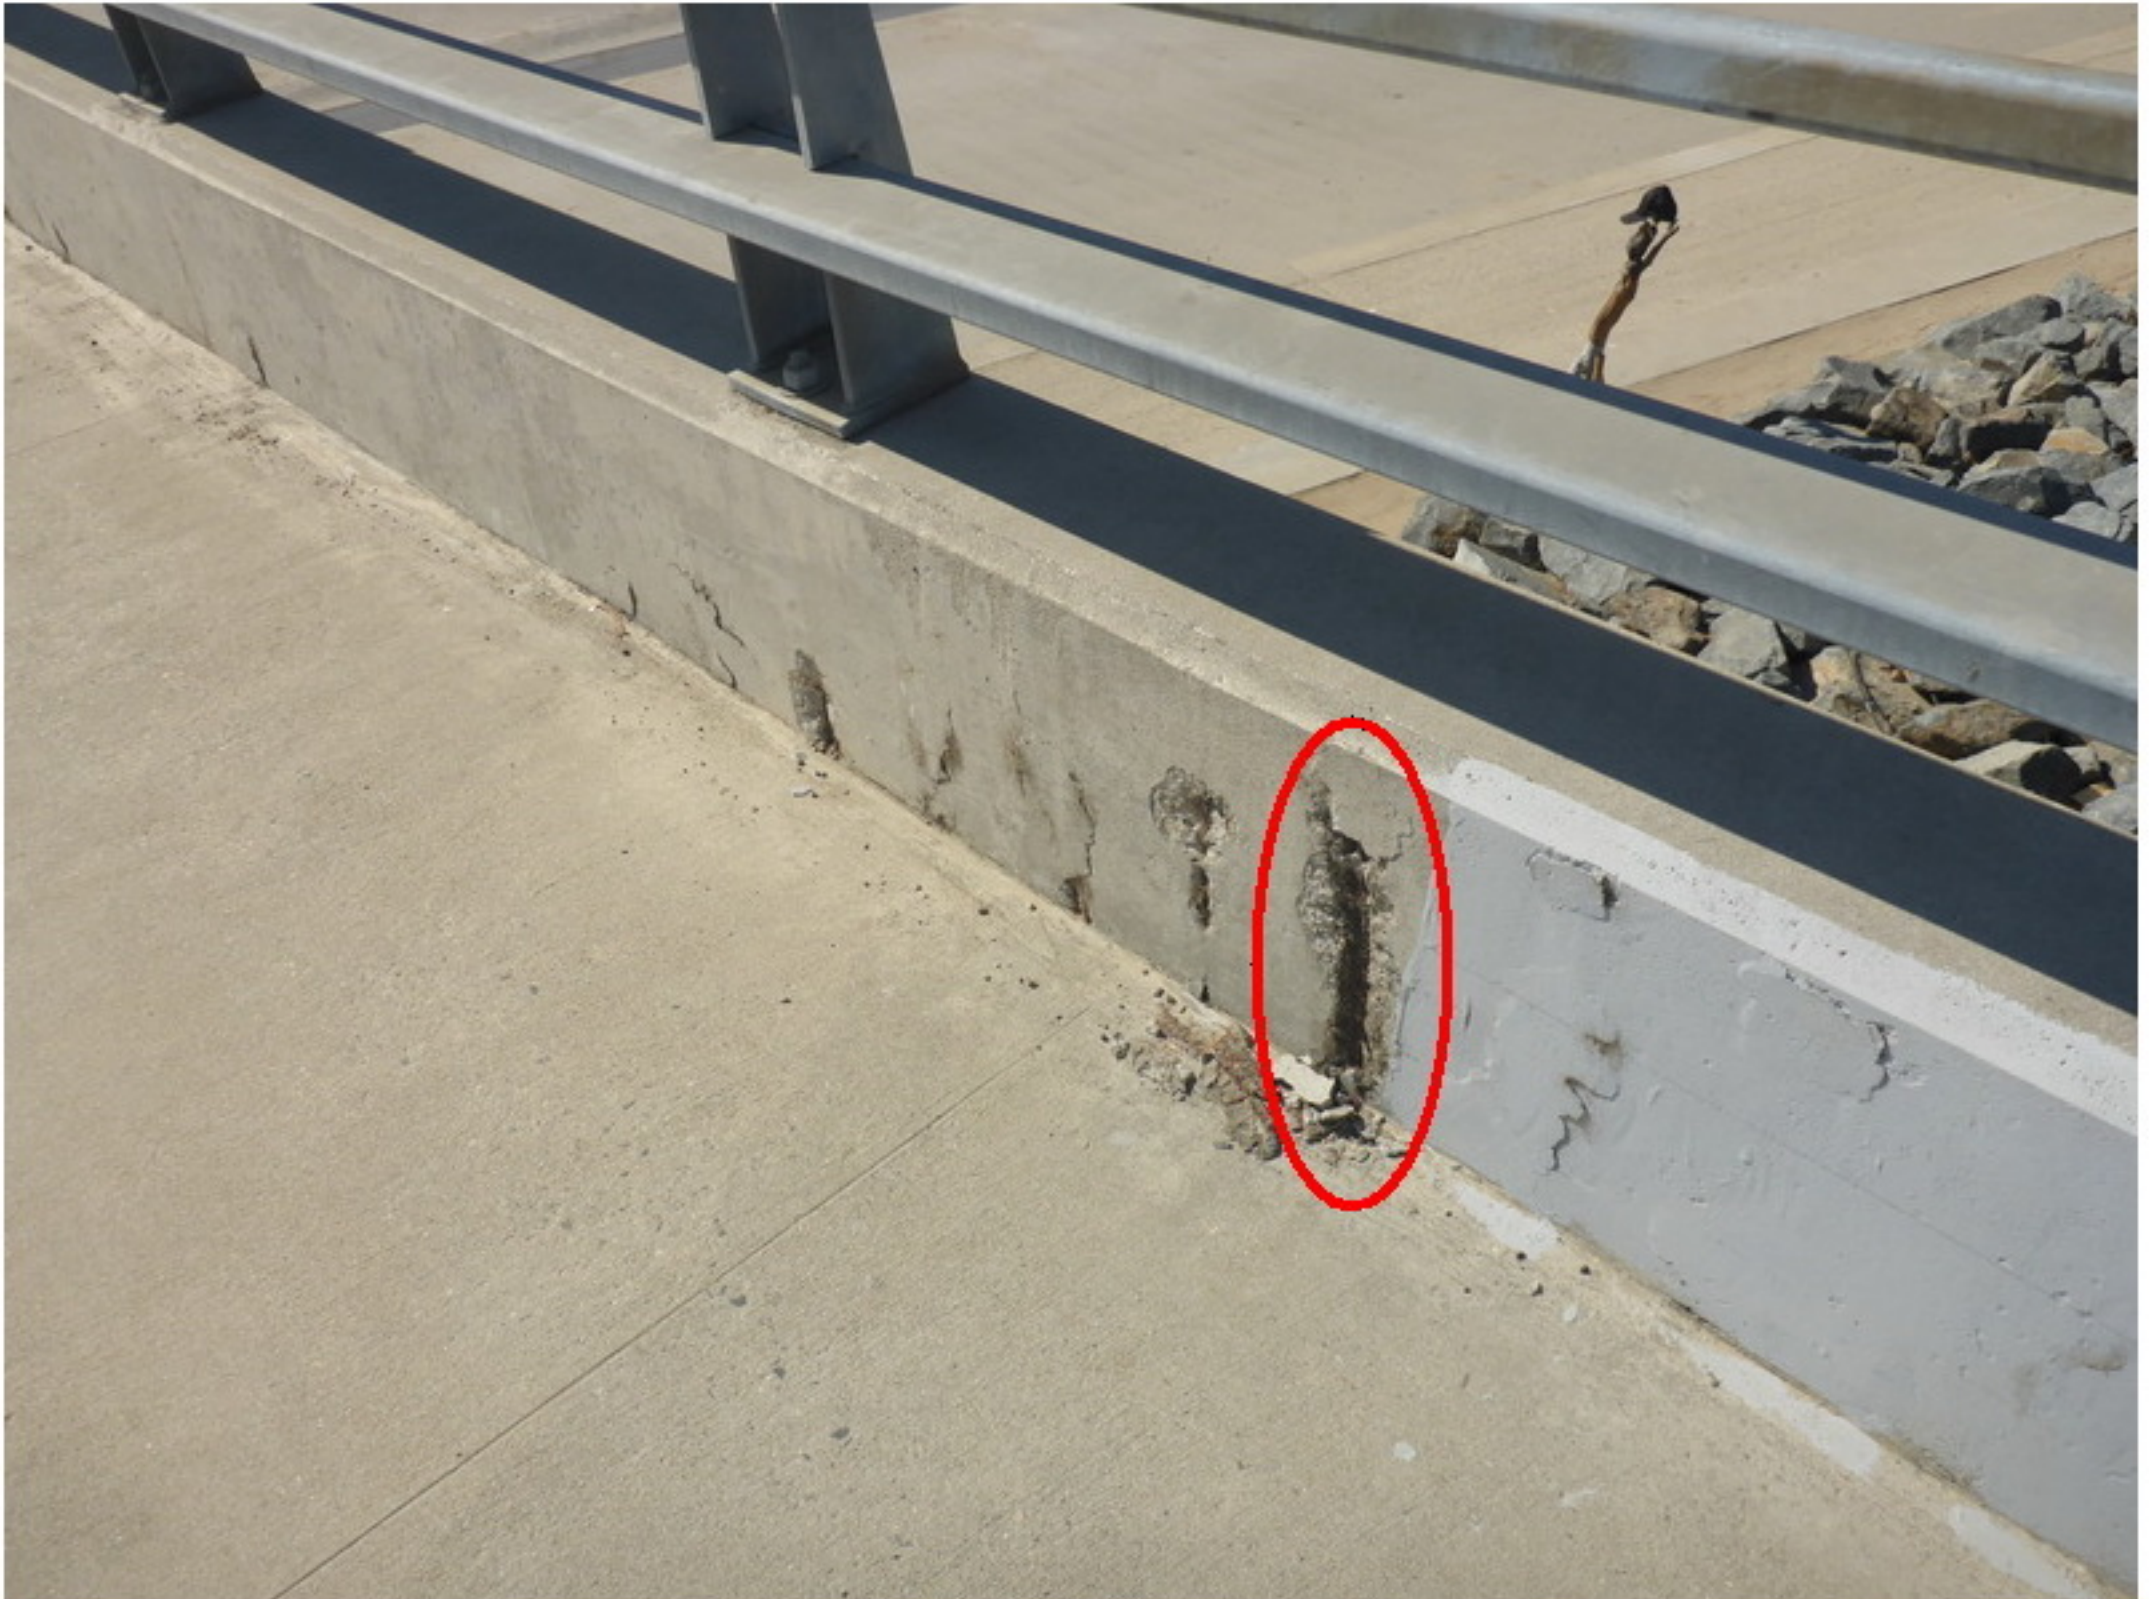
Photo No. 5

A spall 15 " X 5" X 1.5 at the interior face of the south rail.

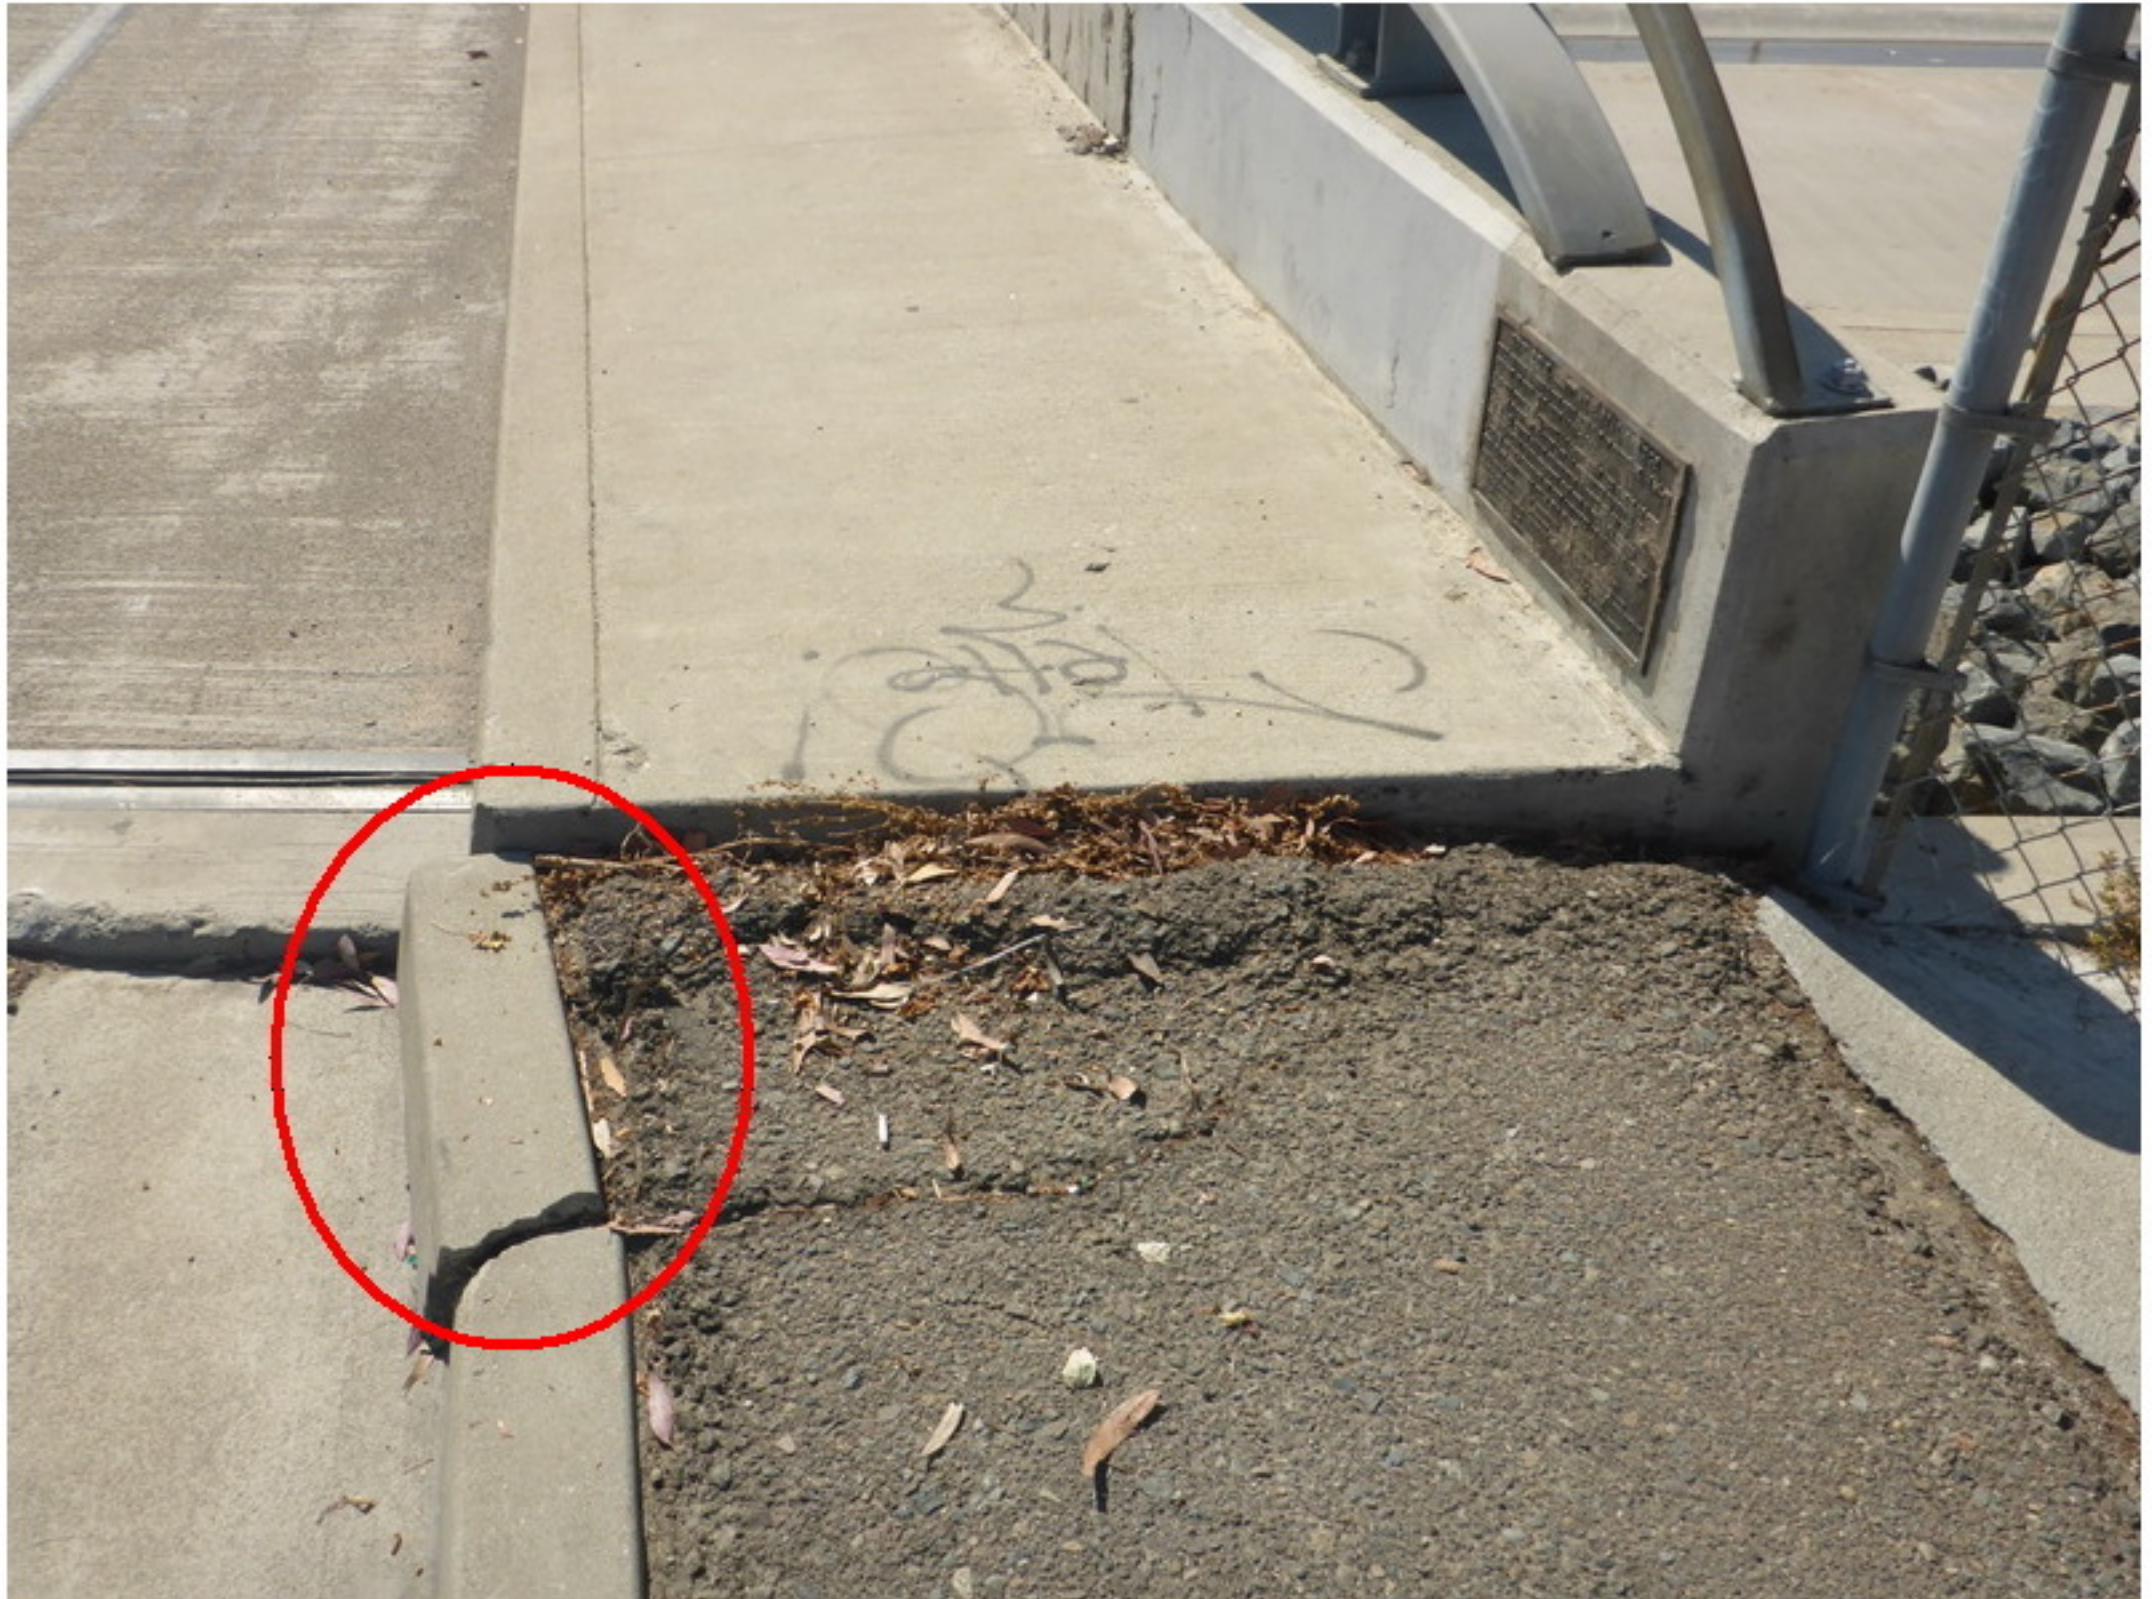
Photo No. 6

The south west corner of the curb is broken 2.5 feet. (see the attached photo no. 6)

Curb south-west corner is broken 2.5 feet.
