DEPARTMENT OF TRANSPORTATION
Structure Maintenance & Investigations

Bridge Number : 55C0371
Facility Carried: SEGERSTROM-SLATER
Location : 0.3 MI. W/O HARBOR BLVD.
City :
Inspection Date : 06/28/2017

Bridge Inspection Report

STRUCTURE NAME: SANTA ANA RIVER CHANNEL (SEGERSTROM-SLATER)

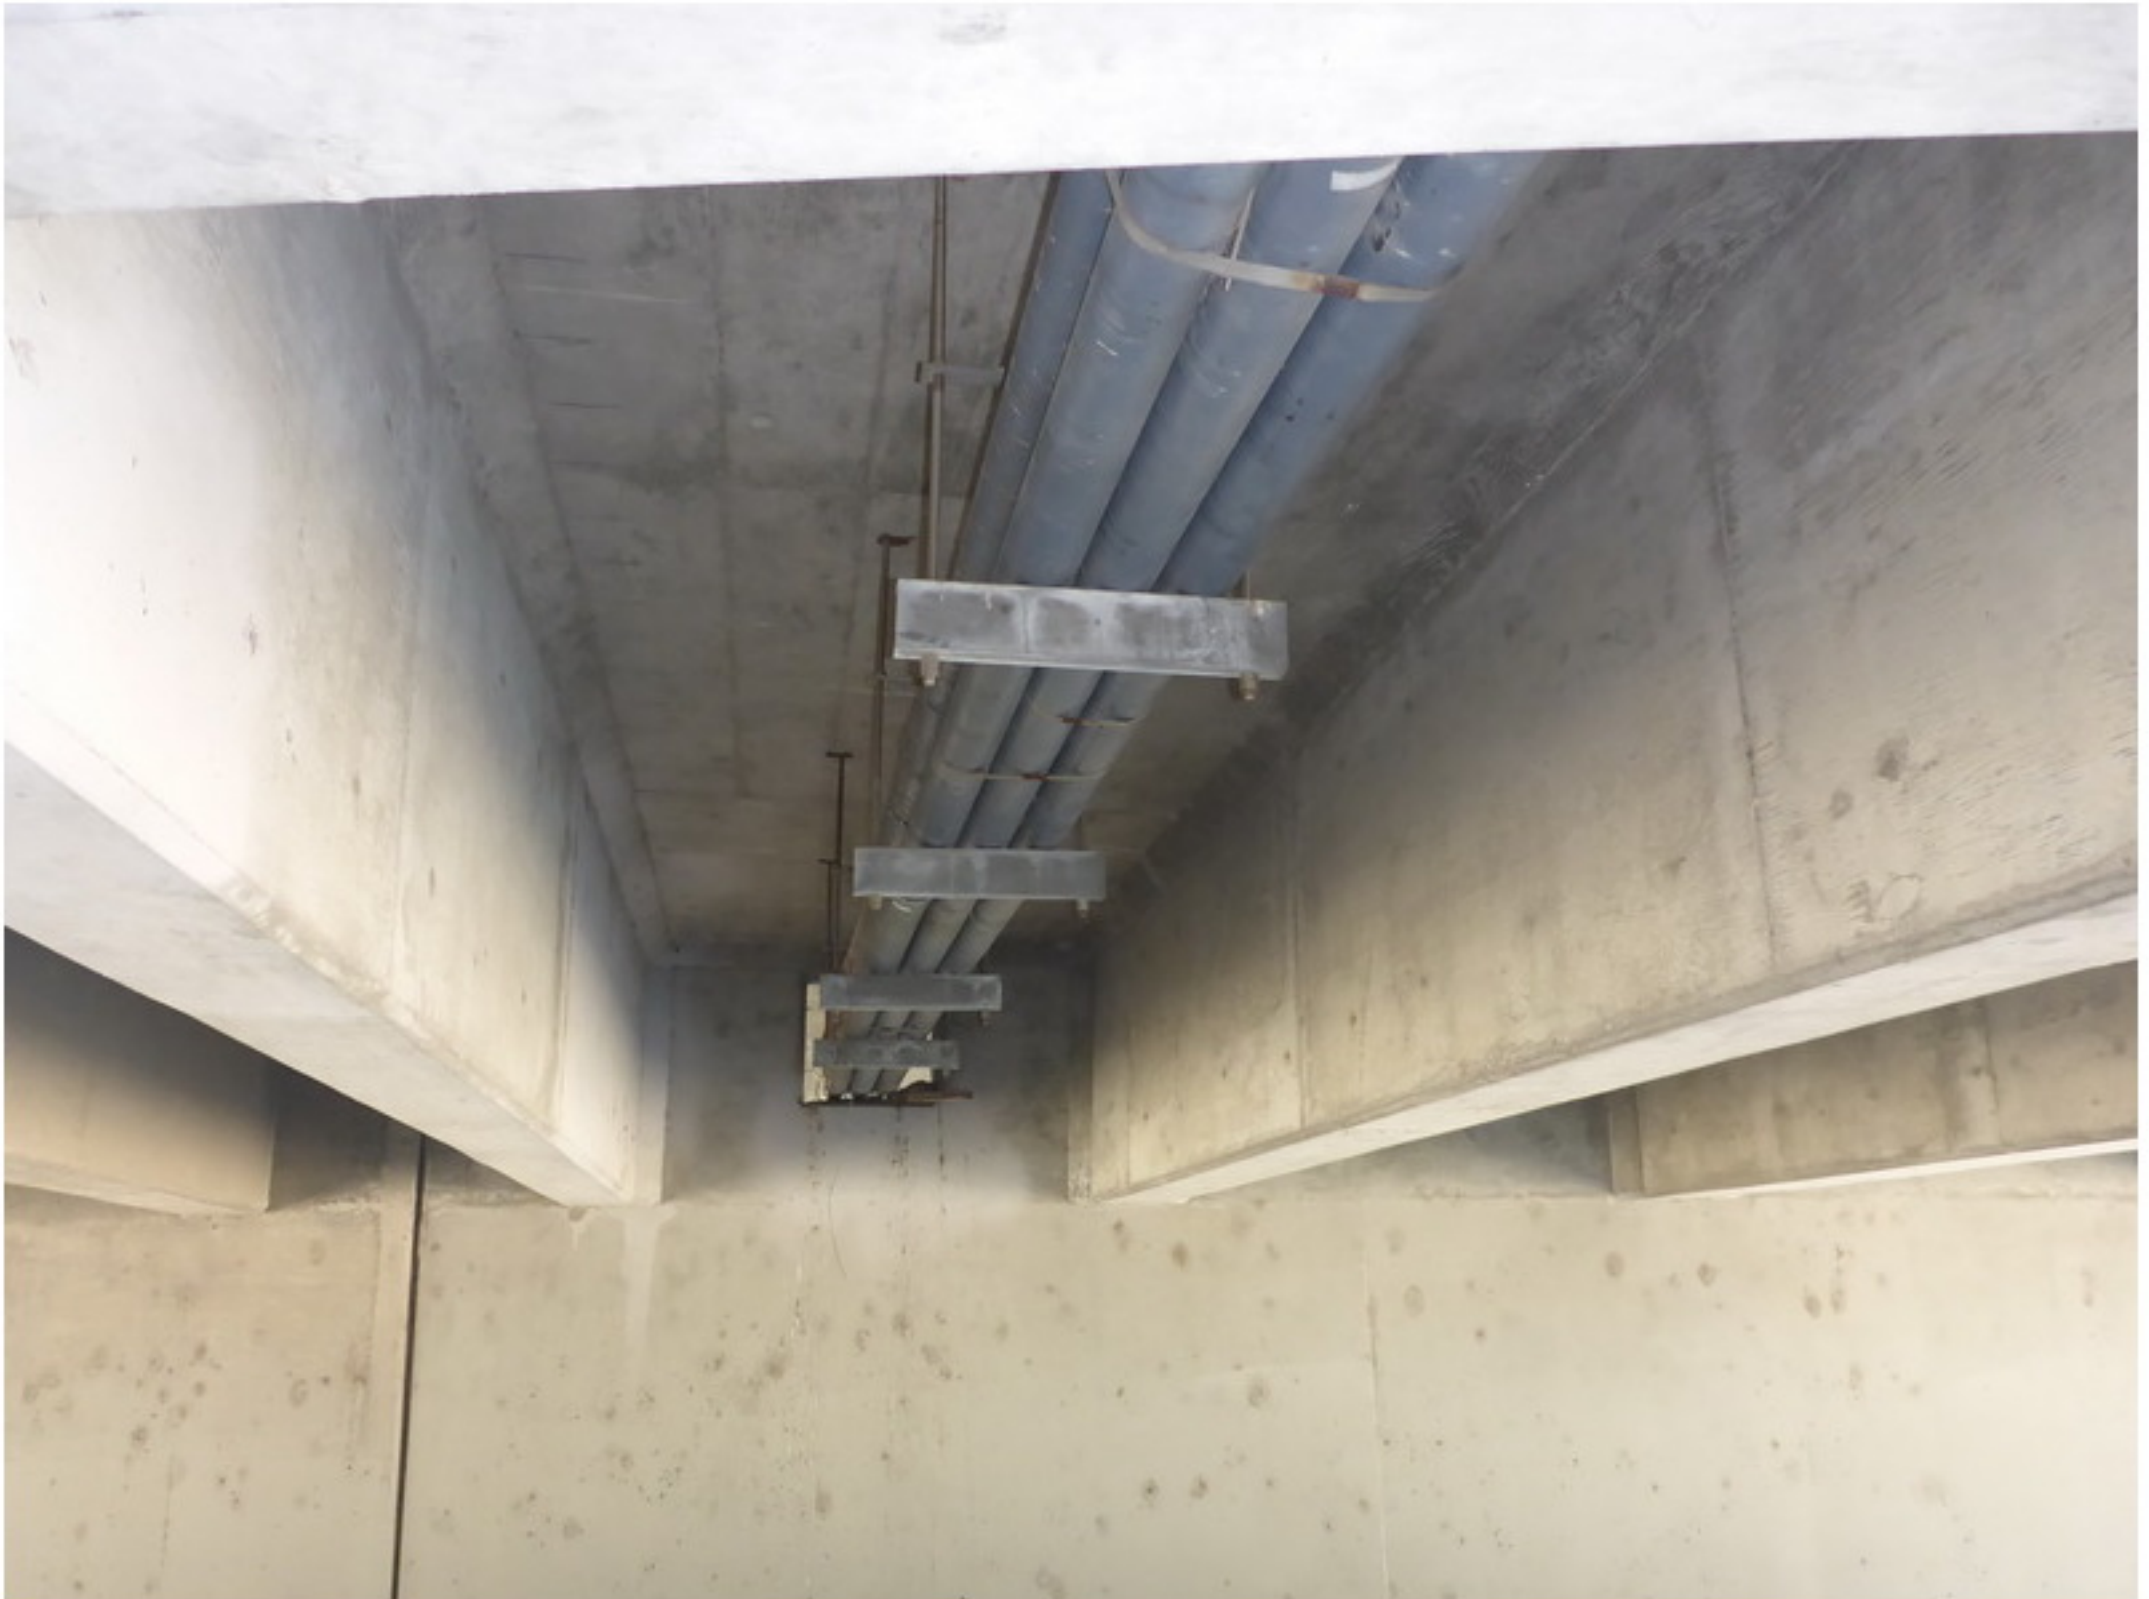
Photo No. 7
Enchoachment.

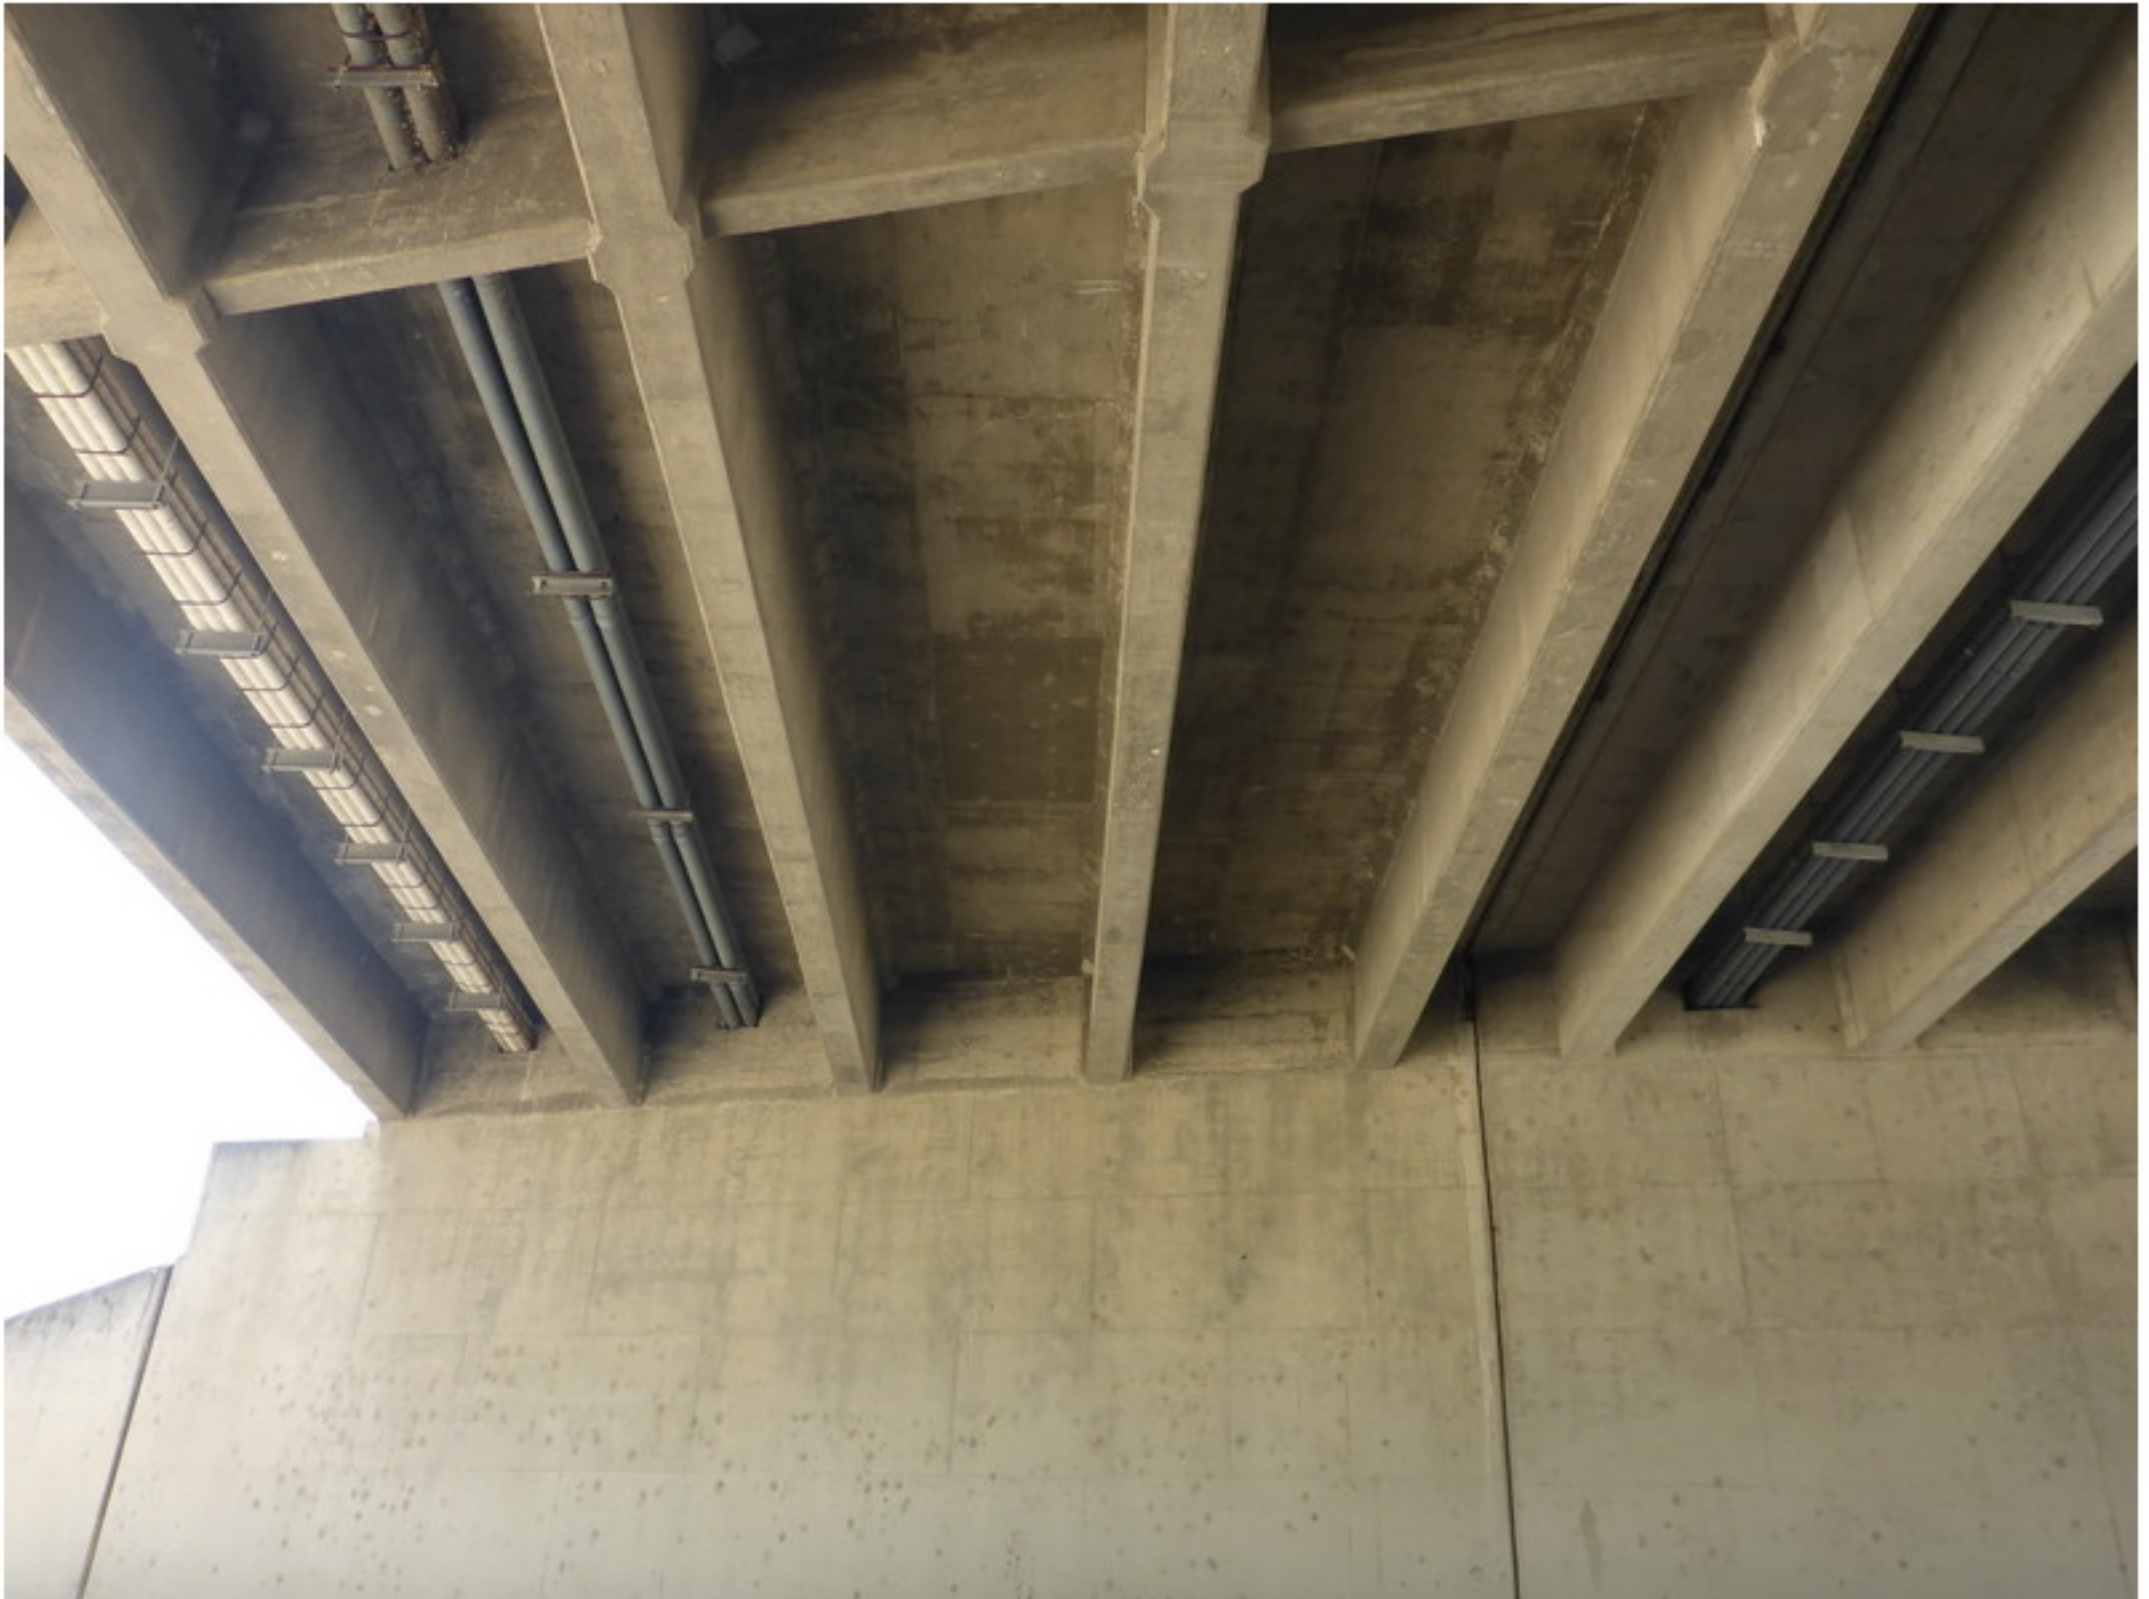
Photo No. 8
Encroachment

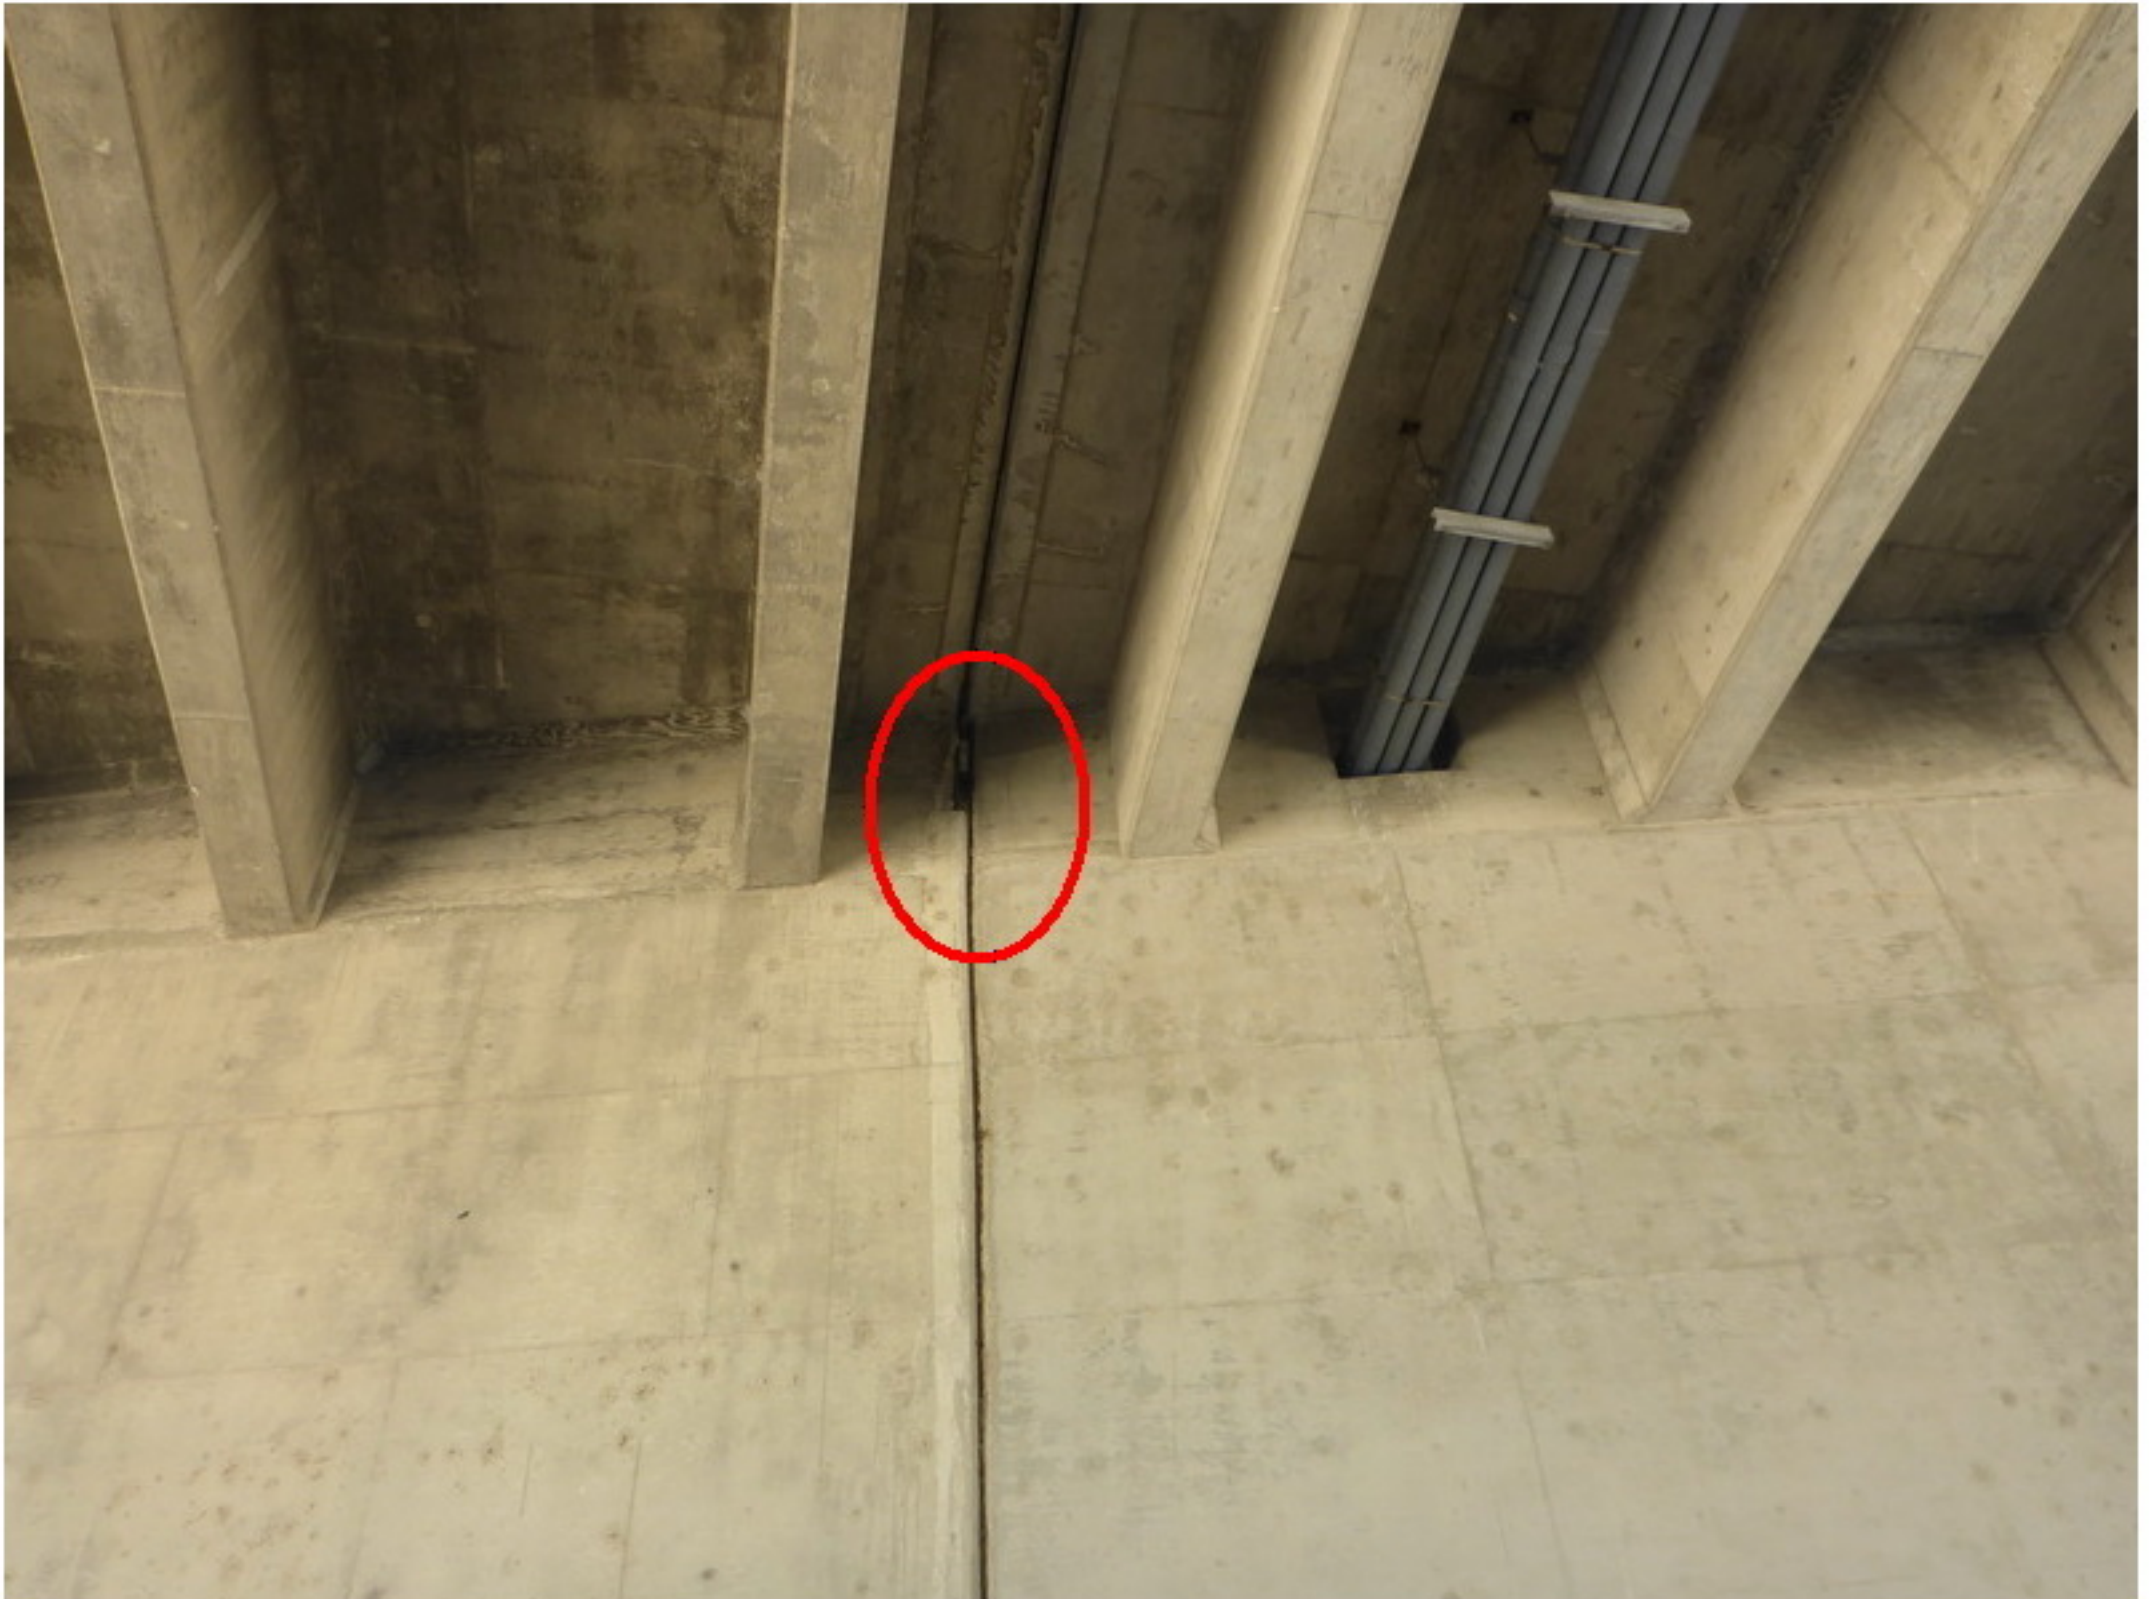
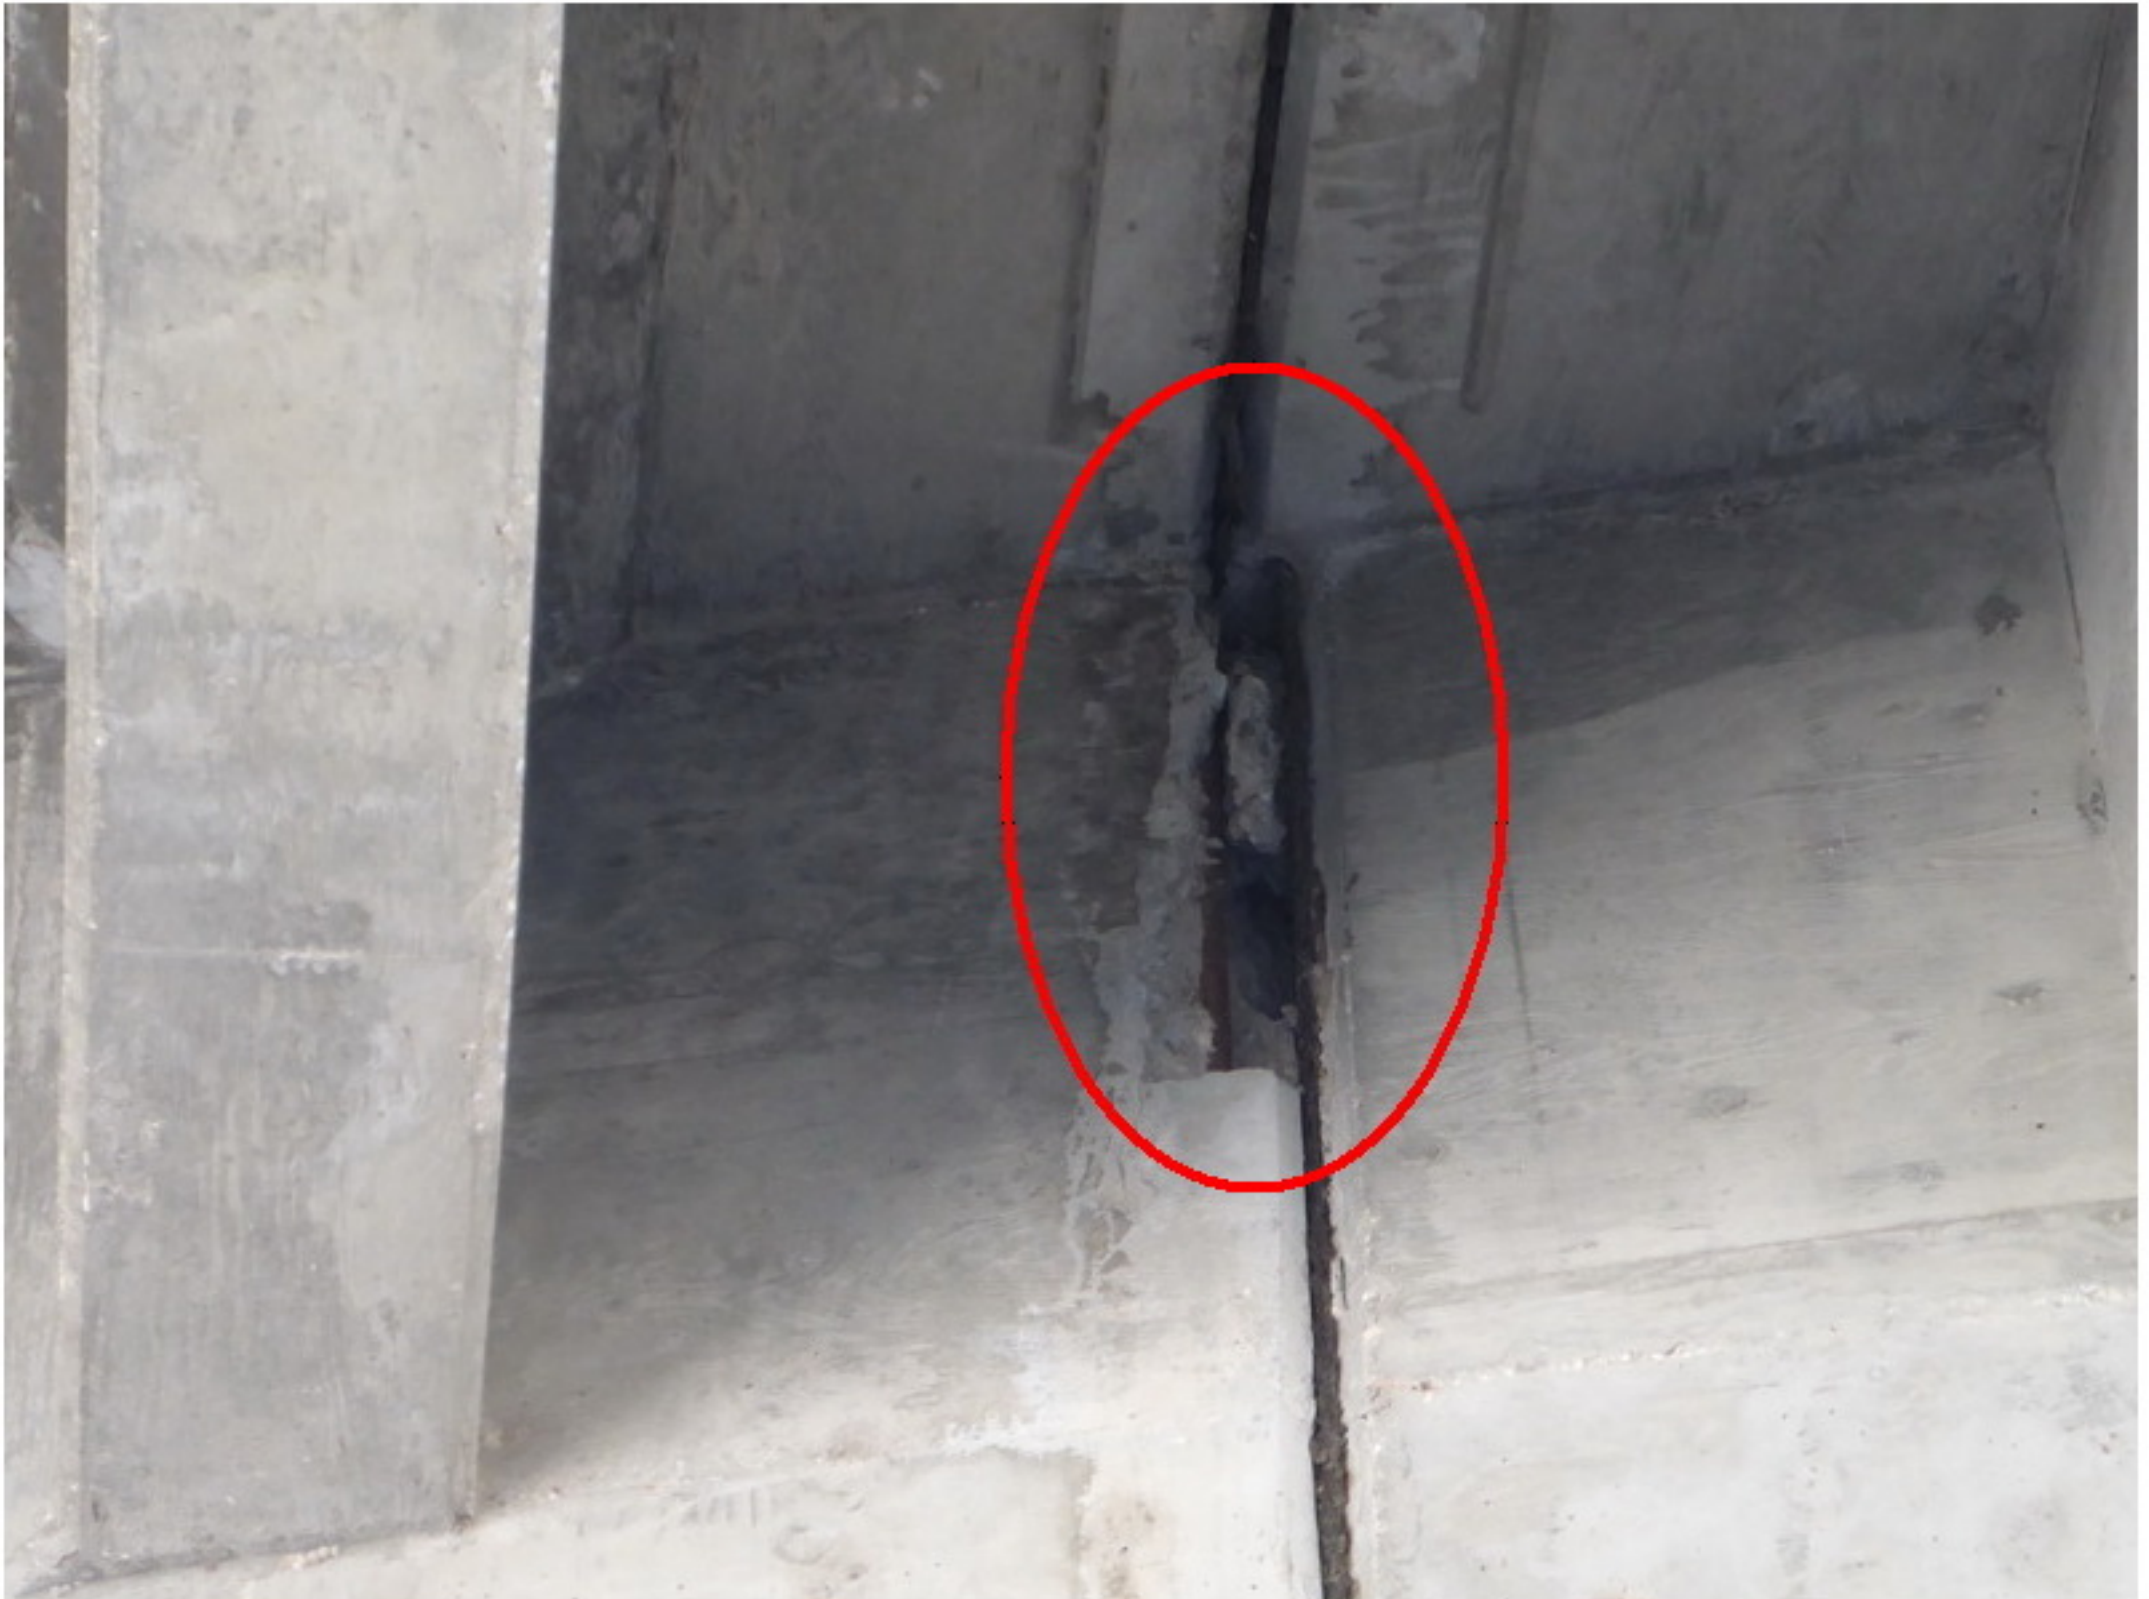
The south end of northerly portion of pier wall 3 has a spall 6 inches W X 24 inches L X 3 inches D at the top. (see the attached photos no. 9 & 10)

Spall 6 in X 24 in X 3 in at the top of the southerly end of the northerly half.

RecDate: 06/28/2017	EstCost:	Repair the spall at the south end of
Action : Sub-Patch spalls	StrTarget: 2 YEARS	northerly portion of pier wall 3 that has
Work By: LOCAL AGENCY	DistTarget:	a spall 6 inches W X 24 inches L X 3
Status : PROPOSED	EA:	inches D at the top.
RecDate: 10/24/2014	EstCost:	Repair the approach sidewalks at the two
Action : Railing-Misc.	StrTarget: 2 YEARS	corners northeast and southwest are
Work By: LOCAL AGENCY	DistTarget:	vertically offset up to 2 inches.
Status : PROPOSED	EA:	
RecDate: 05/16/2012	EstCost:	Repair the two spalls 15 inches X 5
Action : Railing-Repair	StrTarget: 2 YEARS	inches X 1.5 inches with exposed rebars
Work By: LOCAL AGENCY	DistTarget:	at the inside face of the south rail at
Status : PROPOSED	EA:	50 and 70 feet from west end; and many
		spalls +/- 6 inches X 4 inches X 1 inch
		with rebar exposed and rusted at many
		locations of the inside face of both
		rails.

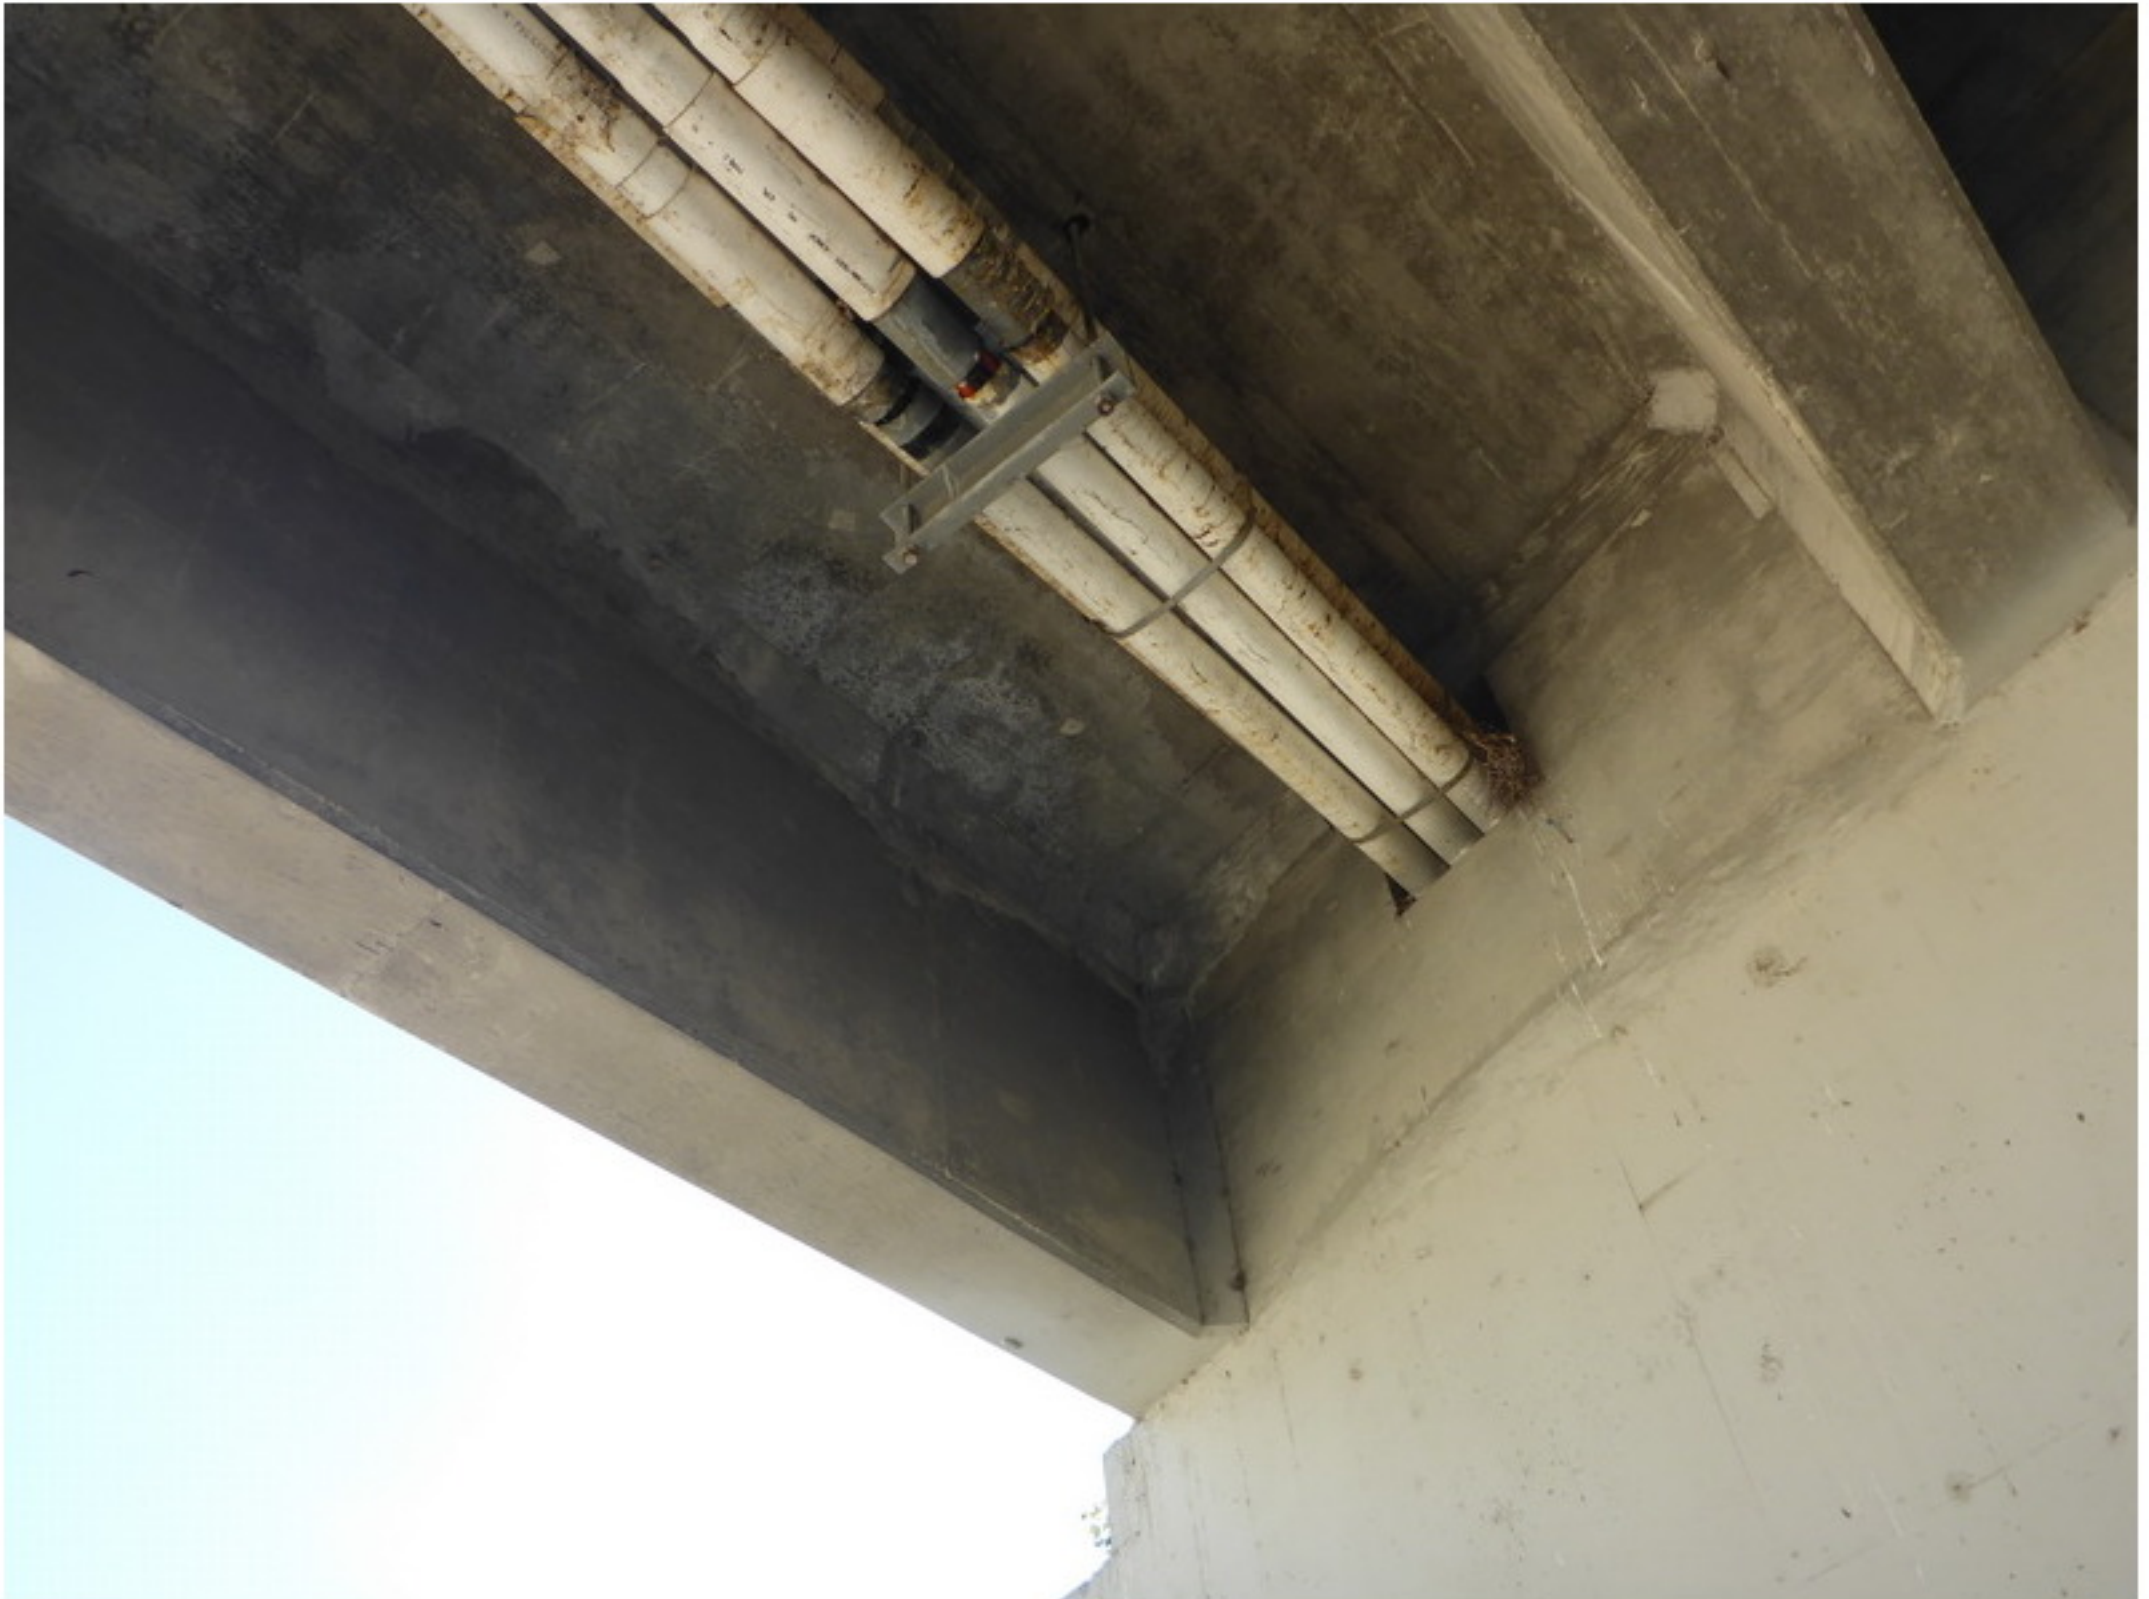
Photo No. 11
Encroachments

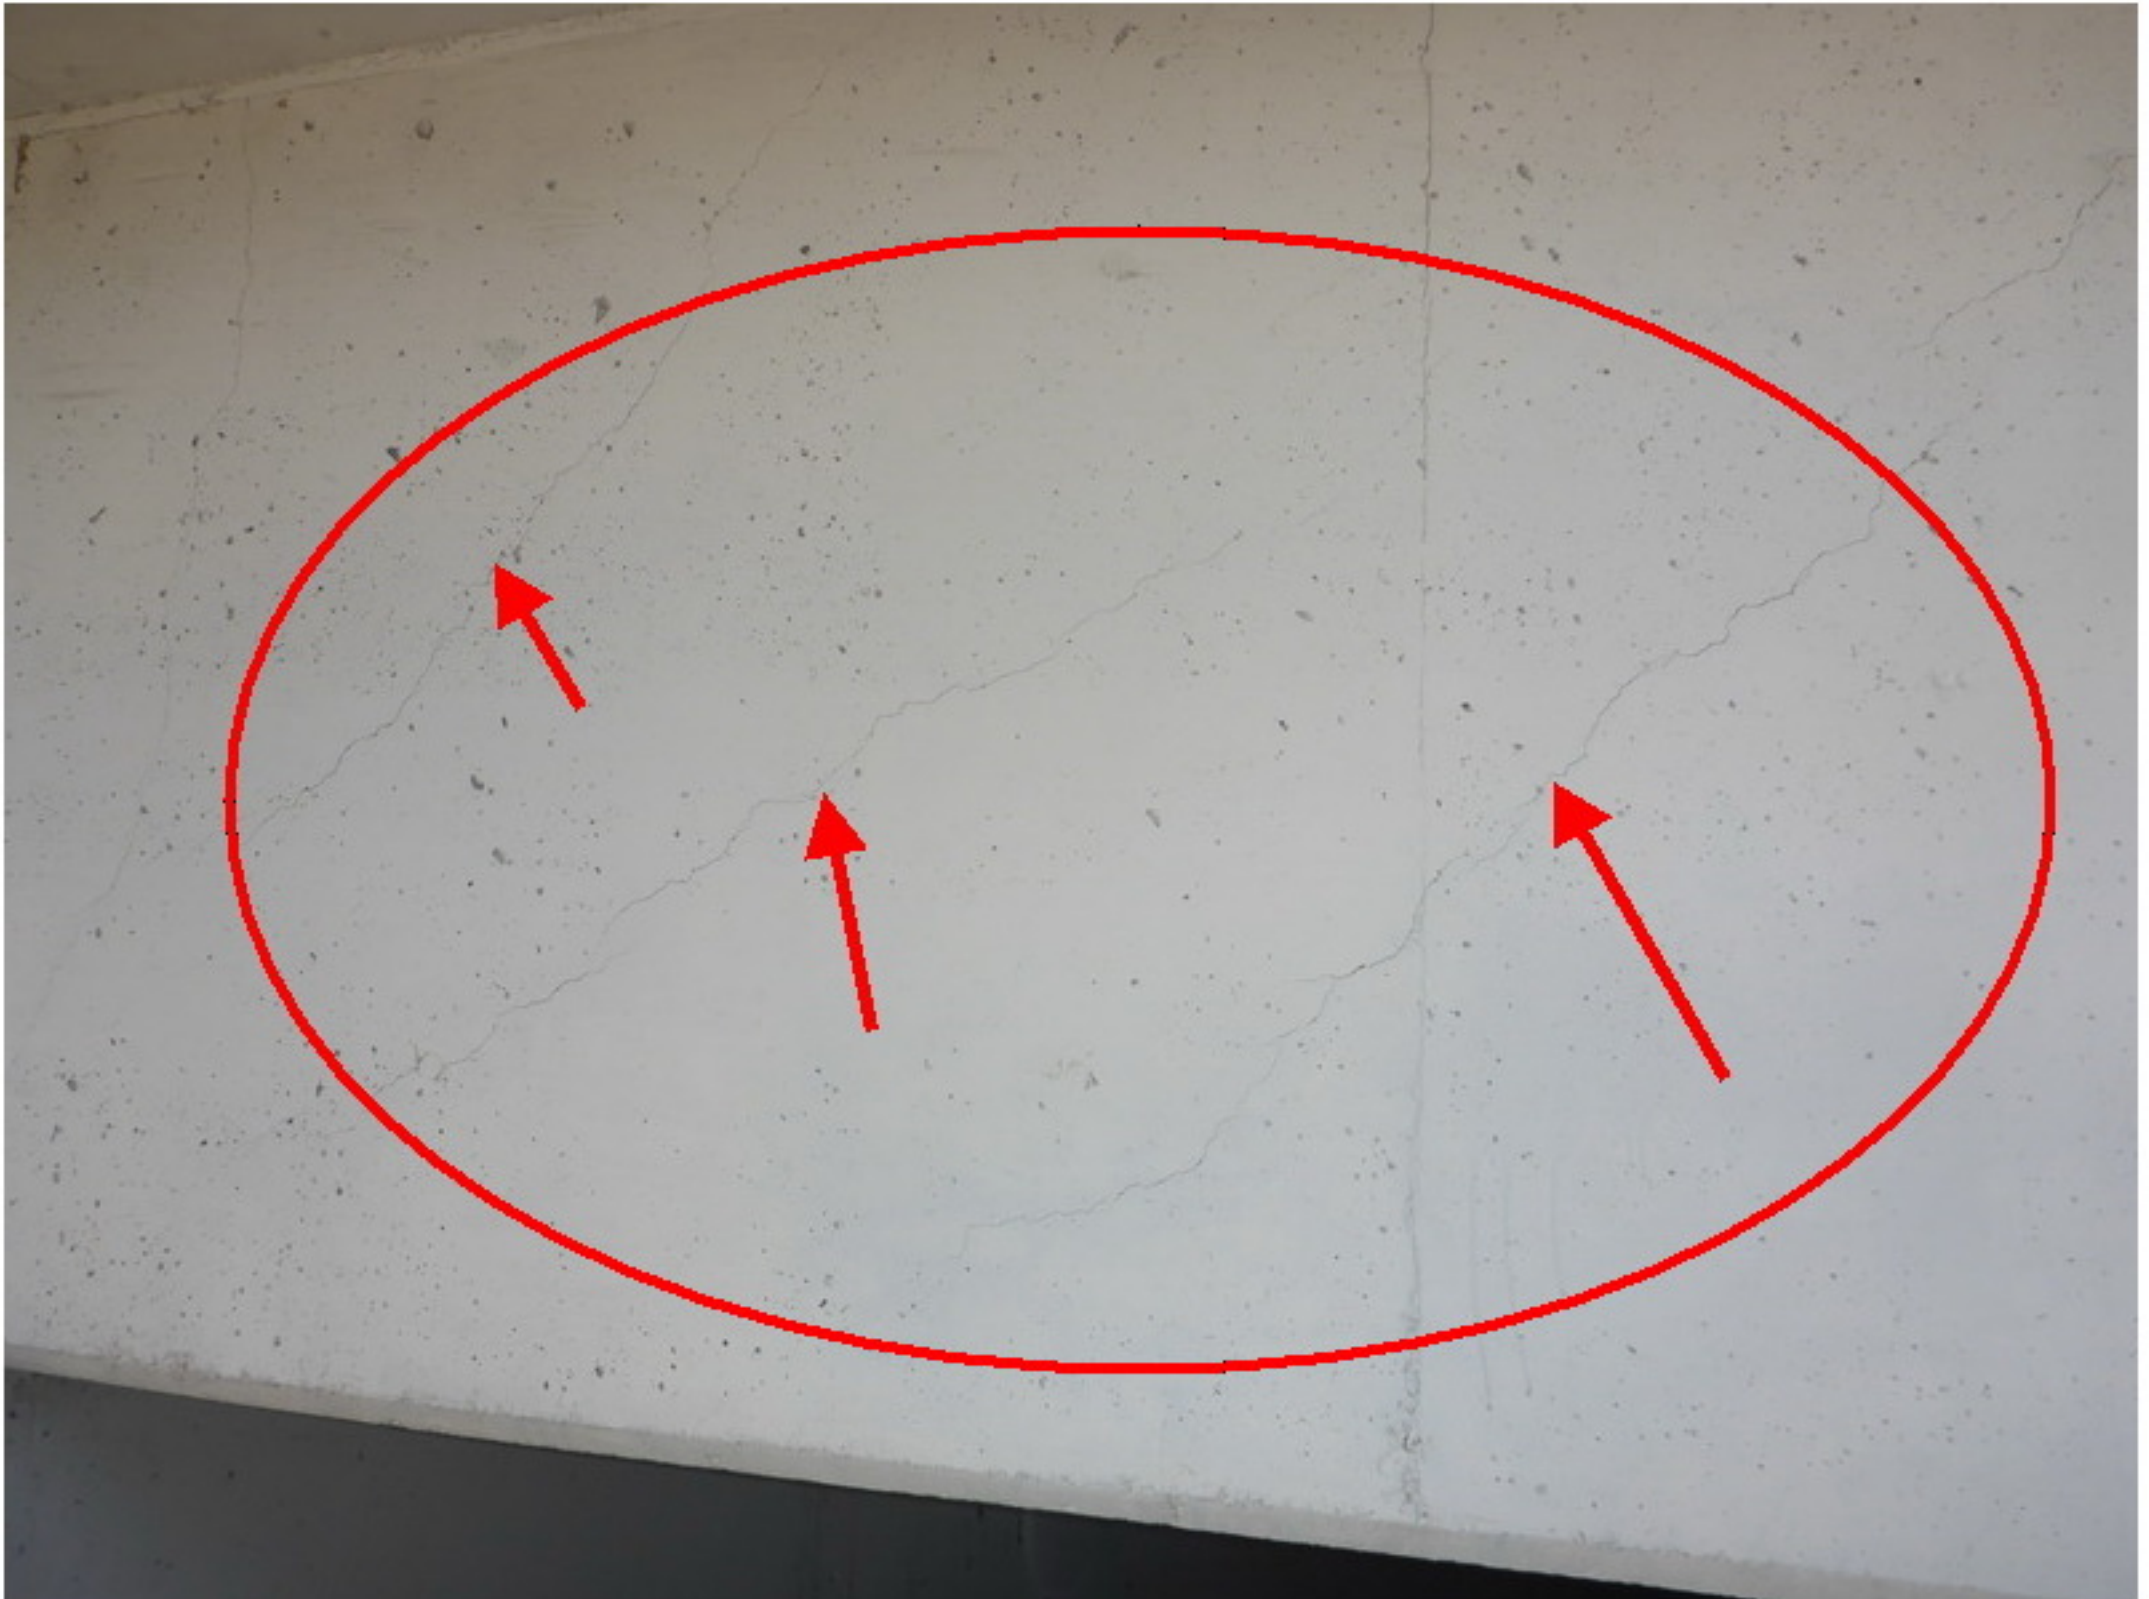
Photo No. 12

(110-1120)									
The north girder at pier wall 3 has a white efflorescence stain 3 feet long at north face.									
(110-1130)									
Most concrete girders have few vertical and diagonal cracks, up to 0.03 inches wide near the supports.									
210			Pier Wall-RC	2	96	m	92	3	1 0

Vertical and diagonal cracks at the RC girders near the supports.
