DEPARTMENT OF TRANSPORTATION
Structure Maintenance & Investigations

Bridge Number : 55C0400
Facility Carried: EDINGER AVE
Location : 1.7 MI W/O BOLSA CHICA R
City :
Inspection Date : 06/23/2017

Bridge Inspection Report

STRUCTURE NAME: BOLSA CHICA CHANNEL

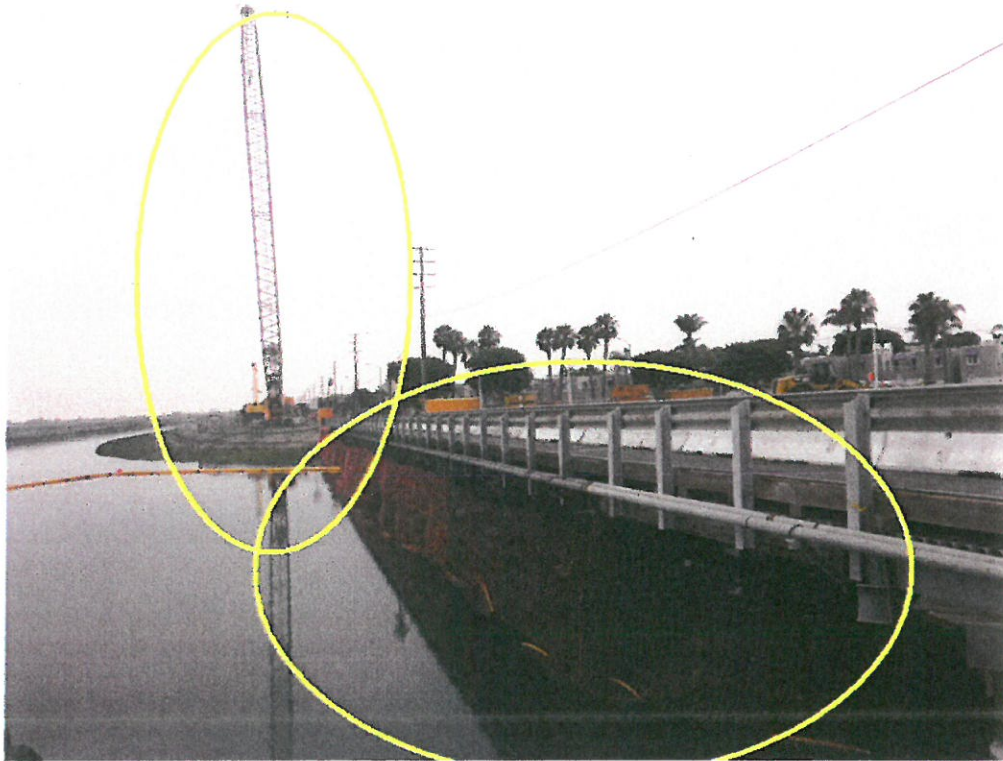
Photo No. 1

Process of constructing new bridge

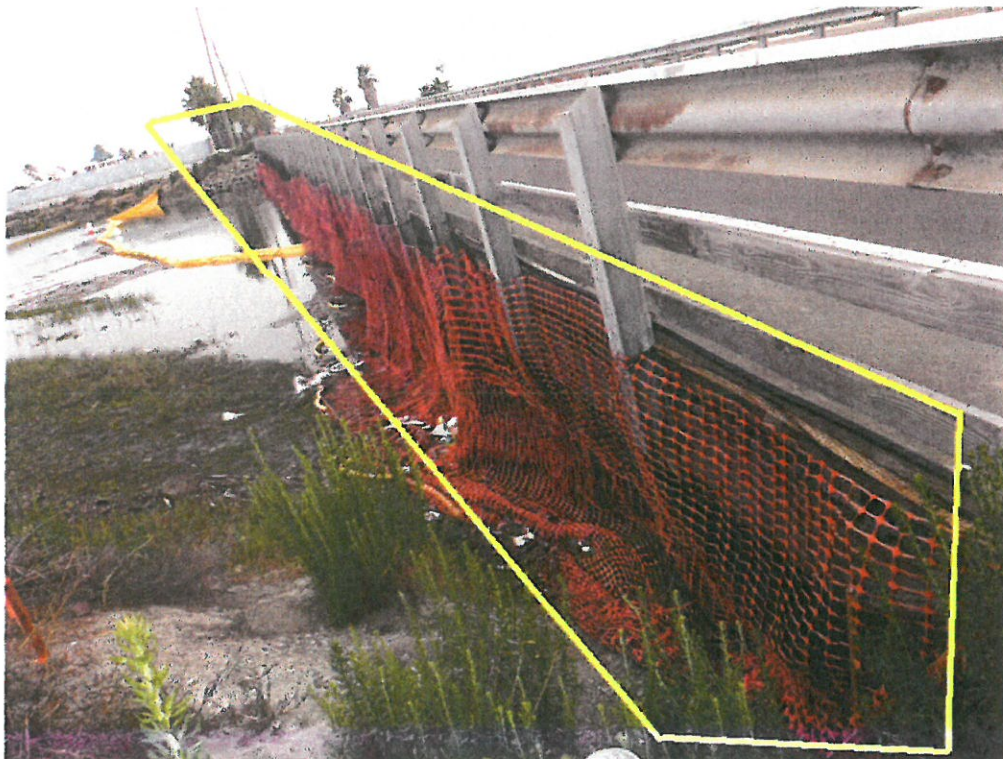
Photo No. 1

Process of constructing new bridge

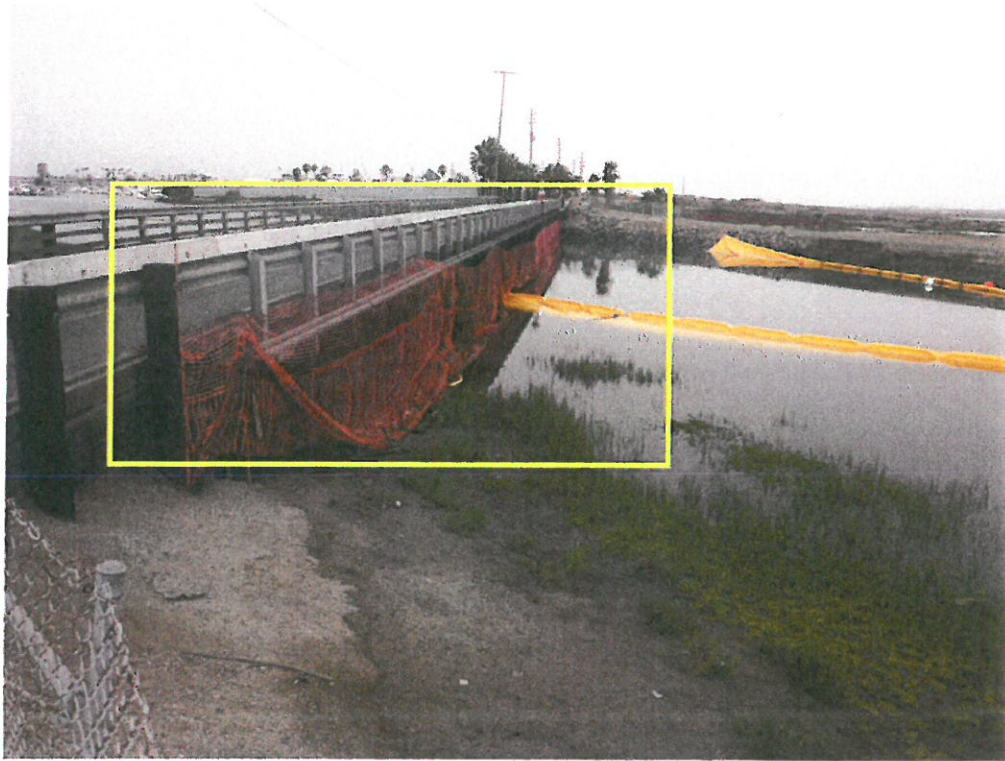
Photo No. 1

Process of constructing new bridge
