Bridge Number : 55C0511
Facility Carried: VILLA PARK ROAD
Location : 1.74 MI. E/O ROUTE 55 FW
City :
Inspection Date : 12/21/2018

Bridge Inspection Report

STRUCTURE NAME: SANTIAGO CREEK

Structure Description: Single 21.00 feet diameter x 330.00 feet long corrugated steel
multiplate pipe culvert (non-grade top) beneath 40.00 feet of earth
fill.

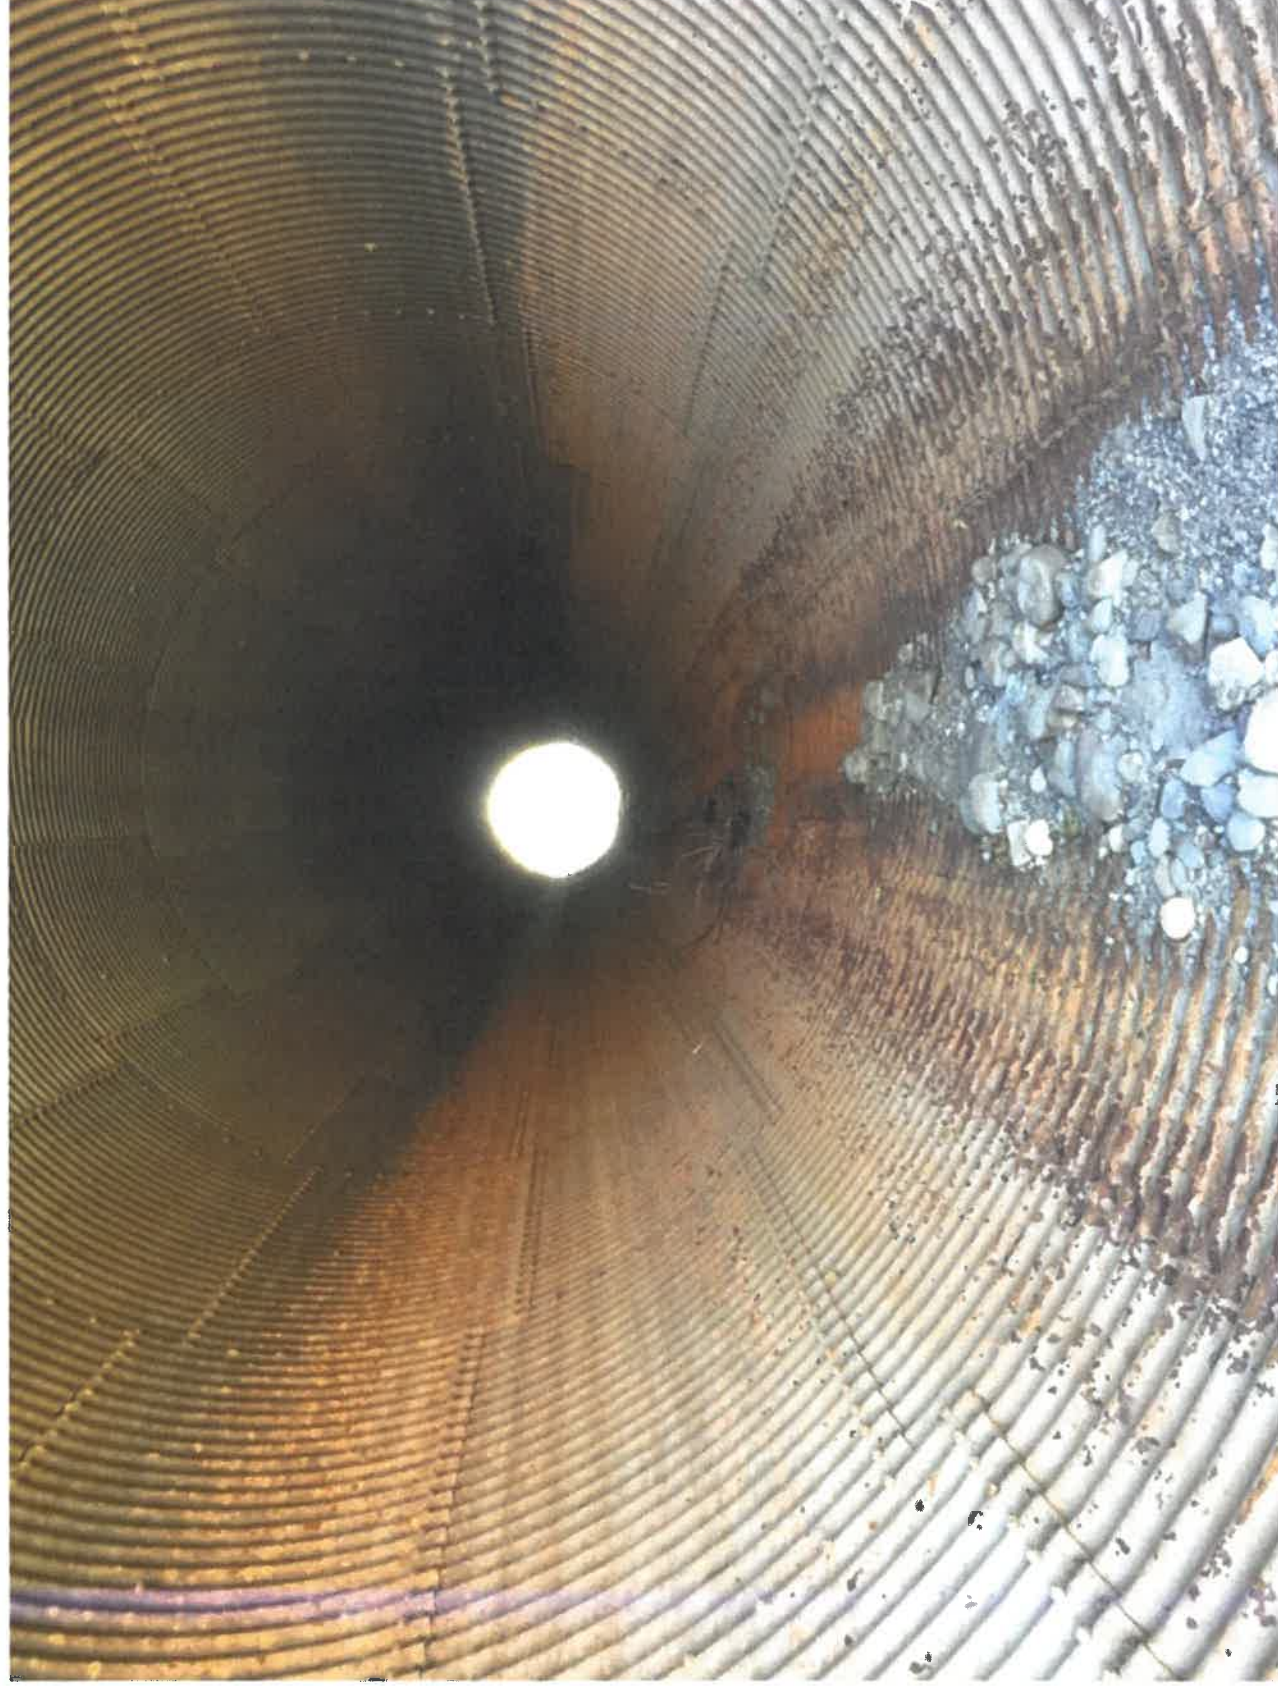
Photo No. 1

Rust was noticed at the bottom surface of the corrugated pipe throughout.

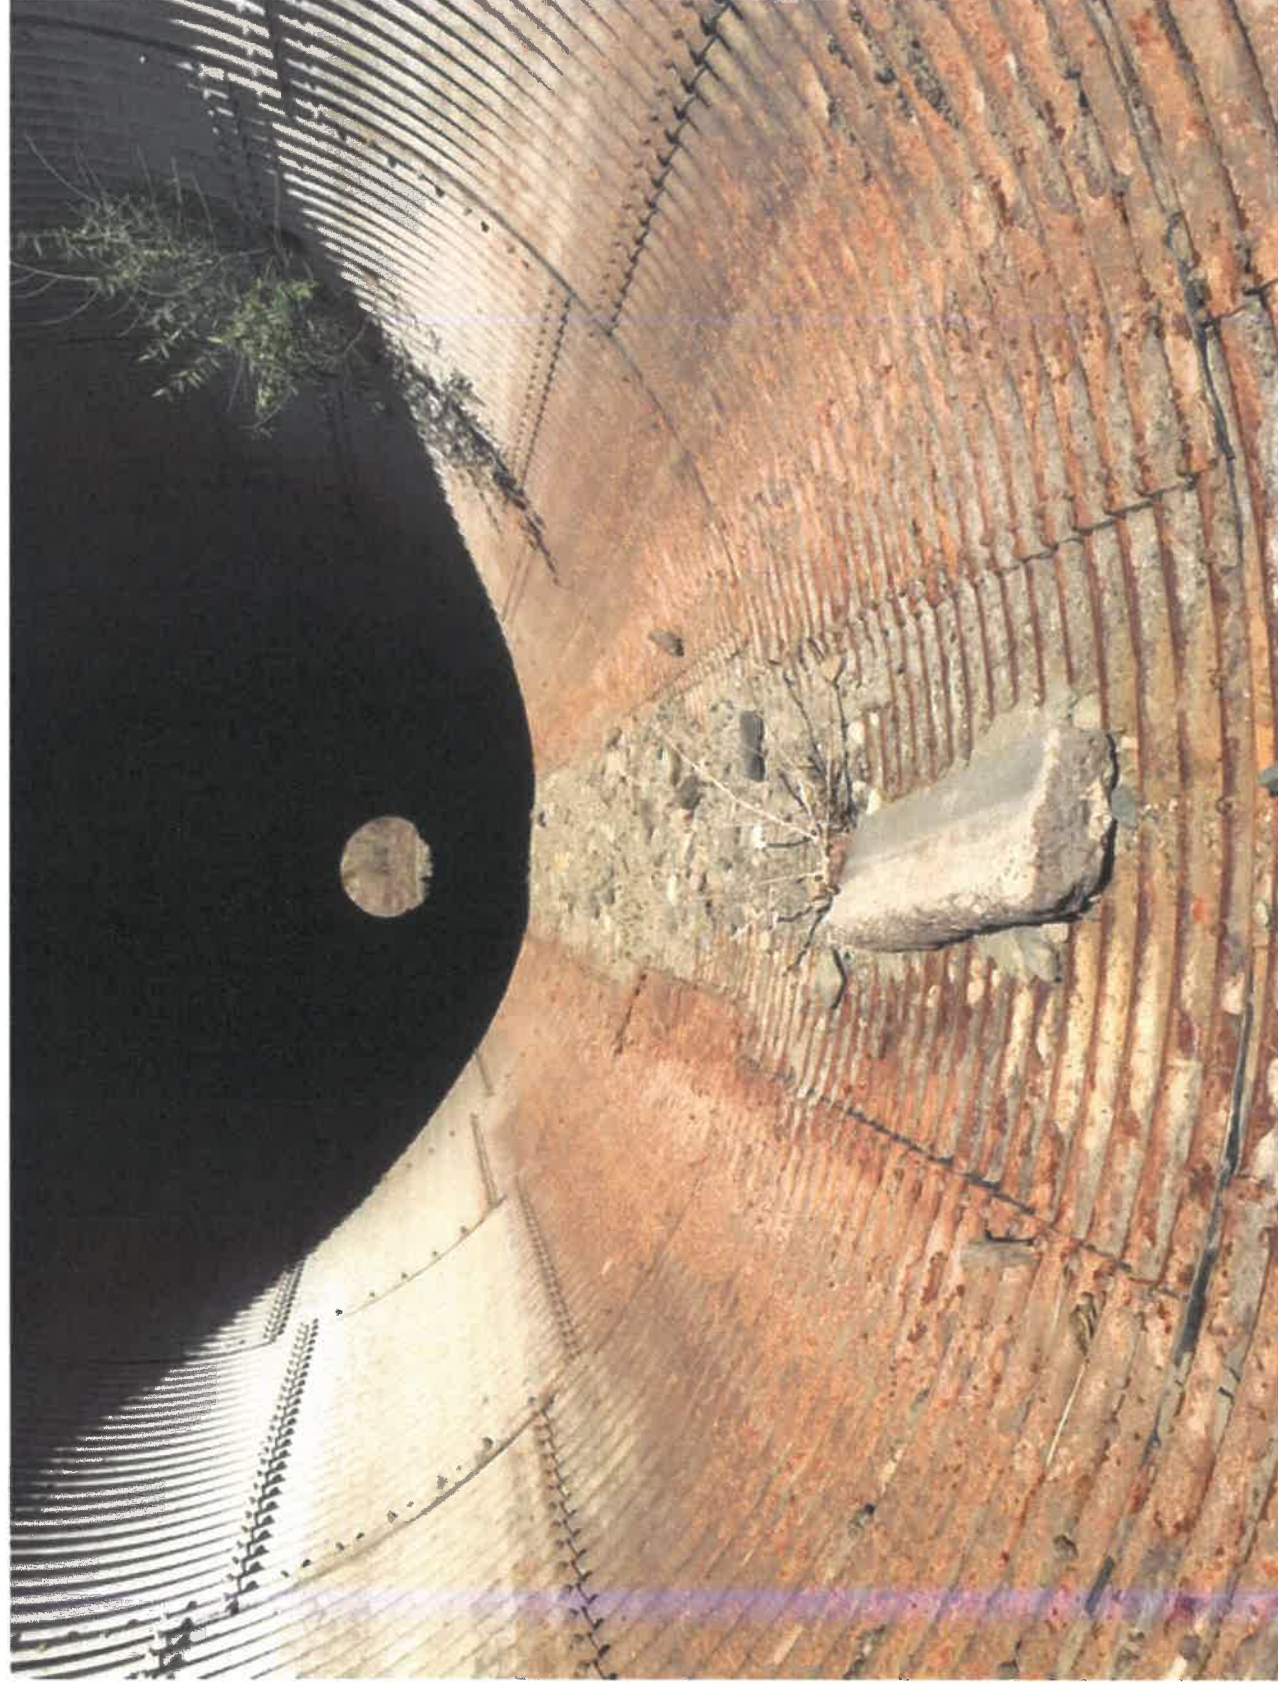
Photo No. 1

Rust was noticed at the bottom surface of the corrugated pipe throughout. (N end).

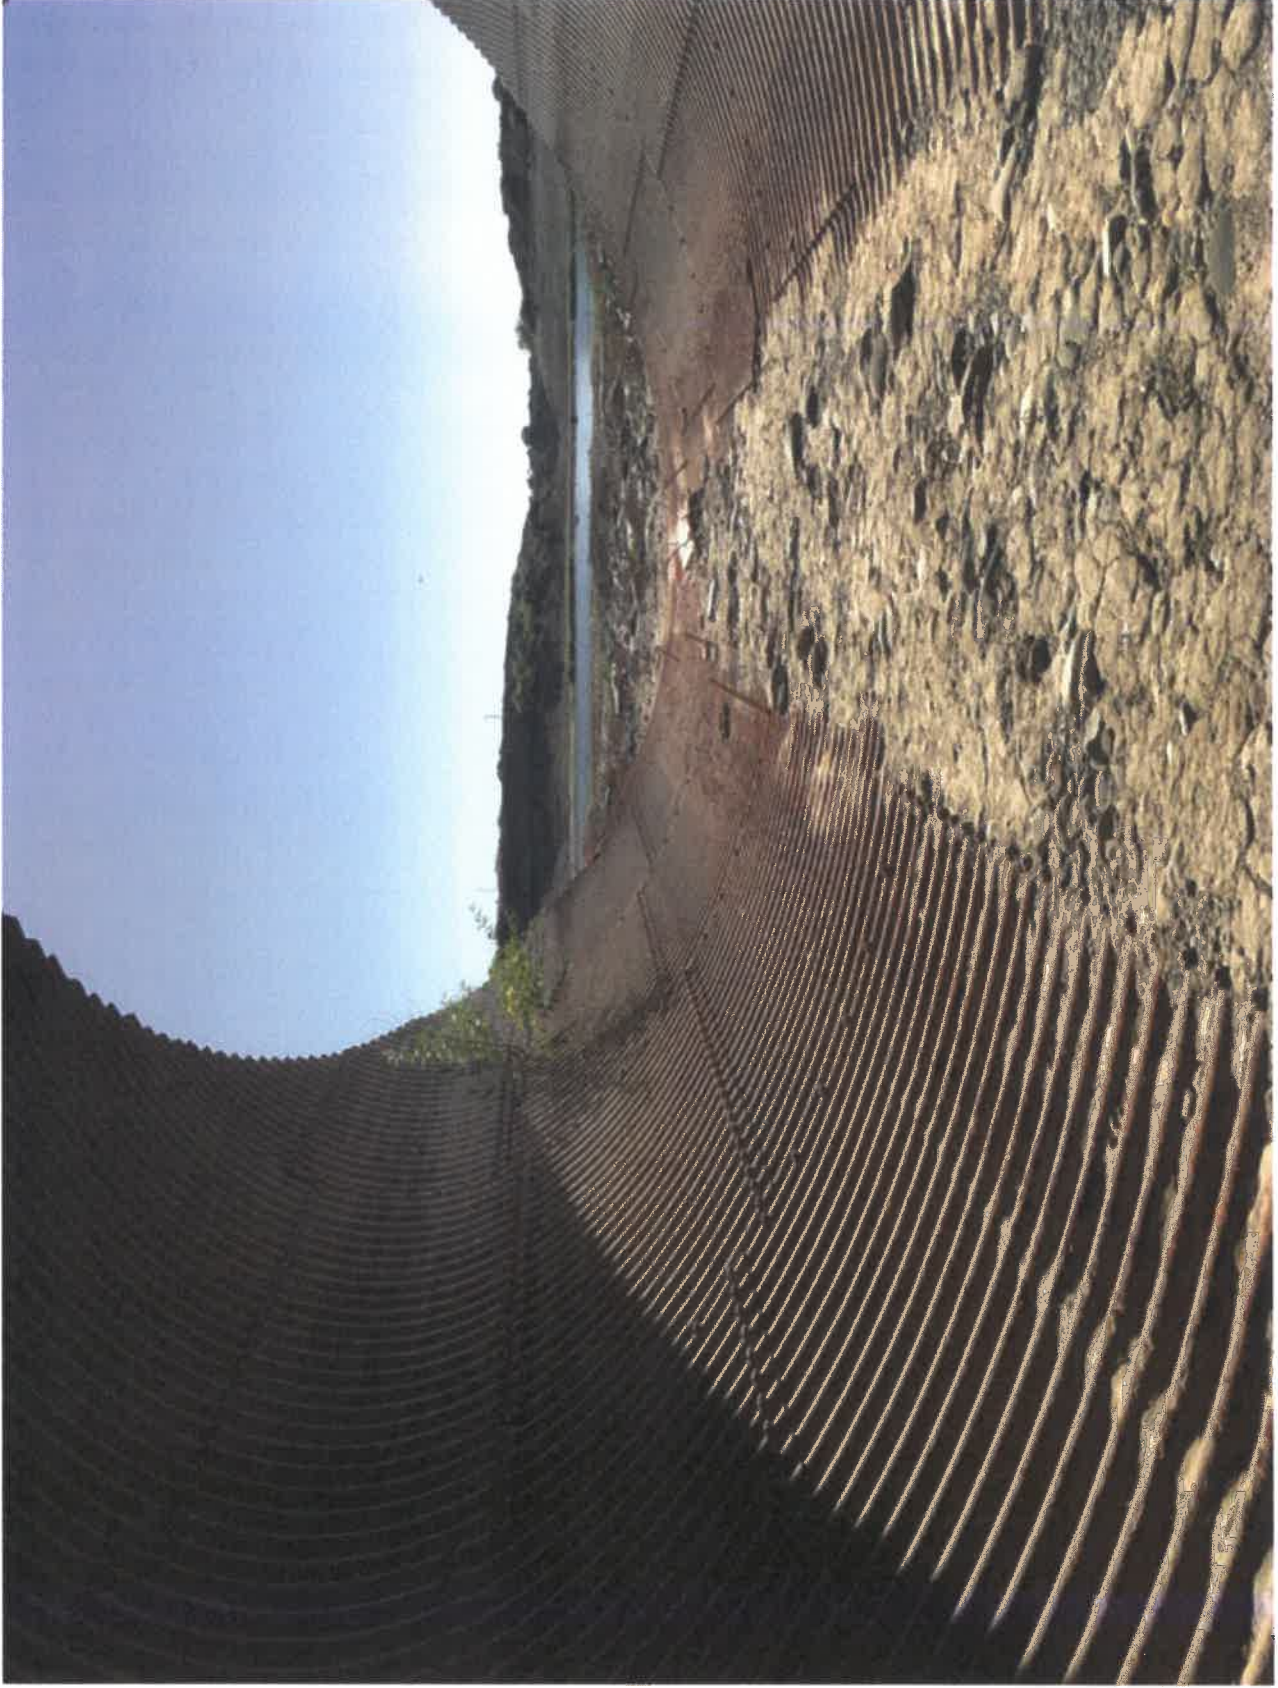
Photo No. 1
Rust was formed throughout at the bottom surface.

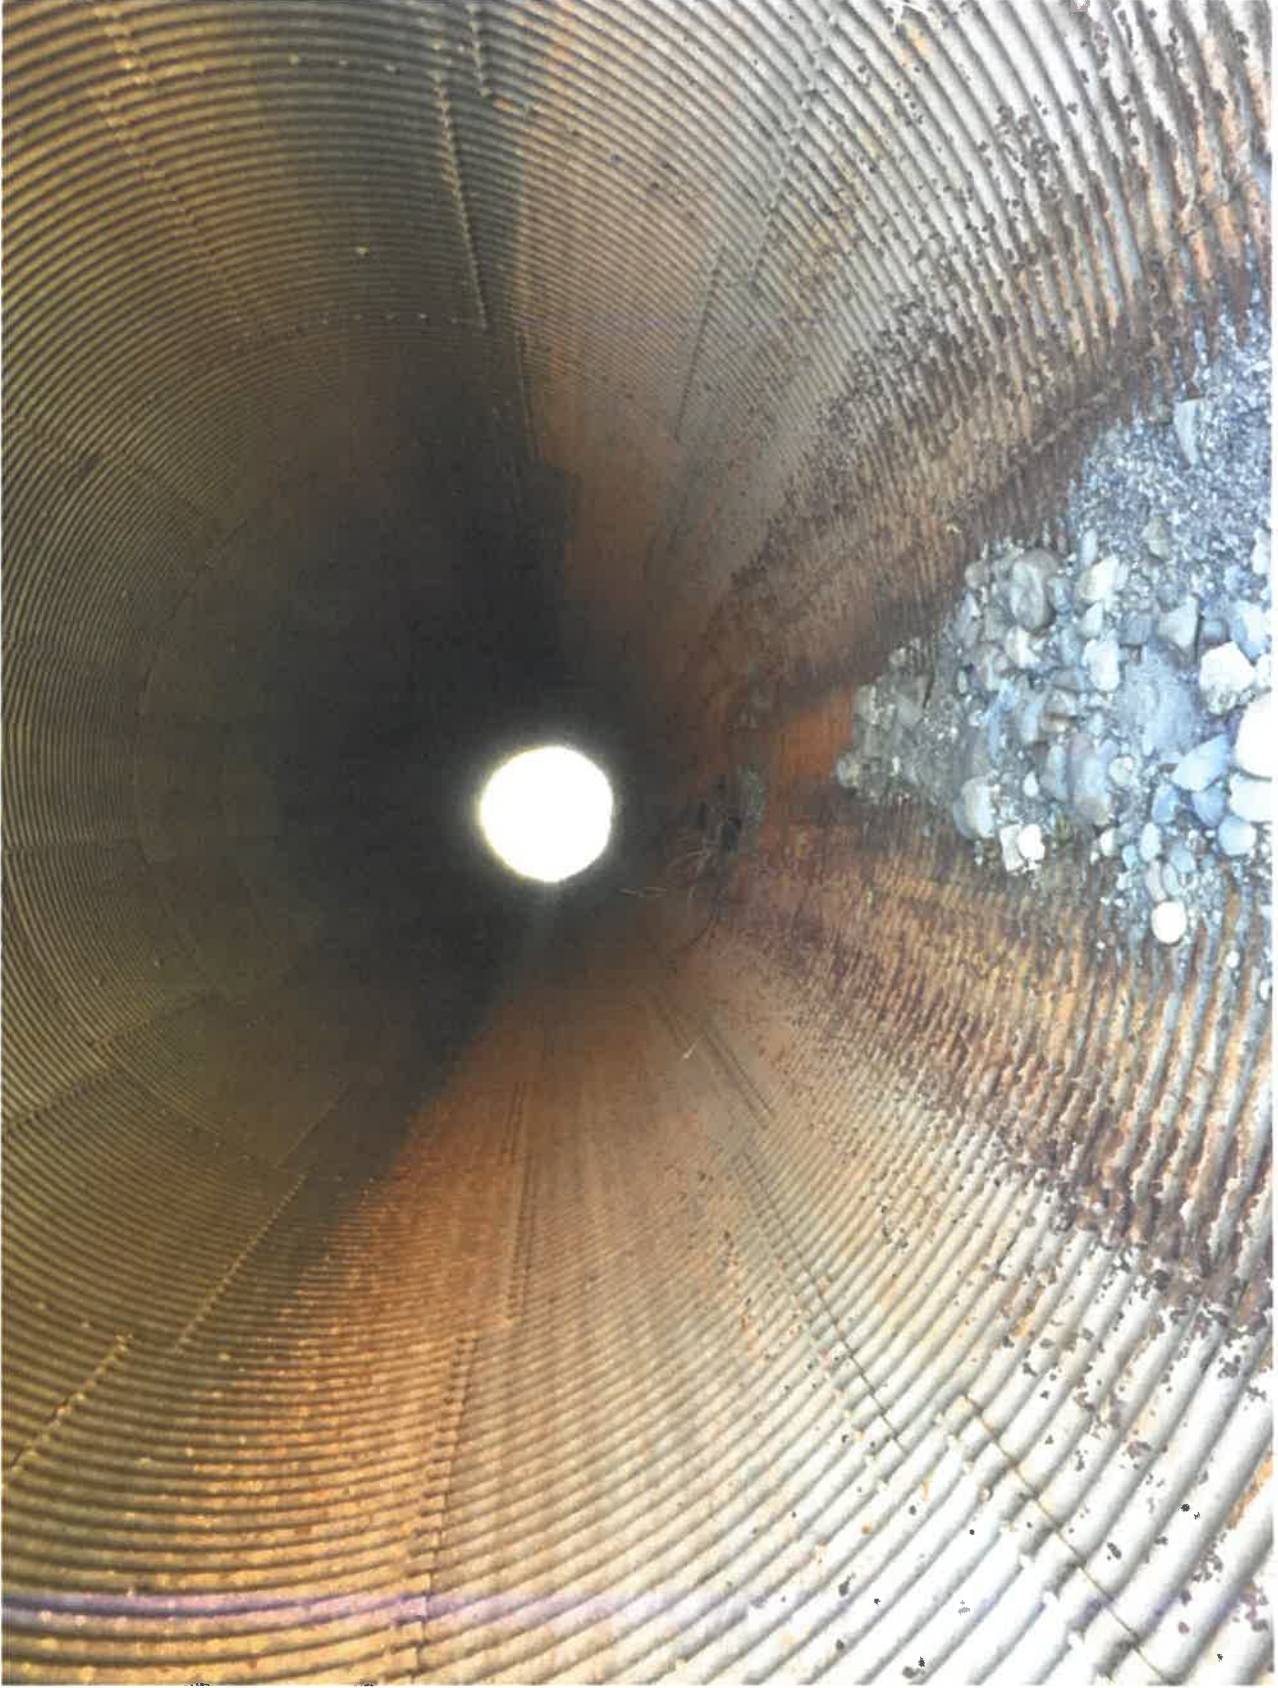
The culvert invert was rusted about 25.0 percentage of the circumference throughout the culvert length, most noticeable at the ends, and at the seam connection of the plates (see photos 3 and 4).

The galvanized coating system is failed and rust is noticed about 30% of the steel pipe area especially the bottom part. (see photos 3 and 4).

The culvert invert was rusted about 25% of the circumference throughout the culvert length, most noticeable at the ends, and at the seam connection of the plates (see photos 3 and 4)

Photo No. 3
Rust is noticed at the bottom of the steel pipe throughout the entire length.

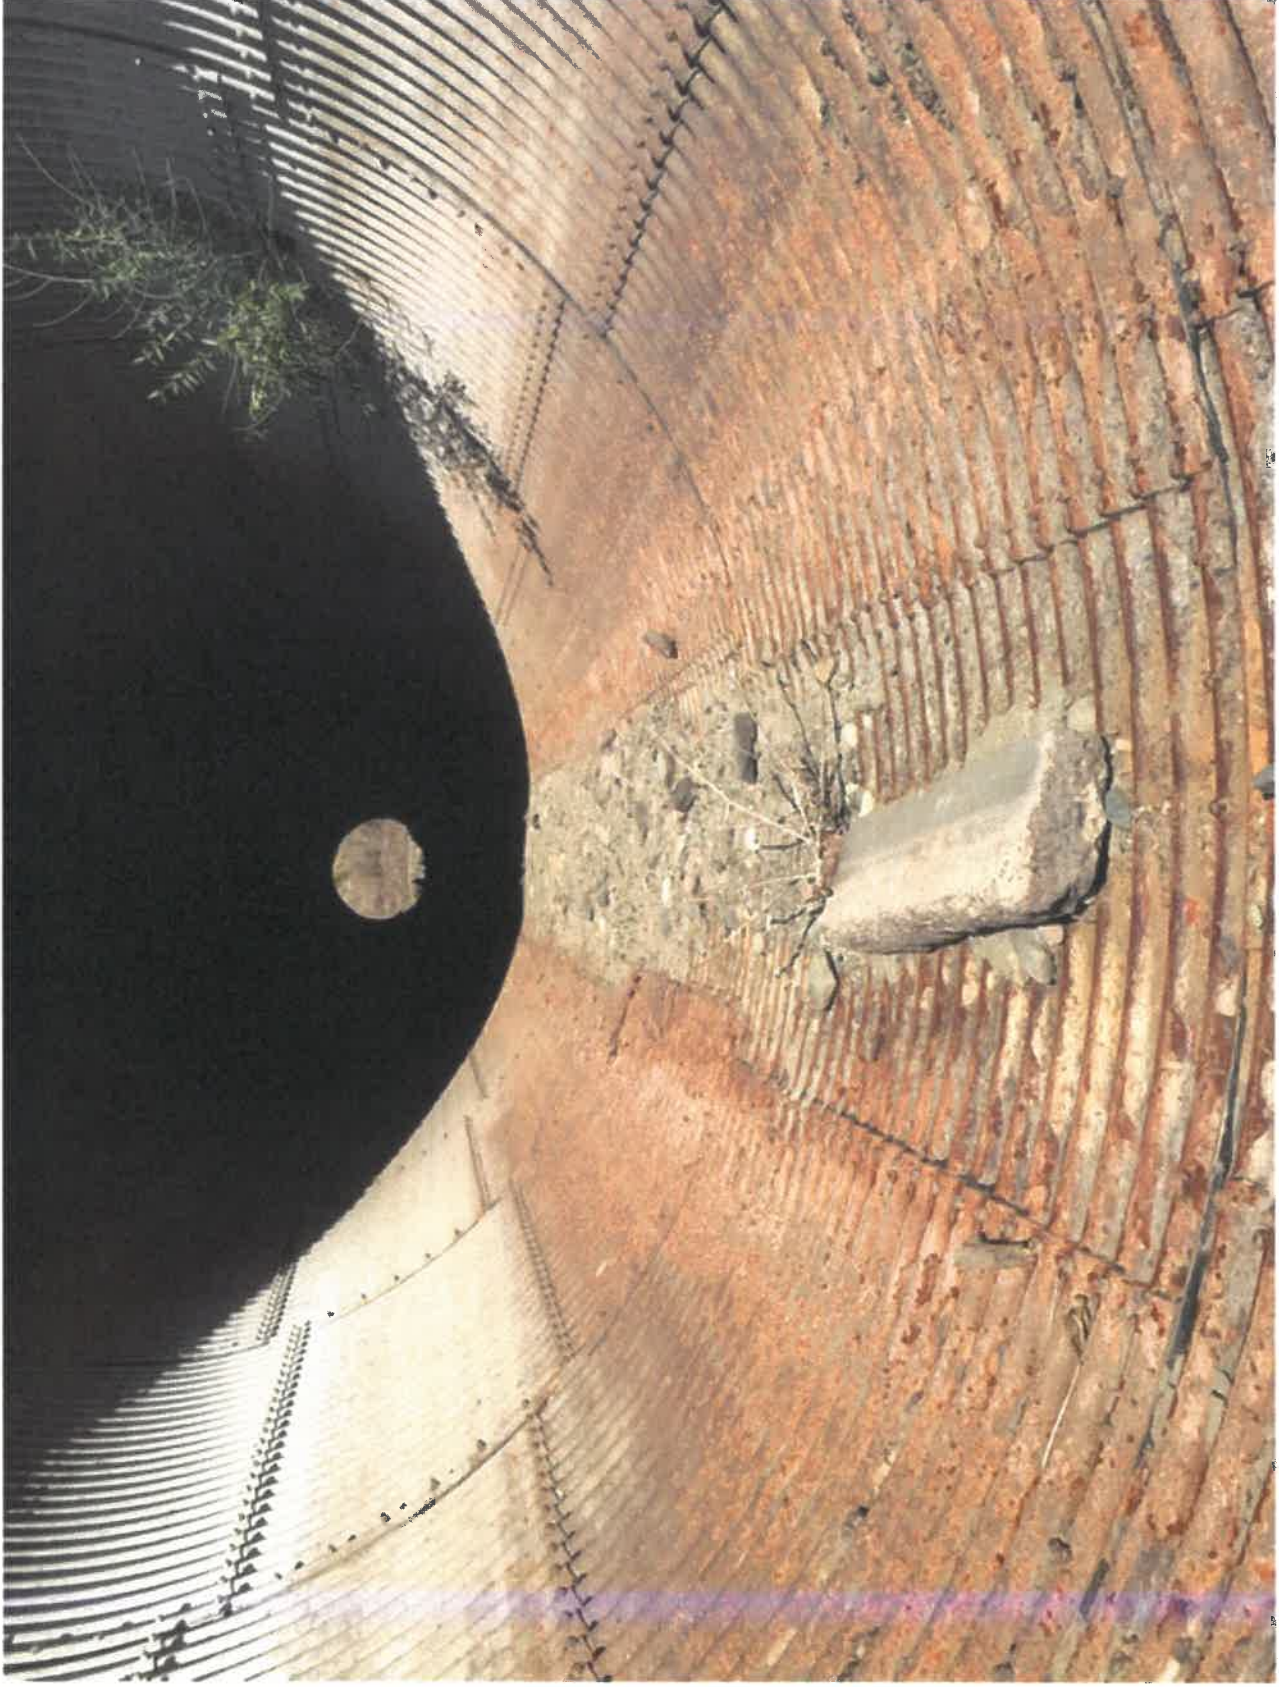
Photo No. 4
Rust is more noticed at the south end.
