DEPARTMENT OF TRANSPORTATION  
Structure Maintenance & Investigations

Bridge Number : 55C0550  
Facility Carried: ALISO CREEK ROAD  
Location : 100' W/O ALICIA PARKWAY  
City :  
Inspection Date : 05/24/2017

## Bridge Inspection Report

**STRUCTURE NAME:** ALISO CREEK

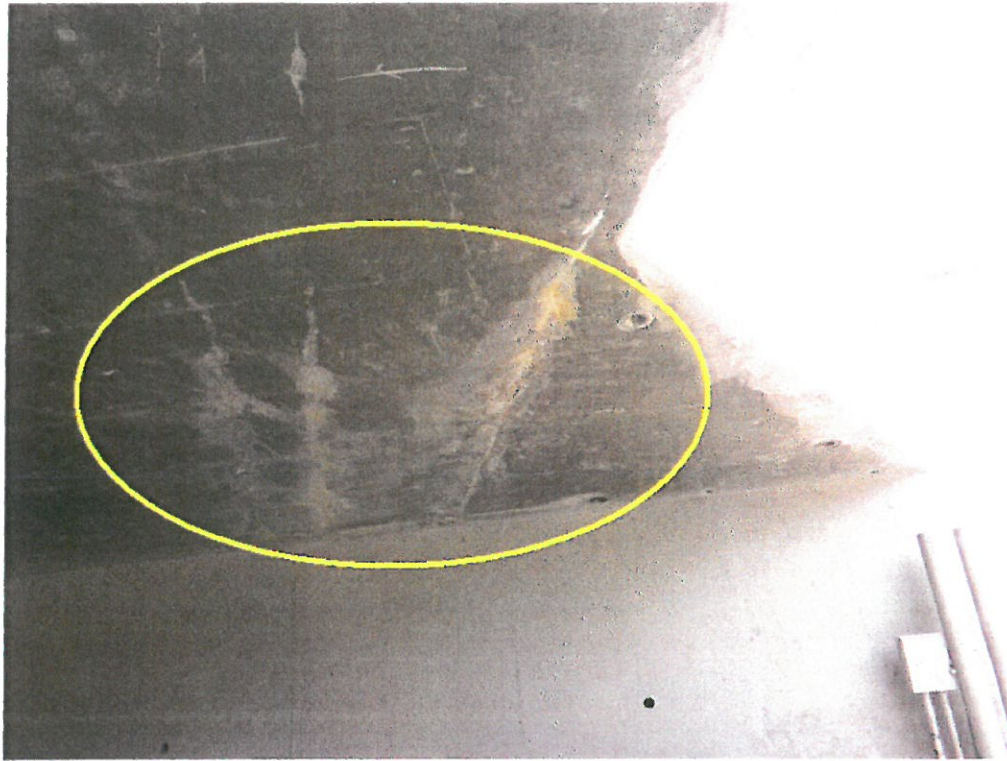
Photo No. 1

The soffit of the box girder has 3 longitudinal cracks with white efflorescence.

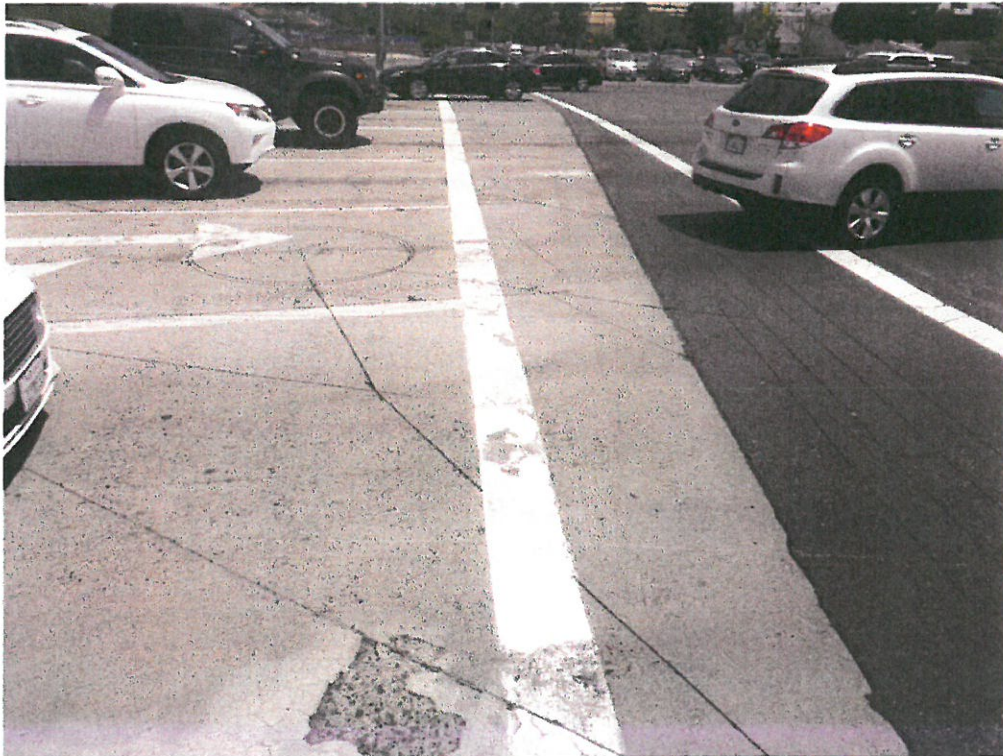
Photo No. 2

There is a loop detector in the concrete deck at the easterly end of the eastbound lanes.  
(see the attached photo no. 2)

loop detector in the deck at east end at eastbound lanes.

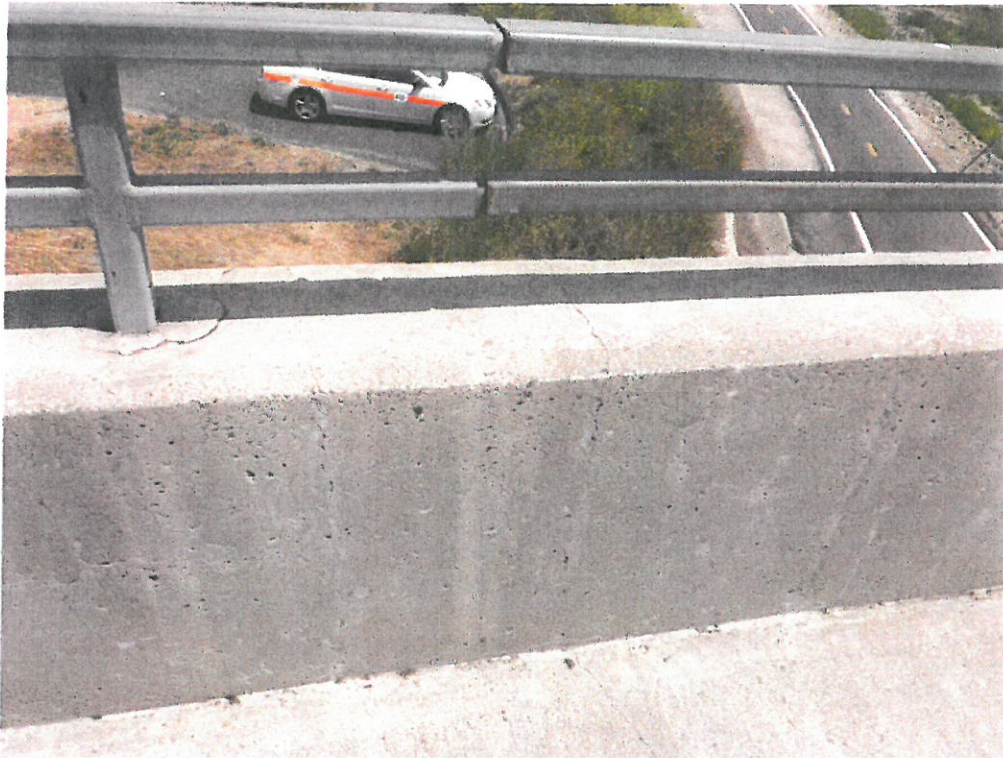
Photo No. 3

Elem No.	Defect /Prot	Defect	Element Description	Env Qty	Total Qty	Units	Qty in each Condition	State
							St. 1	St. 2
(331-1080)			The south rail exhibits several spalls +/- 4 inches X 4 inches X 1 inch.					
(331-1130)			The south rail exhibits vertical cracks, up to 0.04 inches wide. (see the attached photo no. 3)

Vertical cracks at the south rail.

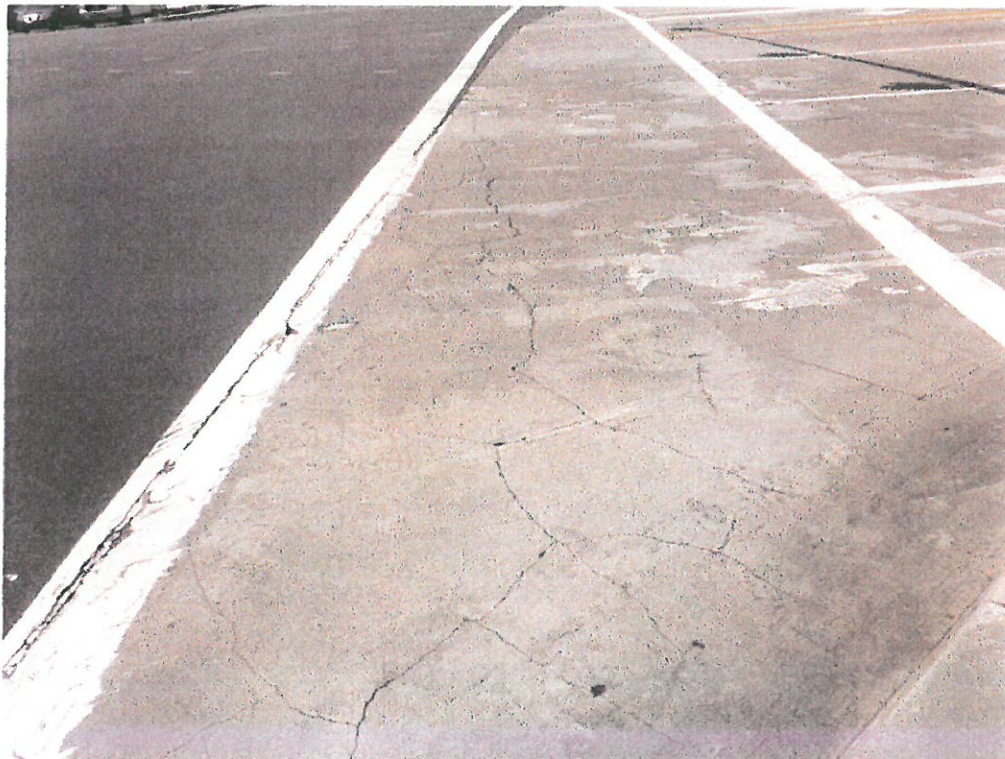
Photo No. 4

Map cracks at the east end, up to 0.2 inches wide.

Seal the concrete deck cracks with

Action : Deck-Methacrylate

methacrylate.

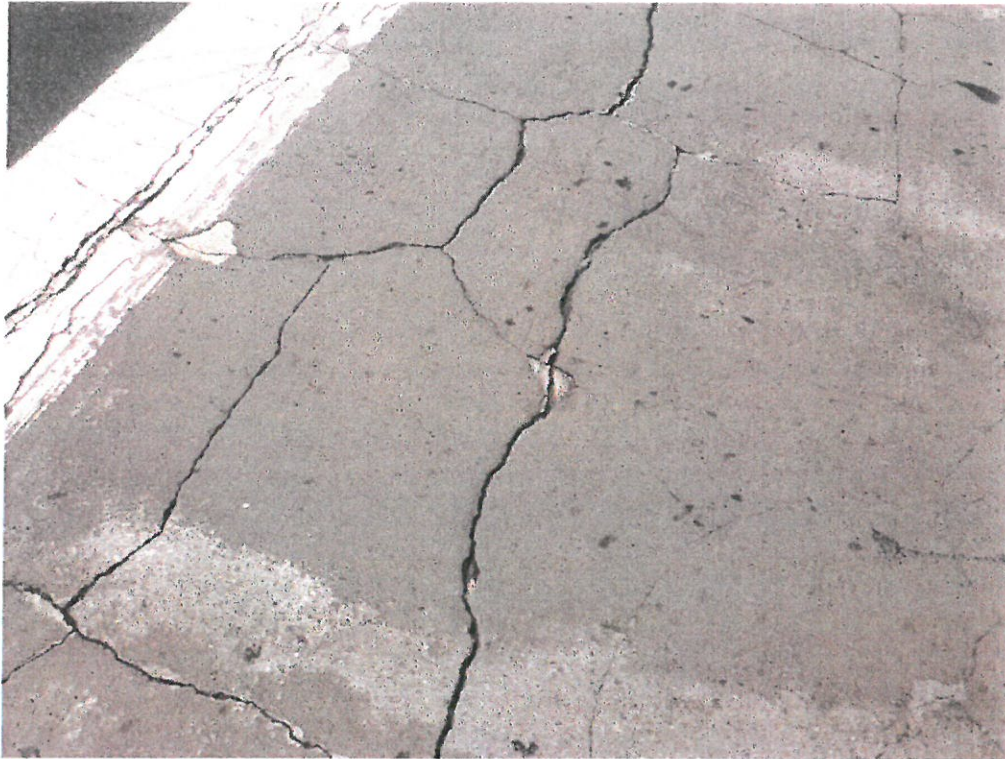
Photo No. 5

Map cracks at the east end, up to 0.2 inches wide.

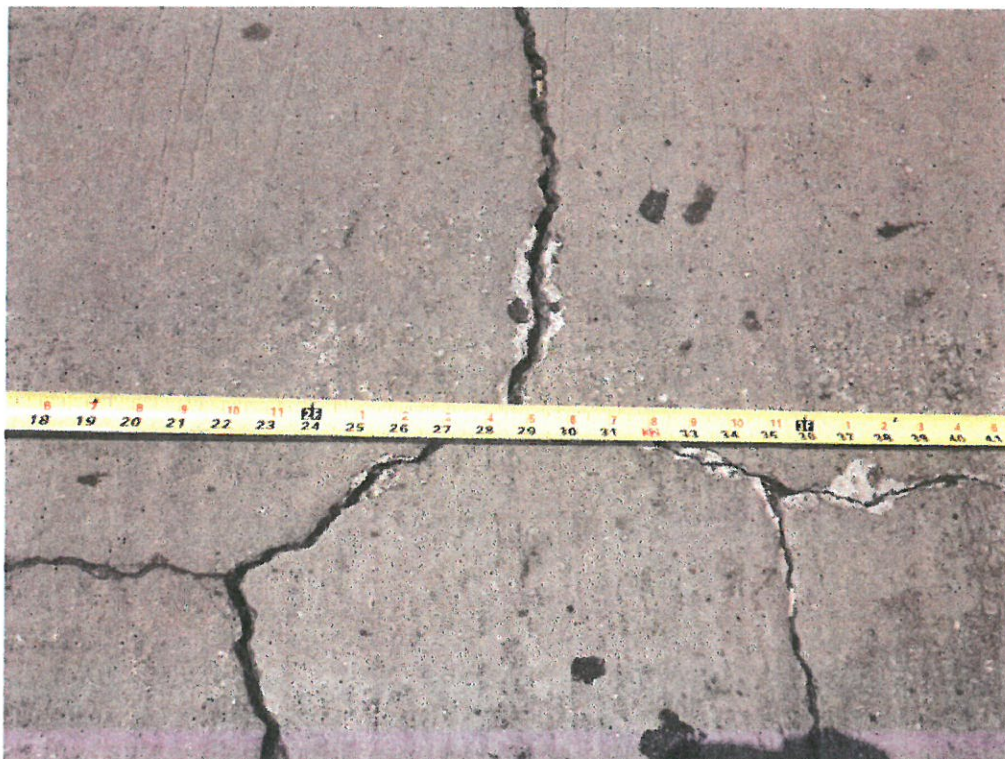
Photo No. 6

Map cracks at the east end, up to 0.2 inches wide.
