<b>Bridge #</b>	<b>Bridge Name</b>	<b>Location</b>	<b>Inspection</b>		<b>Outstanding</b>	
			<b>Date</b>	<b>Type</b>	<b>Work</b>	<b>Cost</b>
55C0555	CAPISTRANO SRFSD INN POC	0.5 M S/O PARK LANTEM	04/30/2018	Routine	Y	\$

Bridge Number : 55C0555  
Facility Carried: PEDESTRIAN WALKWAY  
Location : 0.5 M S/O PARK LANTEM  
City :  
Inspection Date : 04/30/2018

**Bridge Inspection Report**

**STRUCTURE NAME:** CAPISTRANO SRFSD INN POC

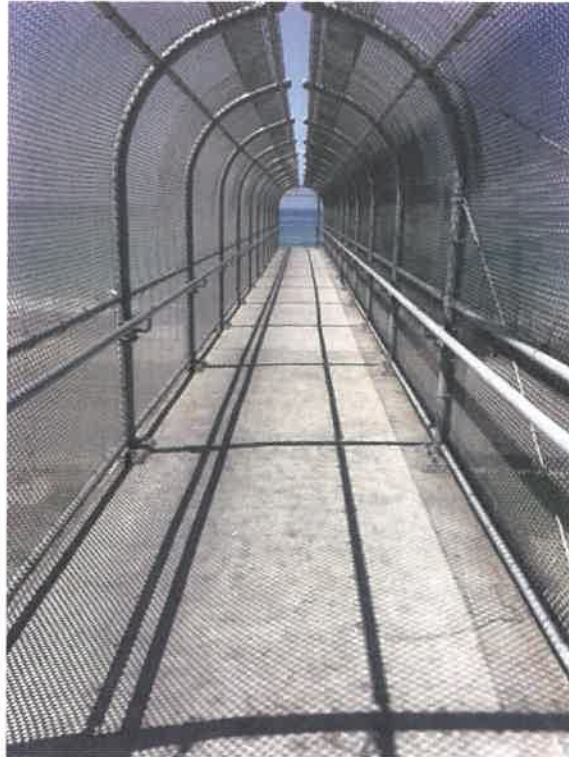
**100 - PHOTO-Routine-Roadway View**

Deckview looking south

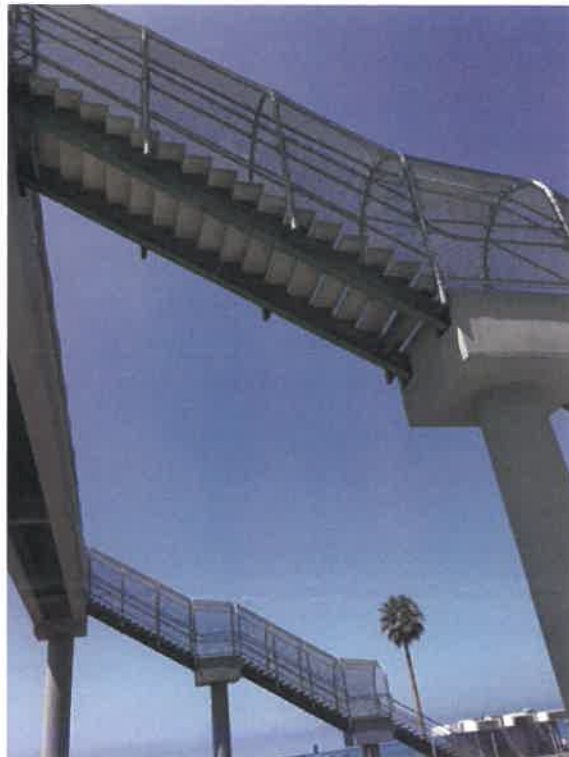
**101 - PHOTO-Routine-Elevation View**

Elevation looking at both trances' staircase

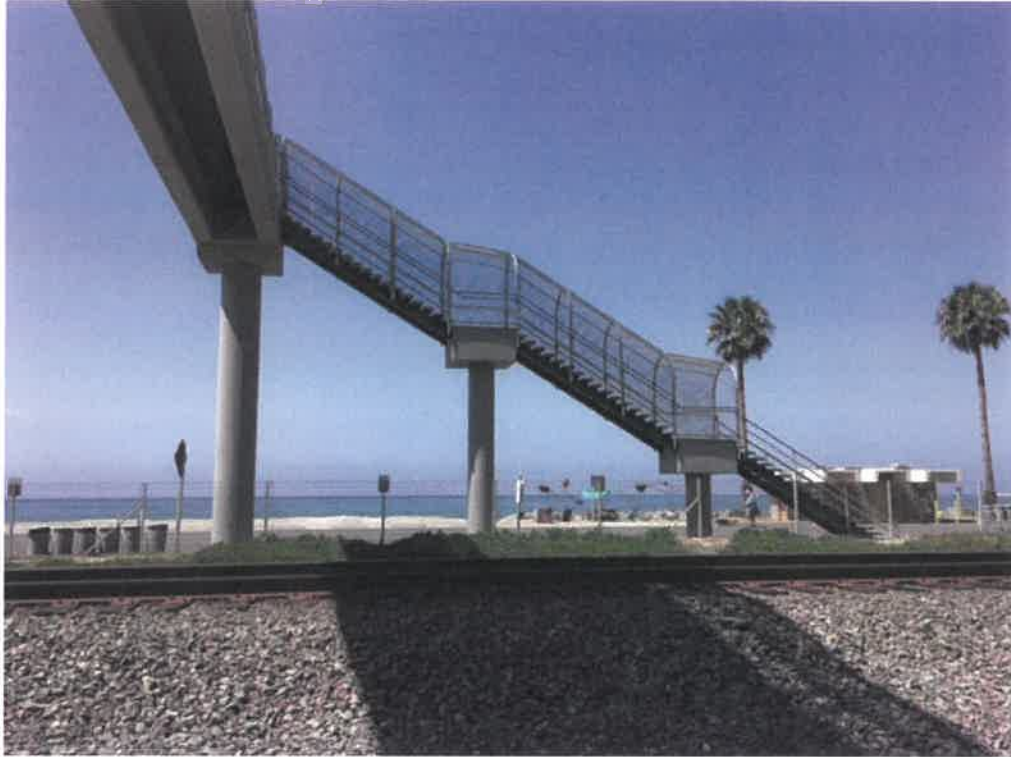
101 - PHOTO-Routine-Elevation View

Elevation looking south

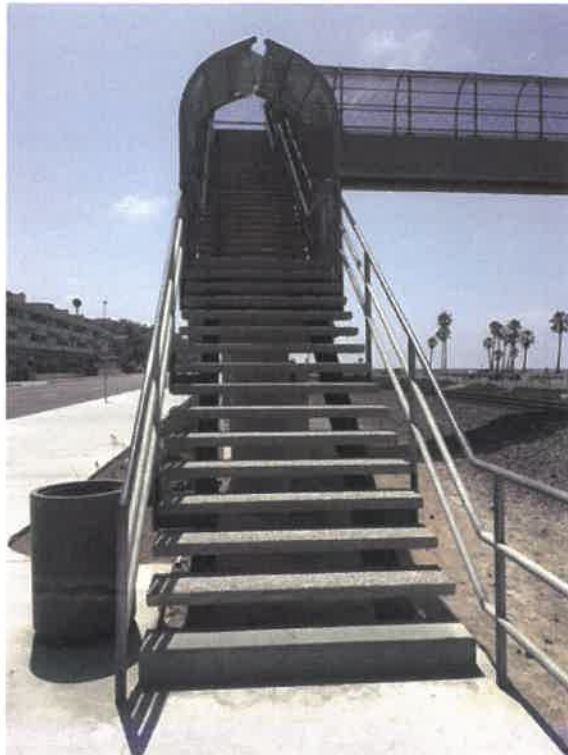
101 - PHOTO-Routine-Elevation View

Entrance along the PCH 01

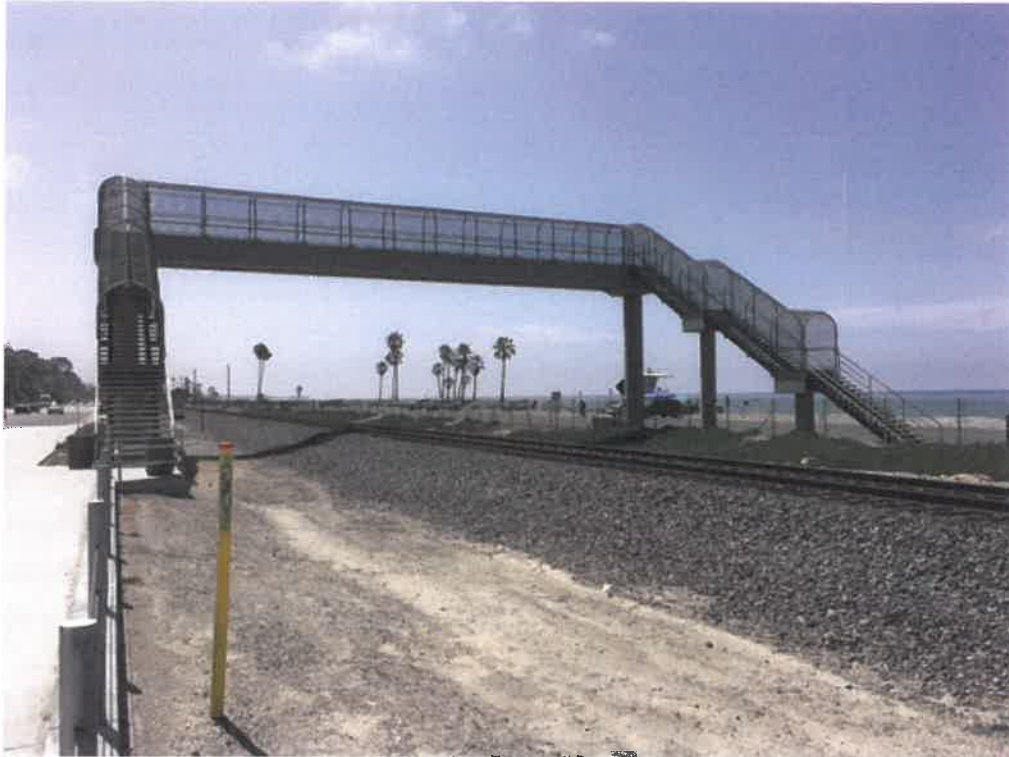
101 - PHOTO-Routine-Elevation View

Elevation looking South. Left section of St. Bridge was removed at the time of inspection

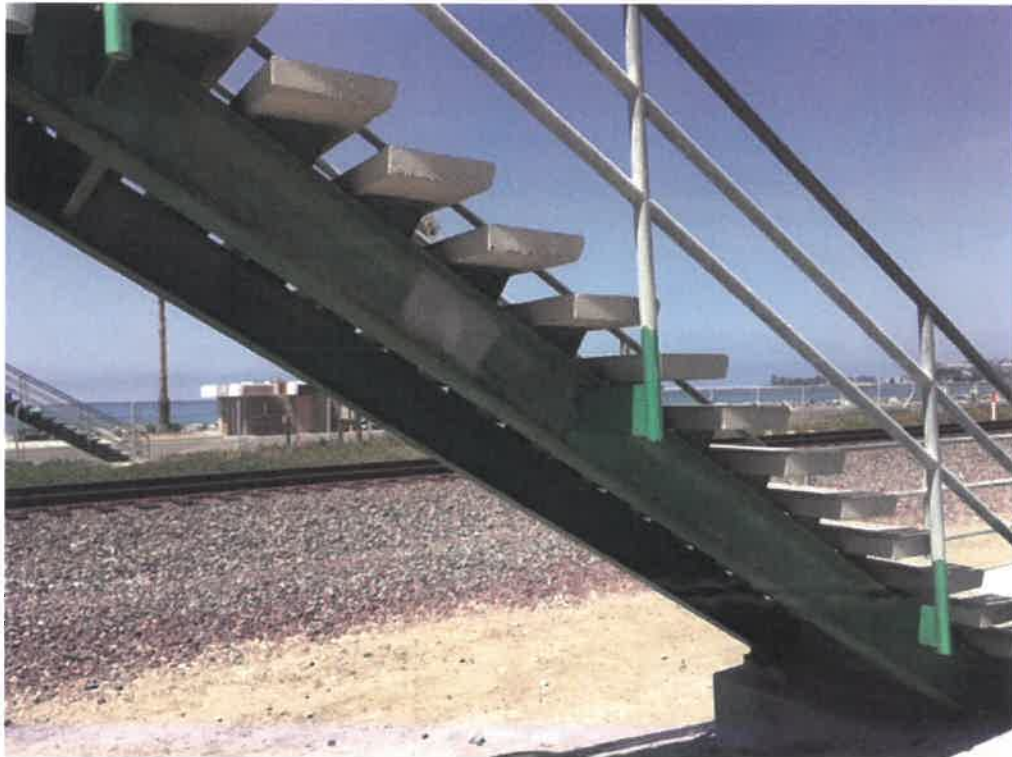
**114 - PHOTO-Sub-Details**

There is rust mainly along, on top and bottom flanges of spans #1 through #3 and #5 to #7. Span #4 is over the railroad. In addition, Rust is building up inside the corner between the webs and flanges of all steel staircase; and also, those right triangular metal brackets that support the concrete treads are rusted too. Due to the natural environment location of this structure, the paint system of all steel members is about 25% rusted,

**Steel girders of staircase**

Remove and repaint all rust on all steel members of this structure, mainly the two steel girders support all staircase for the entire structure, including metal triangular brackets underneath concrete treads.

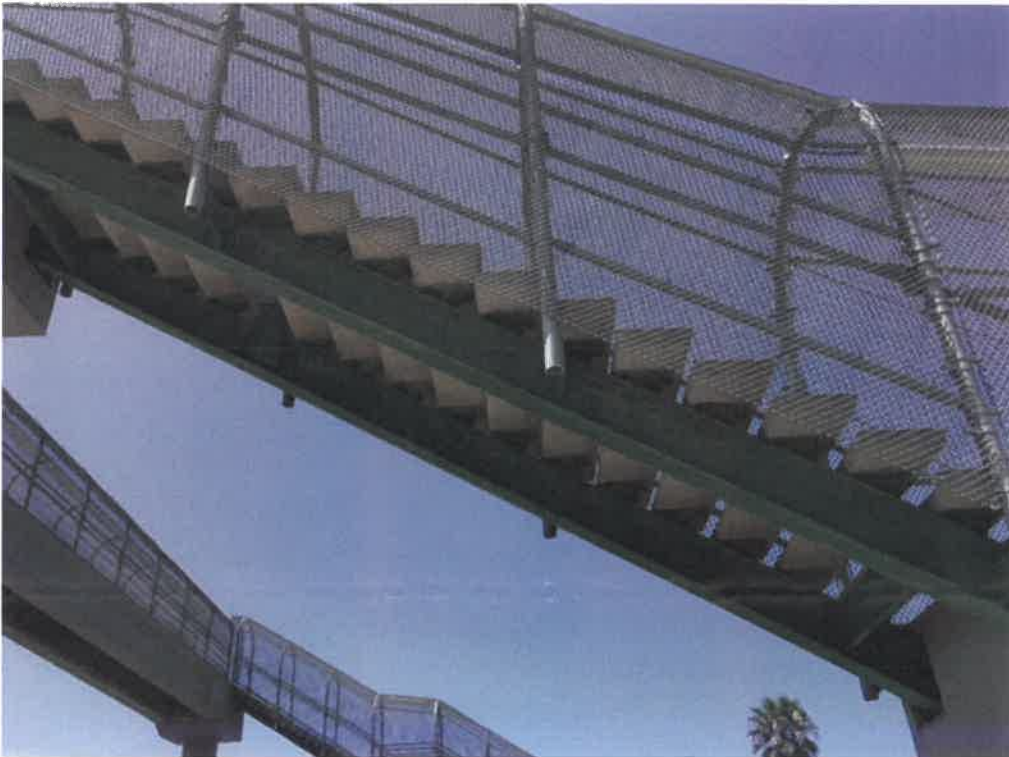
114 - PHOTO-Sub-Details

Steel girders of staircase

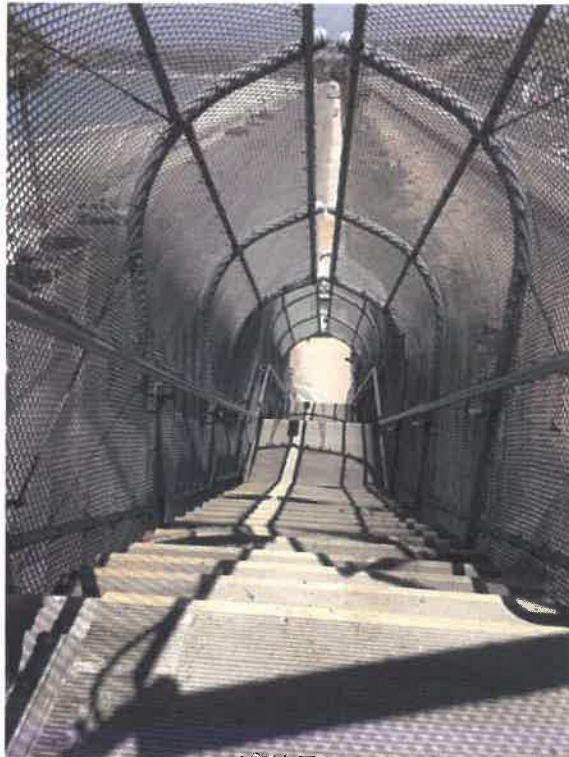
117 - PHOTO-Sub-Misc.

Entrance staircase from the Doheny Beach Park

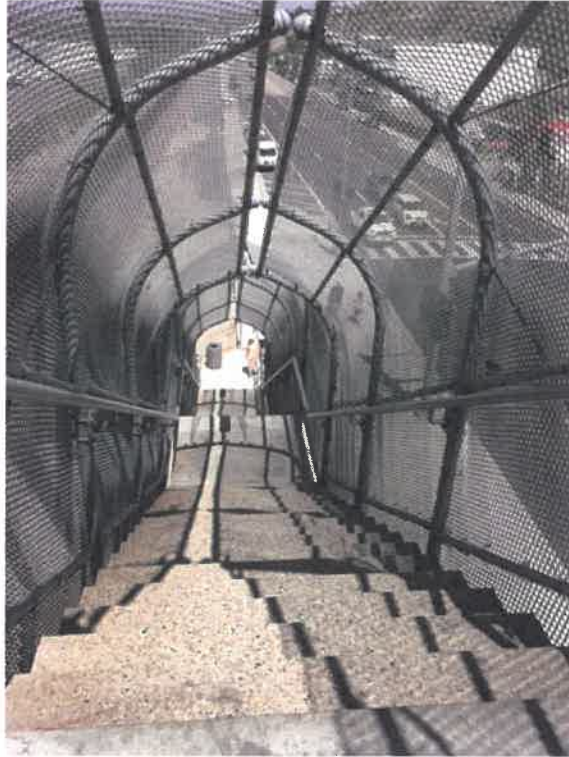
117 - PHOTO-Sub-Misc.

Photo No. 1  
Staircase, PCH entrance

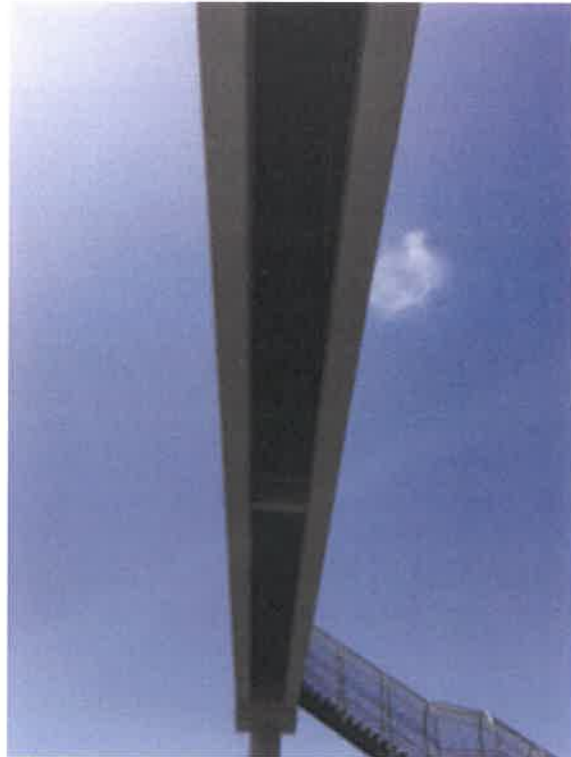
## 135 - PHOTO-Routine-Underside View

The deck soffit is covered by metal corrugated sheet. There is no notable distress observed at the time of inspection.

Deck soffit is covered by corrugated metal sheet
