Bridge Number : 55C0572  
Facility Carried: IRVINE AVENUE  
Location : 0.4 MI SW/O BRISTOL ST.  
City :  
Inspection Date : 02/06/2020  
Inspection Type  
Routine FC Underwater Special Other  
☒ ☐ ☐ ☐ ☐

**Bridge Inspection Report**

**STRUCTURE NAME:** SANTA ANA DELHI CHANNEL

Structure Description: Triple 18 ft x 15 ft x 150 ft long RC box culvert under about 5 ft of fill and AC surfacing.

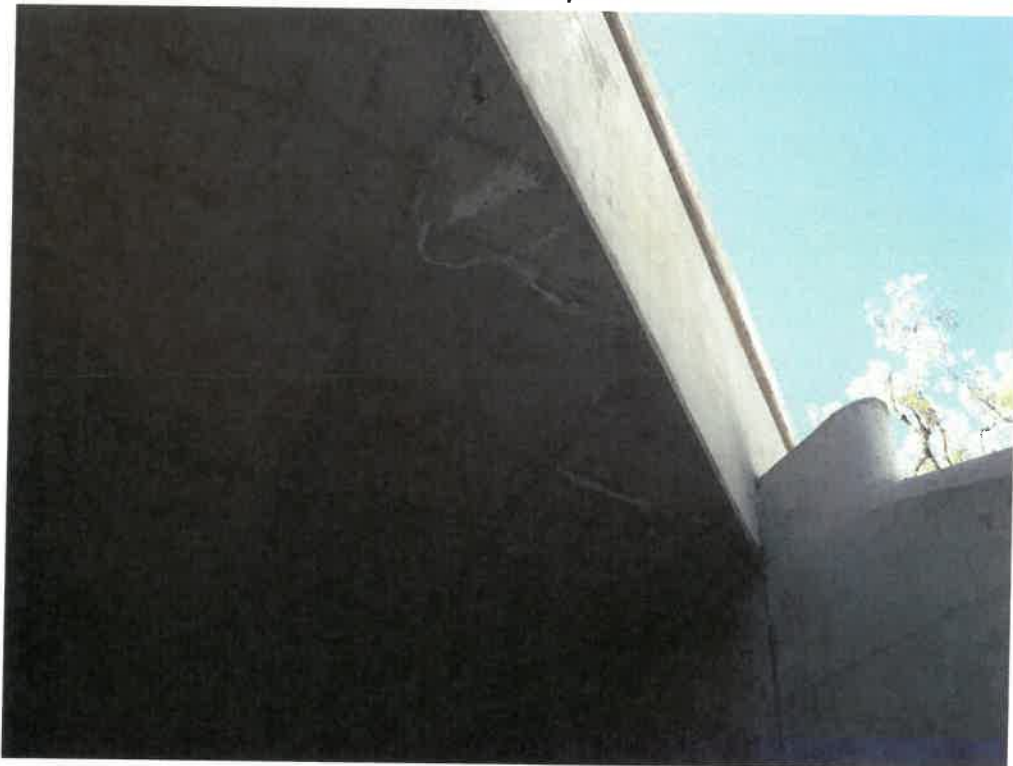
Photo No. 4

White efflorescence deposits and/or brown stains were observed at a few locations in the culvert cells: at the expansion joints especially near the wall and top slab soffit conjunction locations (Photo Number 5); on the soffit near the northern edge of the east cell (Photo Number 4); on the soffit of cells surrounding thin longitudinal cracks.

MINOR EFFLORESCENCE DEPOSITS ON THE TOP SLAB SOFFIT IN THE NORTHERN SIDE OF EAST CELL

Seal the cracks on culvert walls and cell soffits by epoxy injection.

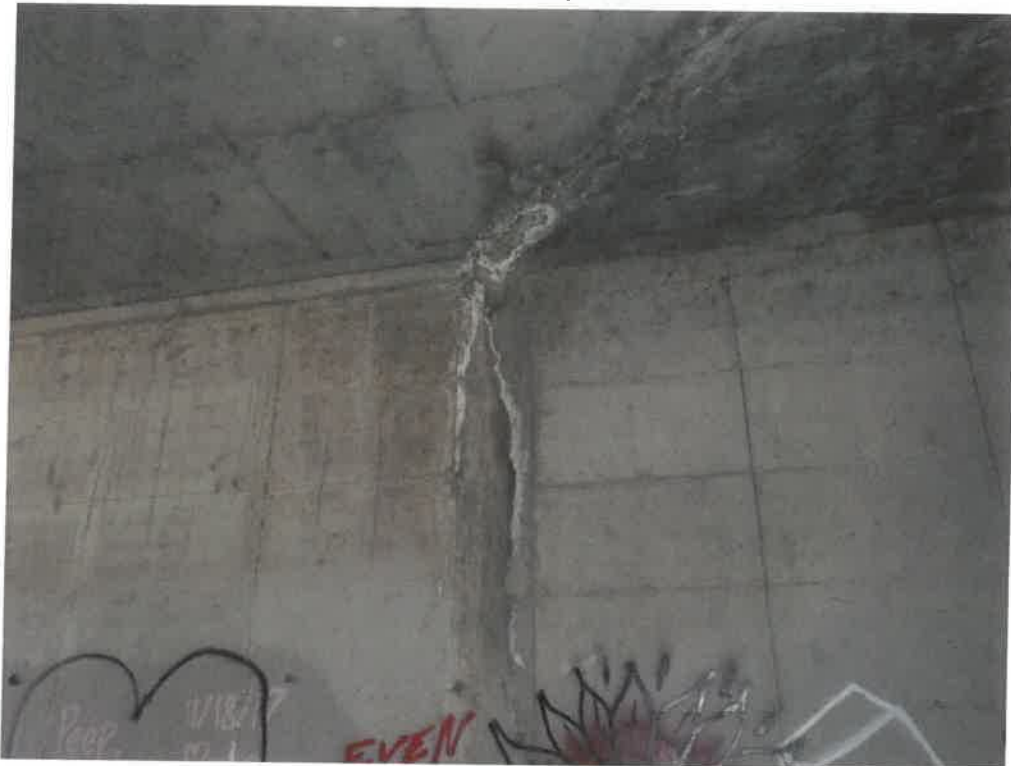
Photo No. 5

TYPICAL EFFLORESCENC DEPOSITS AT AN EXPANSION JOINT

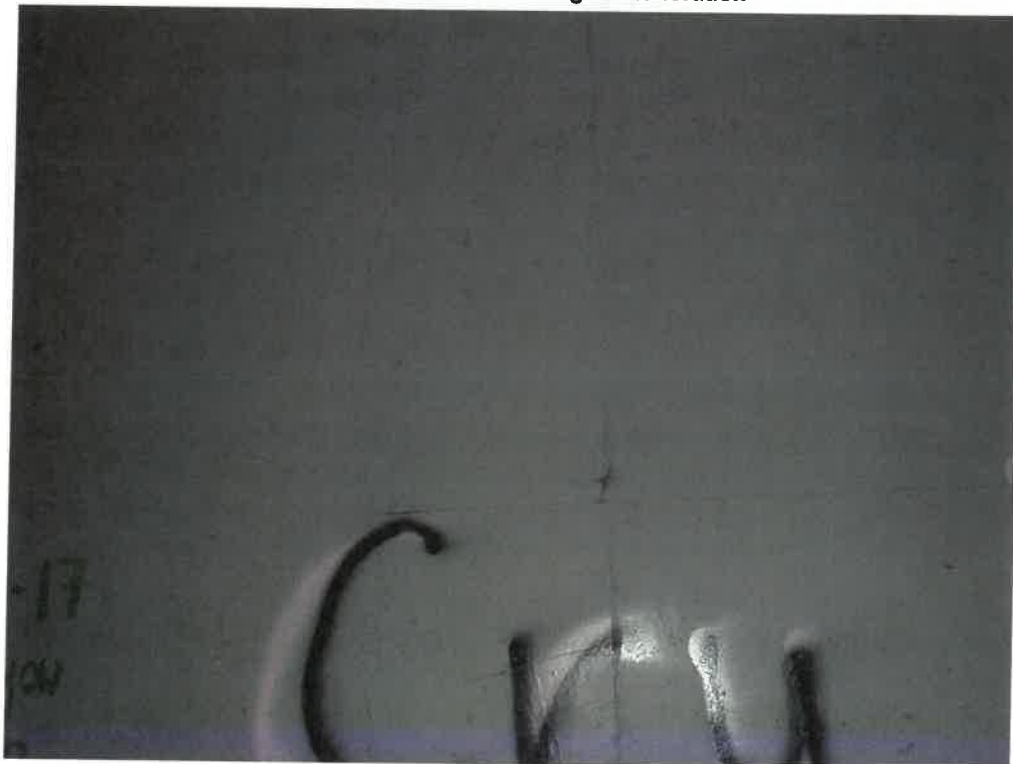
Photo No. 6

There are 0.02 to 0.04-inch wide vertical cracks in the walls as follows: 1 crack in Wall 1, 3 cracks in Wall 3, and 6 cracks in Wall 3 (Photo Number 6).

TYPICAL VERTICAL CRACKS ON THE MIDDLE PARTITION WALLS

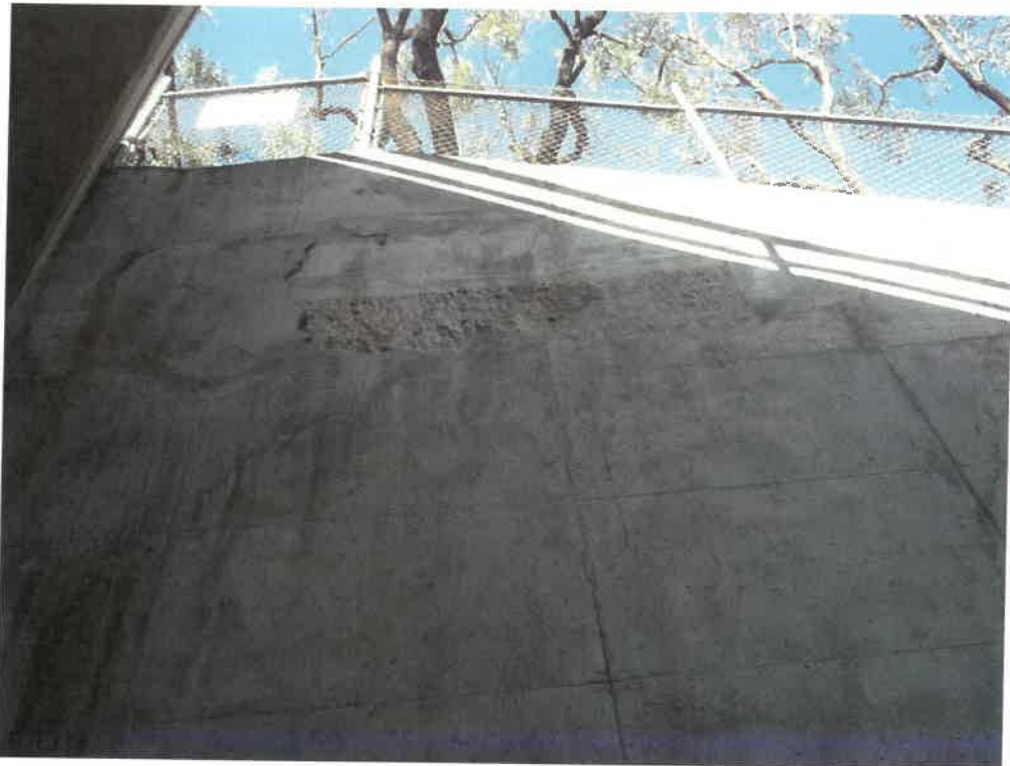
Photo No. 10

A SPALL DUE TO PATCH FAILURE ON THE NORTH CHANNEL WALL NEAR THE EAST SIDE OF THE CULVERT

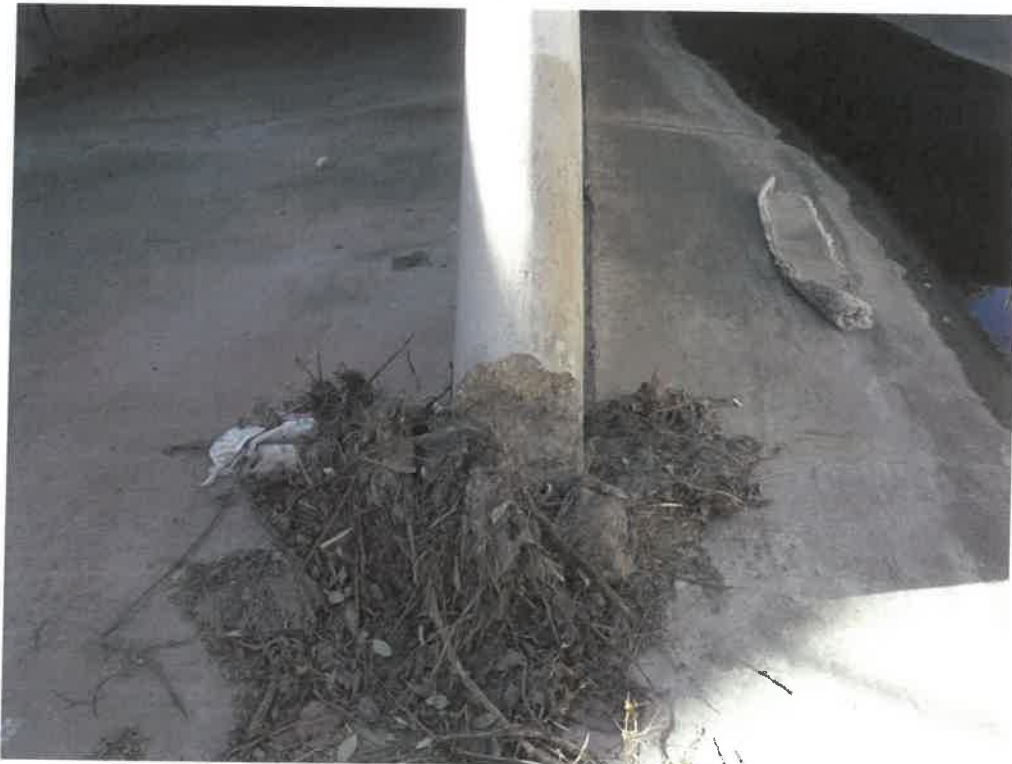
Photo No. 11

a concrete nose wall spall at the northern end of Wall 3, 12 inch x 12 inch x 4 inch (Photo Number 11),

A NOSE WALL BOTTOM SPALL AT WALL 3 BETWEEN THE MIDDLE AND EAST CELLS

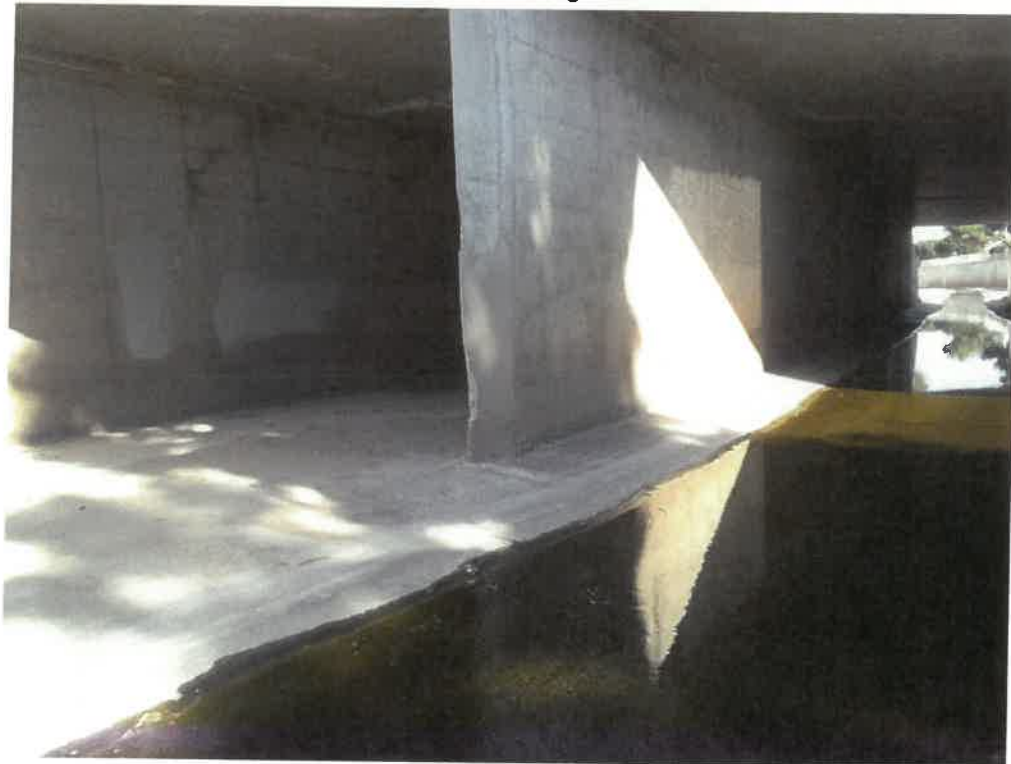
Photo No. 12

a wing wall patch failure near the southeastern corner of the culvert, 8 ft x 2 ft x 1 inch (Photo Number 12).

There are a couple of concrete spalls on the south acute-angle end of Wall 2, up to 12 inch H x 4 inch W x 2 inch D each within the lower half height of the wall (Photo Number 12).

THE LOWER PORTION WALL 2 SOUTH END SPALL
