**Bridge Report Transmittal Sheet****Batch 57987****County of Orange**

Bridge Number : 55C0573  
Facility Carried: RIVERFORD ROAD  
Location : 0.1 MI. NW/O BROWNING AV  
City :  
Inspection Date : 02/06/2020

**Bridge Inspection Report**

**STRUCTURE NAME:** REDHILL CHANNEL

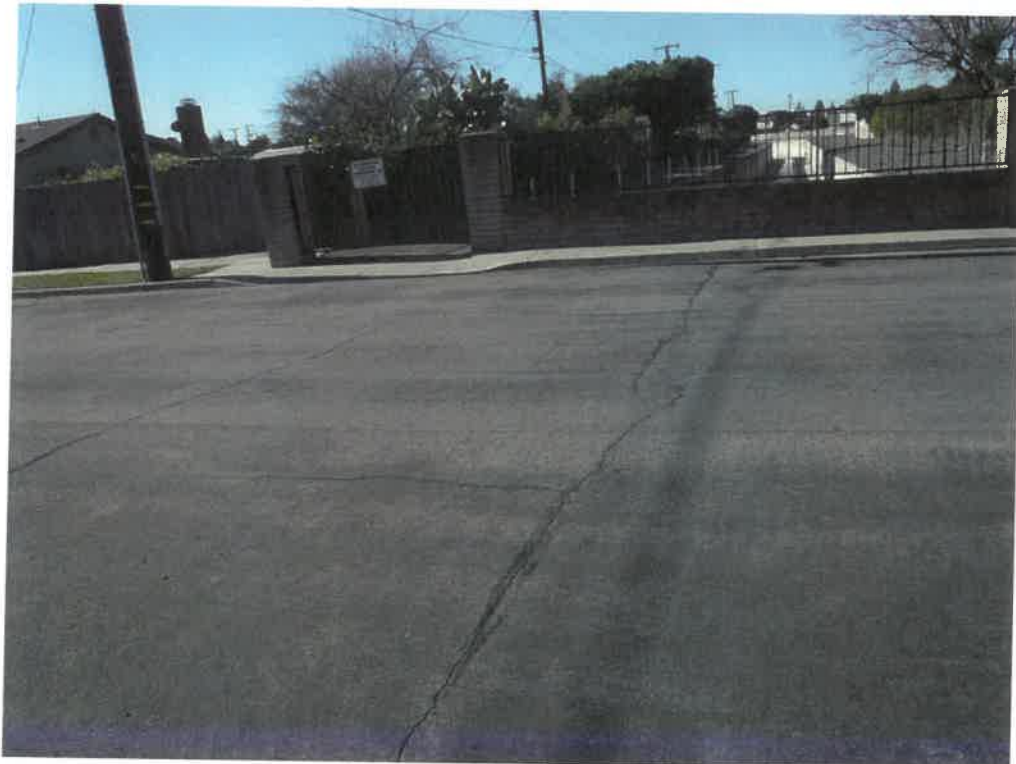
Photo No. 2

There are transverse cracks on AC pavement at the areas above abutments up to 0.2 inch

wide (Photo Number 2).

A TRANSVERSE ROADWAY AC PAVEMENT CRACK ABOVE THE CULVERT

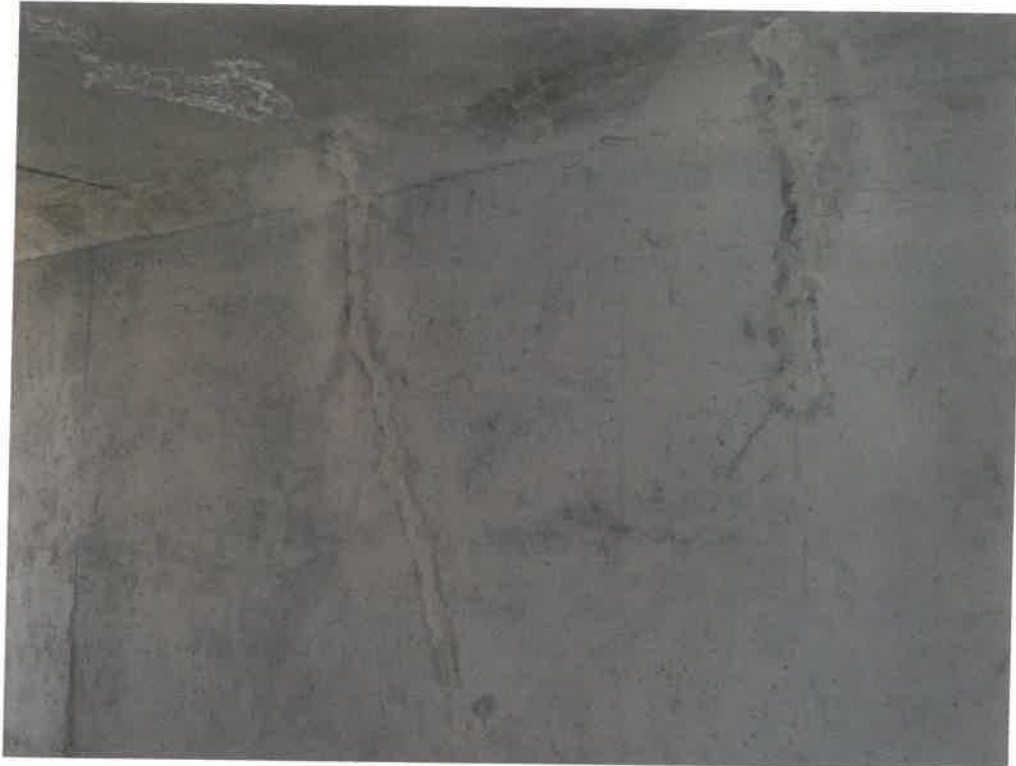
Photo No. 5

Elem No.	Defect /Prot	Element Description	Env	Total Qty	Units	Qty in each State	St. 1	St. 2	St. 3	St. 4
241		Culvert-RC	2	28	m	28	0	0	0	0
(241) There were no significant defects noted. All wall vertical and diagonal cracks are sealed with epoxy paste by local agency (Photo Number 5).										
334		Railing-Masonry	2	13	m	13	0	0	0	0
(334) There were no significant defects noted.

TYPICAL SEALED WALL CRACKS ALONG CELLS
