## Bridge Inspection Report

**STRUCTURE NAME:** REDHILL CHANNEL

02/06/2020 [AAA]

55C0574

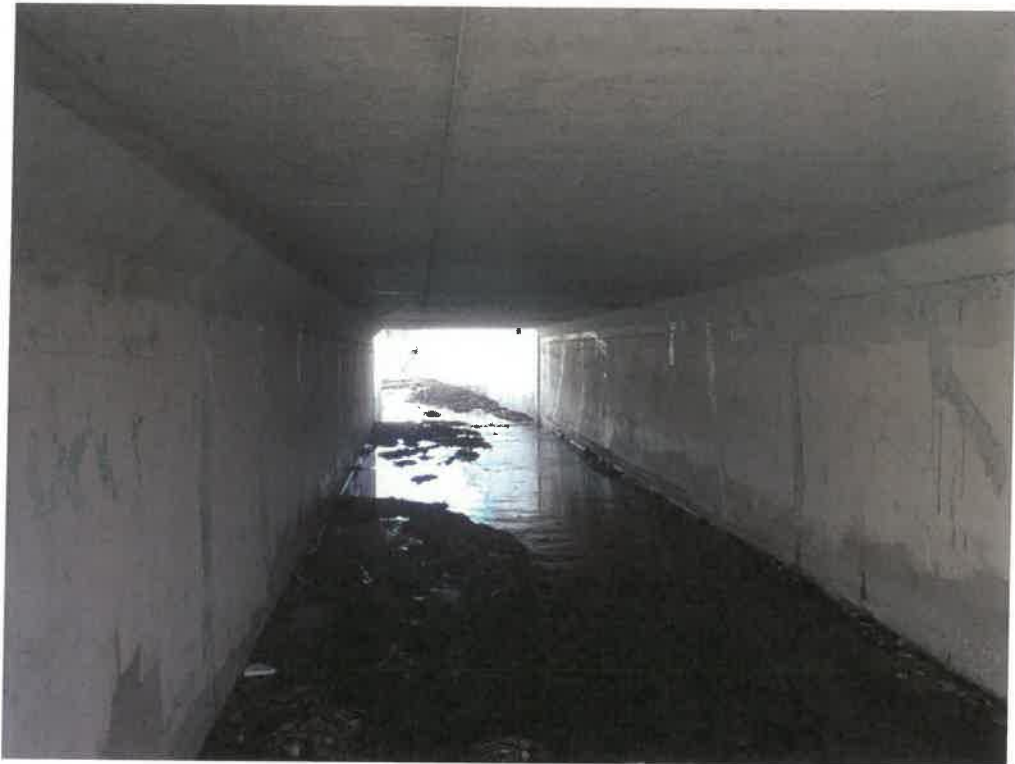
Photo No. 3

There were no significant defects noted. There were no significant defects noted. All wall vertical and diagonal cracks are sealed with epoxy paste by local agency (Photo Numbers 3 - 6).

UNDER VIEW IN THE EAST CELL, LOOKING NORTHEAST

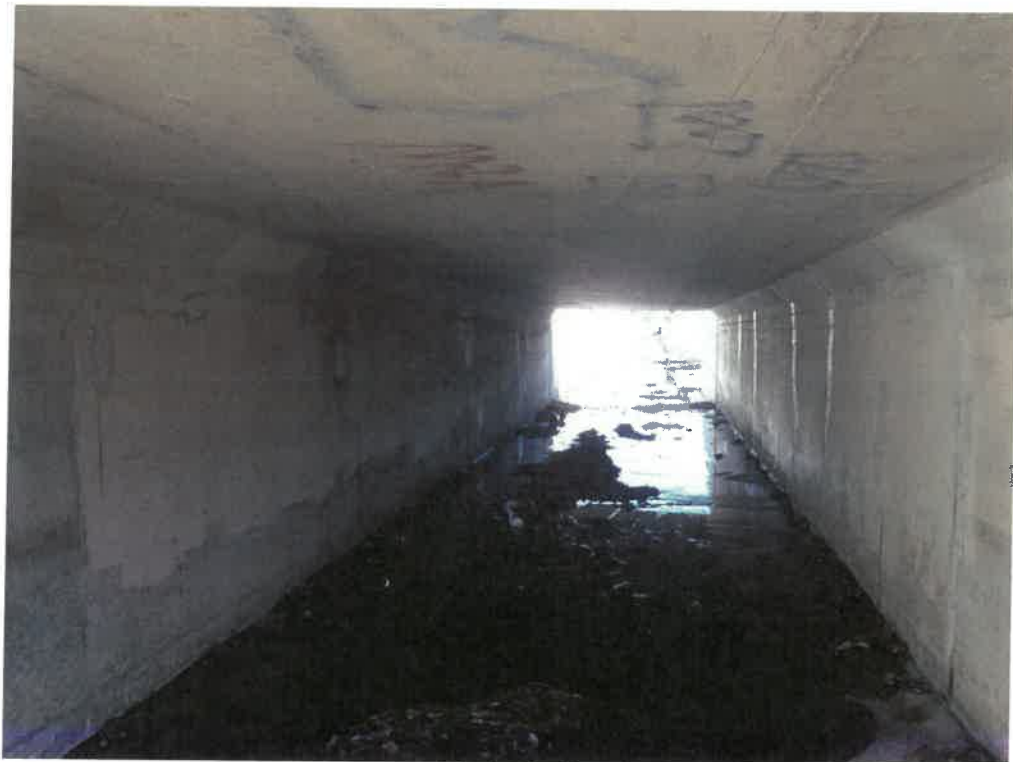
Photo No. 4

UNDER VIEW IN THE MIDDLE CELL, LOOKING NORTHEAST

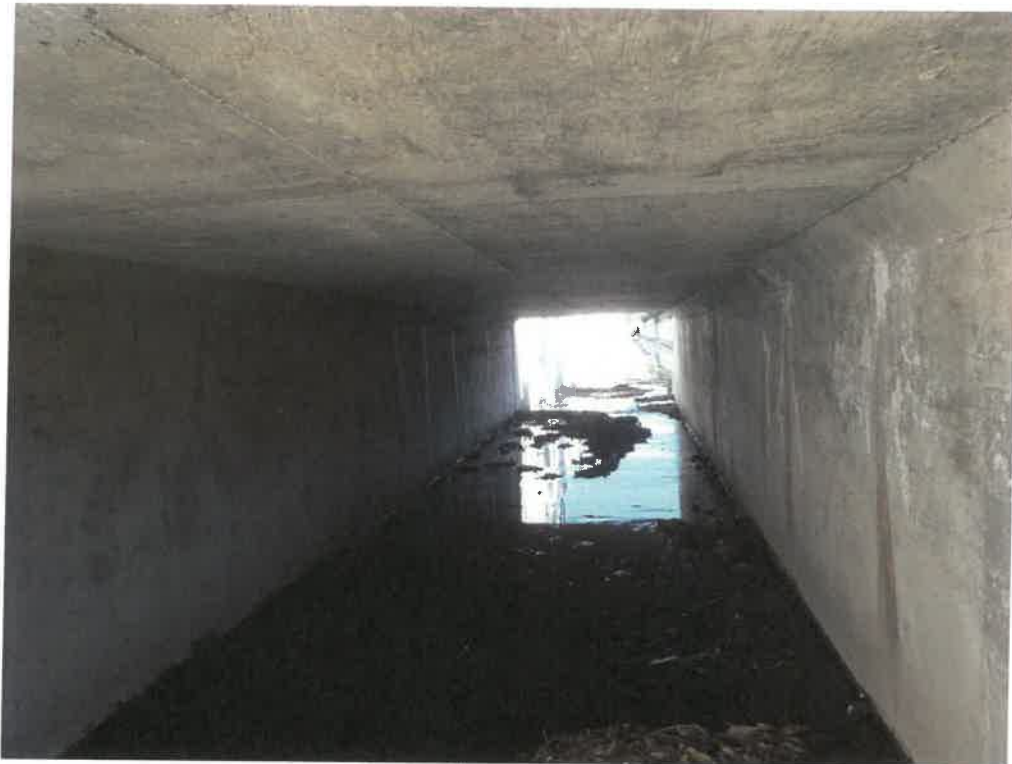
Photo No. 5

UNDER VIEW IN THE WEST CELL, LOOKING NORTHEAST

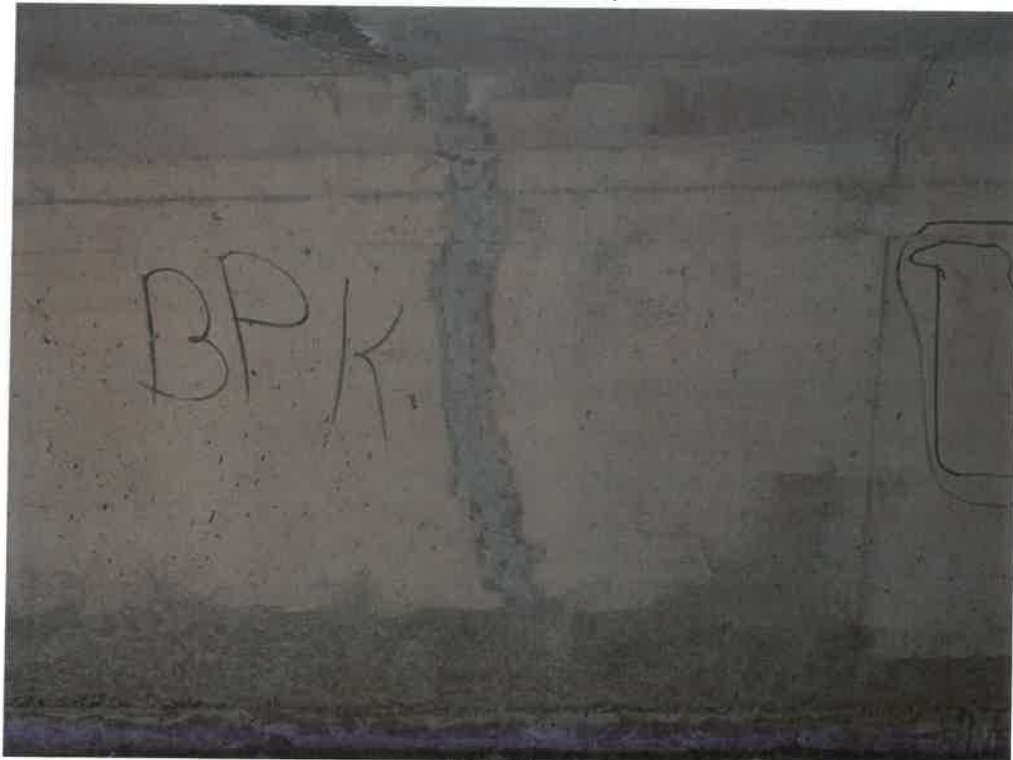
Photo No. 6

TYPICAL SEALED WALL CRACKS ALONG CELLS

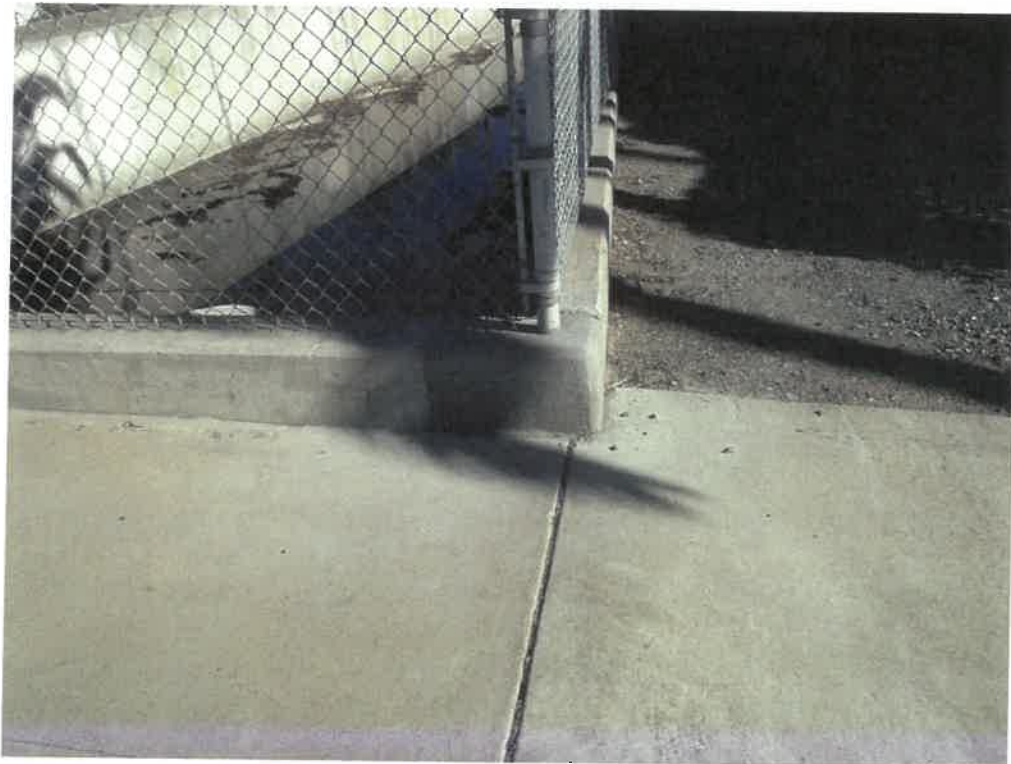
Photo No. 8

The spalls at the chainlink fences bases have been repaired (Photo Number 8).

THE REPAIRED CHAINLINK FENCE BASE LOCATED AT THE NORTHEASTERN CORNER OF THE STRUCTURE

Locate all chainlink fence base spalls, remove unsound concrete, clean and patch the spalled areas.
