Bridge Number : 55C0575
Facility Carried: MESA DRIVE
Location : 100' SE/O IRVINE AVENUE
City :
Inspection Date : 08/07/2018

Bridge Inspection Report

STRUCTURE NAME: SANTA ANA DELHI CHANNEL

Structure Description: Triple 18.0 ft W x 16.0 ft H x 62.0 ft L RC box culvert (Non-Grade top) beneath 4.00 ft of earth fill.

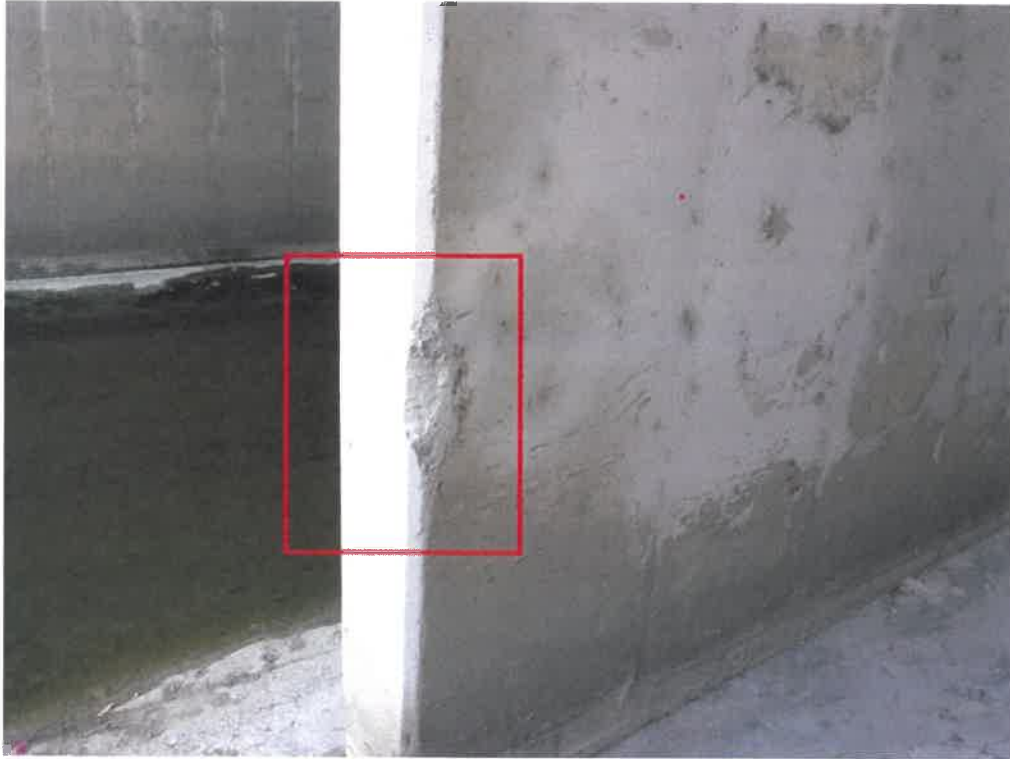
Photo No. 1

Box wall #3 exhibits two spalls +/- 8 inches X 2 inches X 1 inch at south end approximately 20 inches above the invert. (see photo no. 1)

spall 8" X 2" X 1" at south end of wall 3.

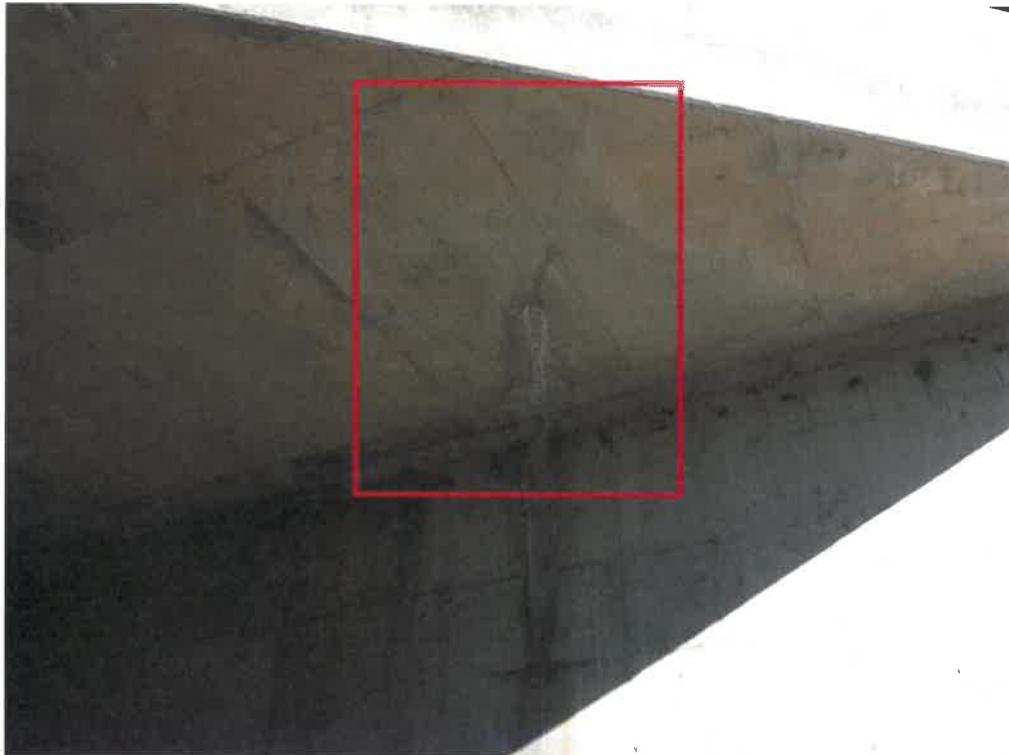
Photo No. 2

- at barrel #1: (see photo no. 2)
- * a longitudinal crack, 10 feet long and 0.03 inches wide at midspan with light white efflorescence;
- * two longitudinal cracks with light white efflorescence at 10 feet from north end; and
- at barrel #2:
- * a longitudinal crack 6 feet long and 0.03 inches wide at northwest corner with heavy white efflorescence;
- * a longitudinal crack 13 feet long and 0.03 inches wide at 7 feet from the north end with heavy white efflorescence; and

Diagonal crack with brown efflorescence at barrel 1.
