Bridge Report Transmittal Sheet

Bridge Number : 55C0606
Facility Carried: OSO PARKWAY
Location : 0.6 MI E/O FELIPE ROAD
City :
Inspection Date : 08/31/2018

Bridge Inspection Report

STRUCTURE NAME: ARROYO TRABUCO

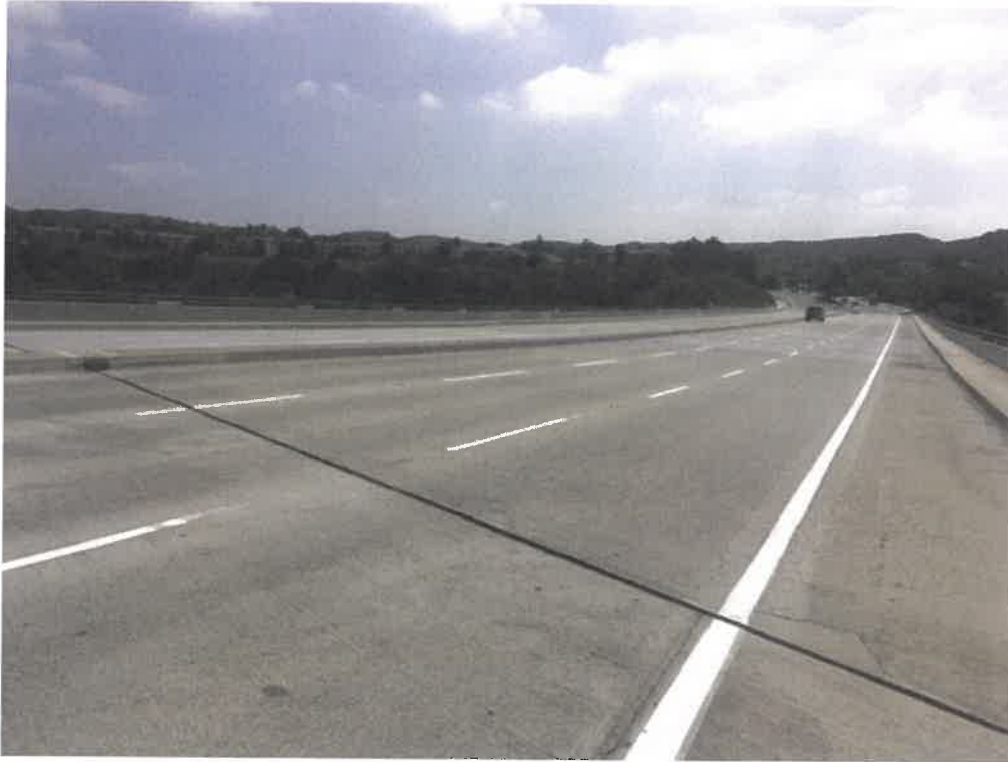
Photo No. 1

Deckview looking east

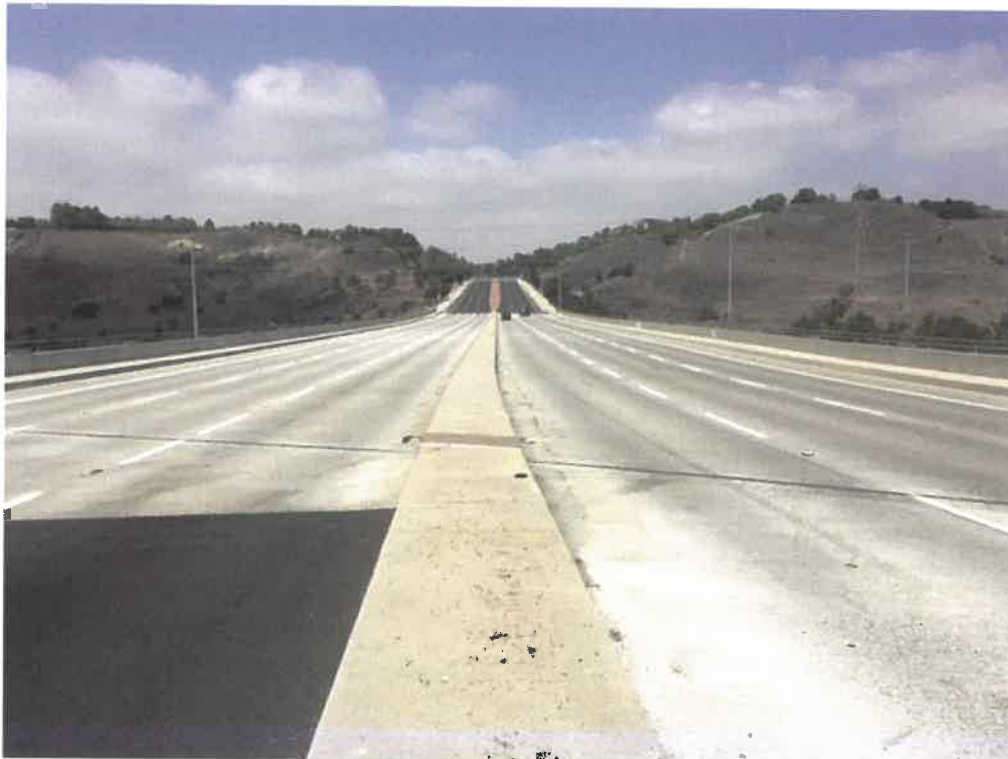
Photo No. 1

Deckview looking west

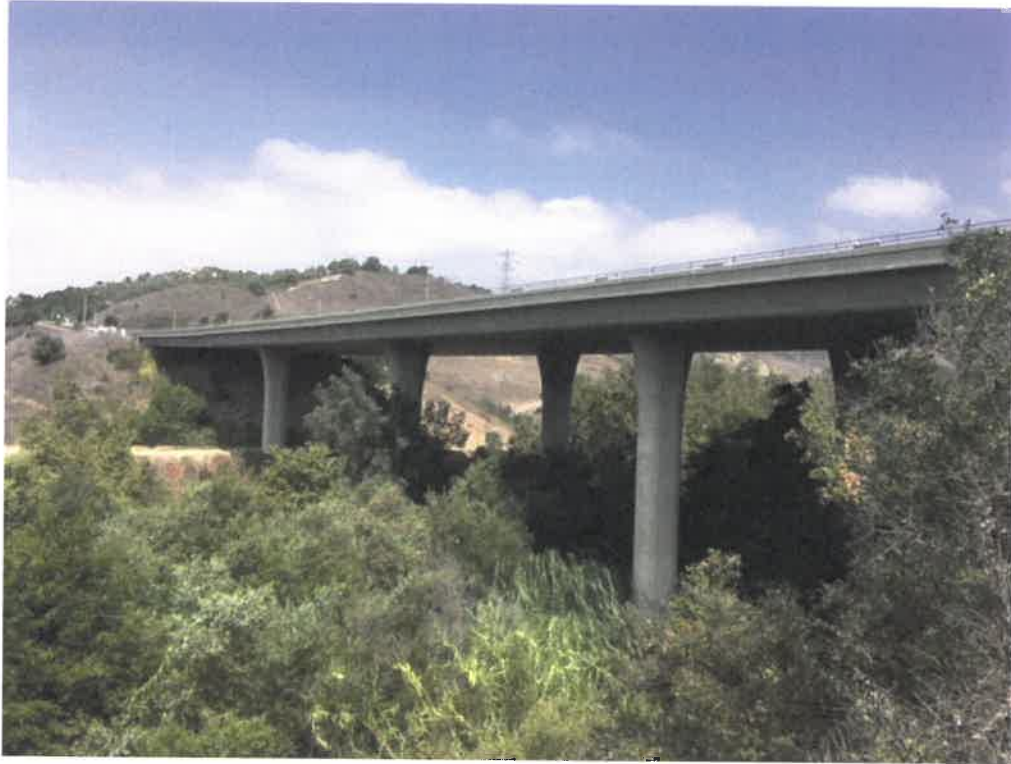
Photo No. 1

Elevation looking southeast

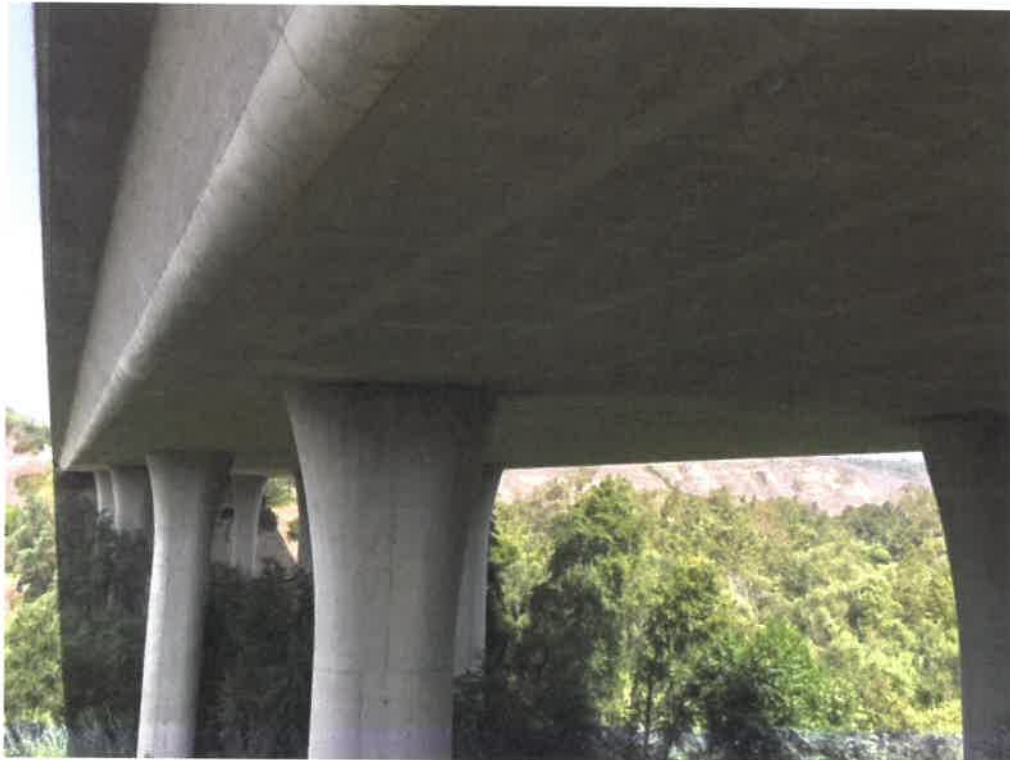
Photo No. 1

Elevation looking northwest

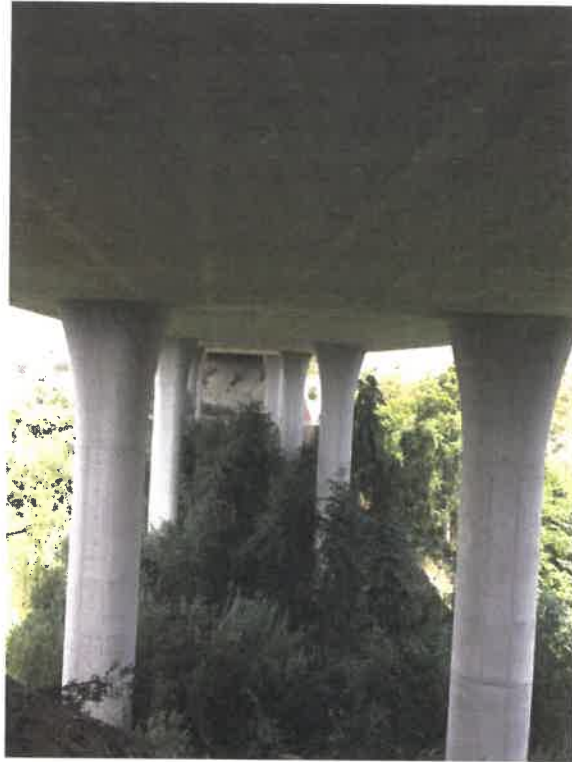
Photo No. 1

Elevation looking west

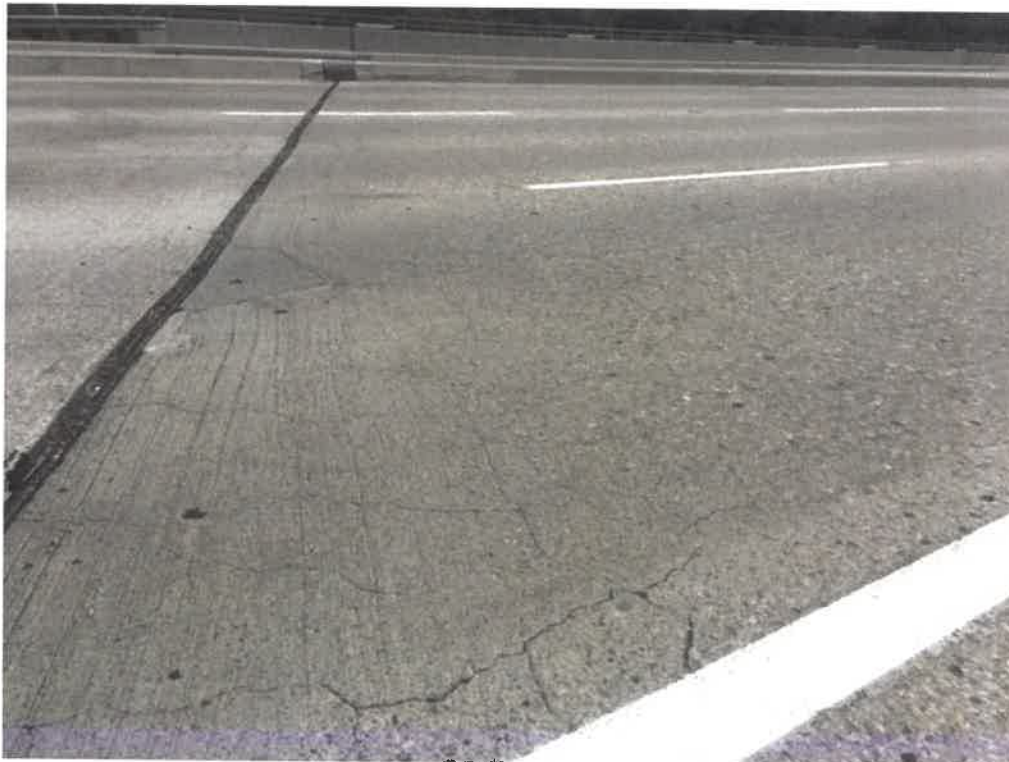
Photo No. 1

The entire type B seal is debonded on both directions at the westerly abutment with 2.5 inches to 3.0 inches gap at 80.5 F degree at the time of inspection.

Type B seal lost adhesion in many locations, and water stain is noticed underneath at the westerly abutment on both directions.

Type B Seal at Westerly Abutment.

Replace entire type B seal at the westerly abutment. In addition, clean out all debris inside the strip seals at hinge and easterly abutment joint at 2.5 inches to 3.0 inches gap at 85.0 F degree.

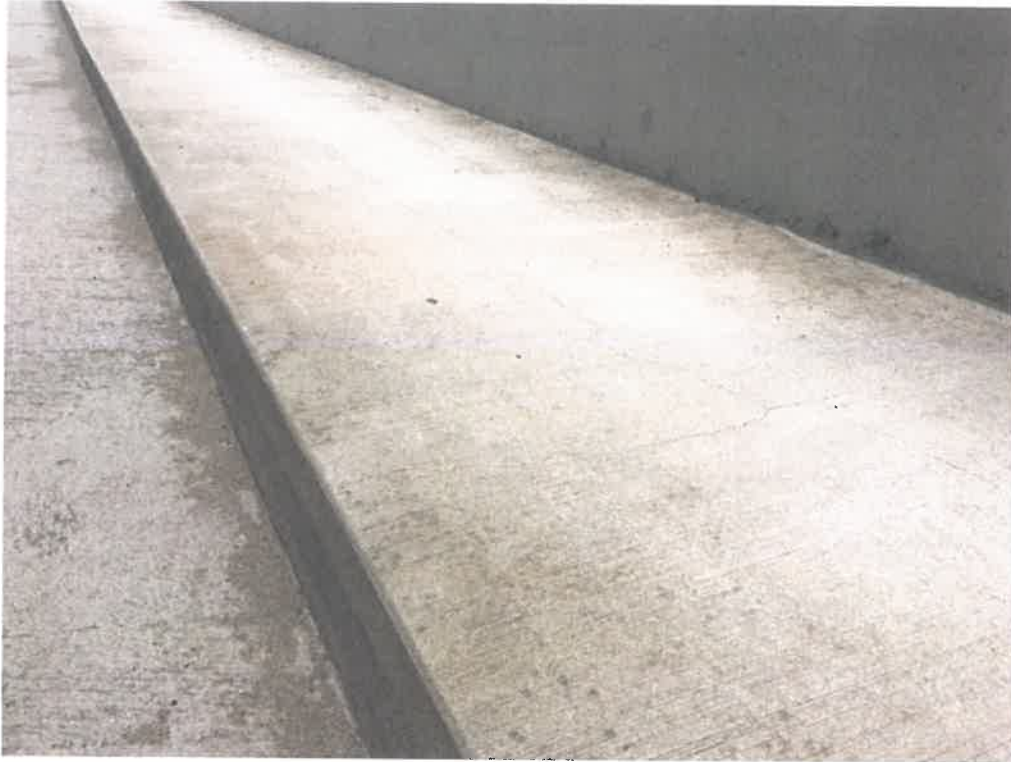
Photo No. 1

Some cracks started to open up again, cracks are up to 0.06 inches wide in many locations. Cracks have been treated with Methacrylate.

There are a few of locations of deck crack gaps where are treated with Methacrylate, they slowly open up gain.

Sign of Methacrylate sealed deck cracks

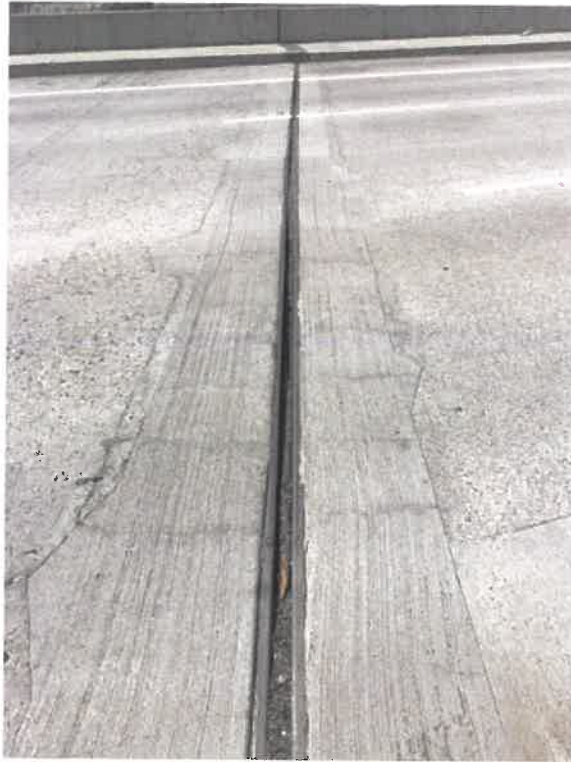
Photo No. 1

Leakage is noticed underneath at east abutment.

Debris is noticed at east abutment joint.

Easterly Abutment with Strip Seal

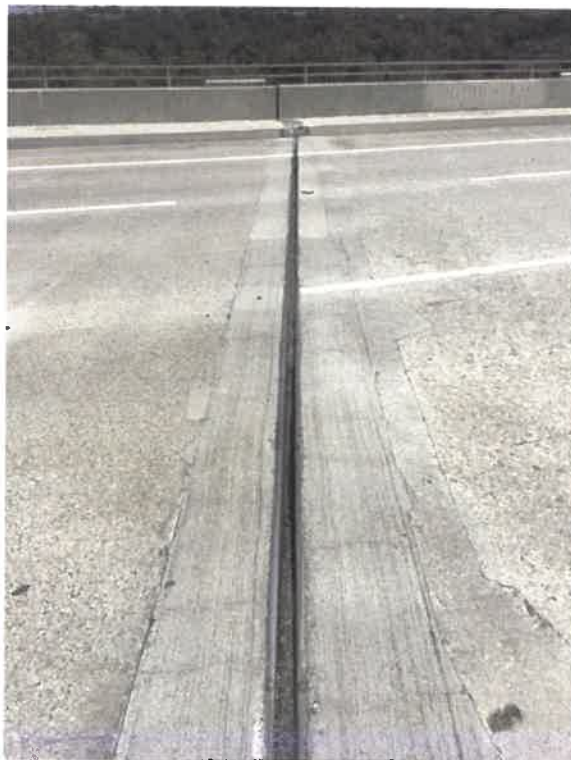
Photo No. 1

Strip seals at hinge (only 01 hinge on this structure).
