DEPARTMENT OF TRANSPORTATION
 Structure Maintenance & Investigations

Bridge Number : 55C0628
Facility Carried: ANTONIO PARKWAY
Location : 0.2 MI. N/O ORTEGA HWY
City :
Inspection Date : 06/26/2019

Bridge Inspection Report

STRUCTURE NAME: SAN JUAN CREEK

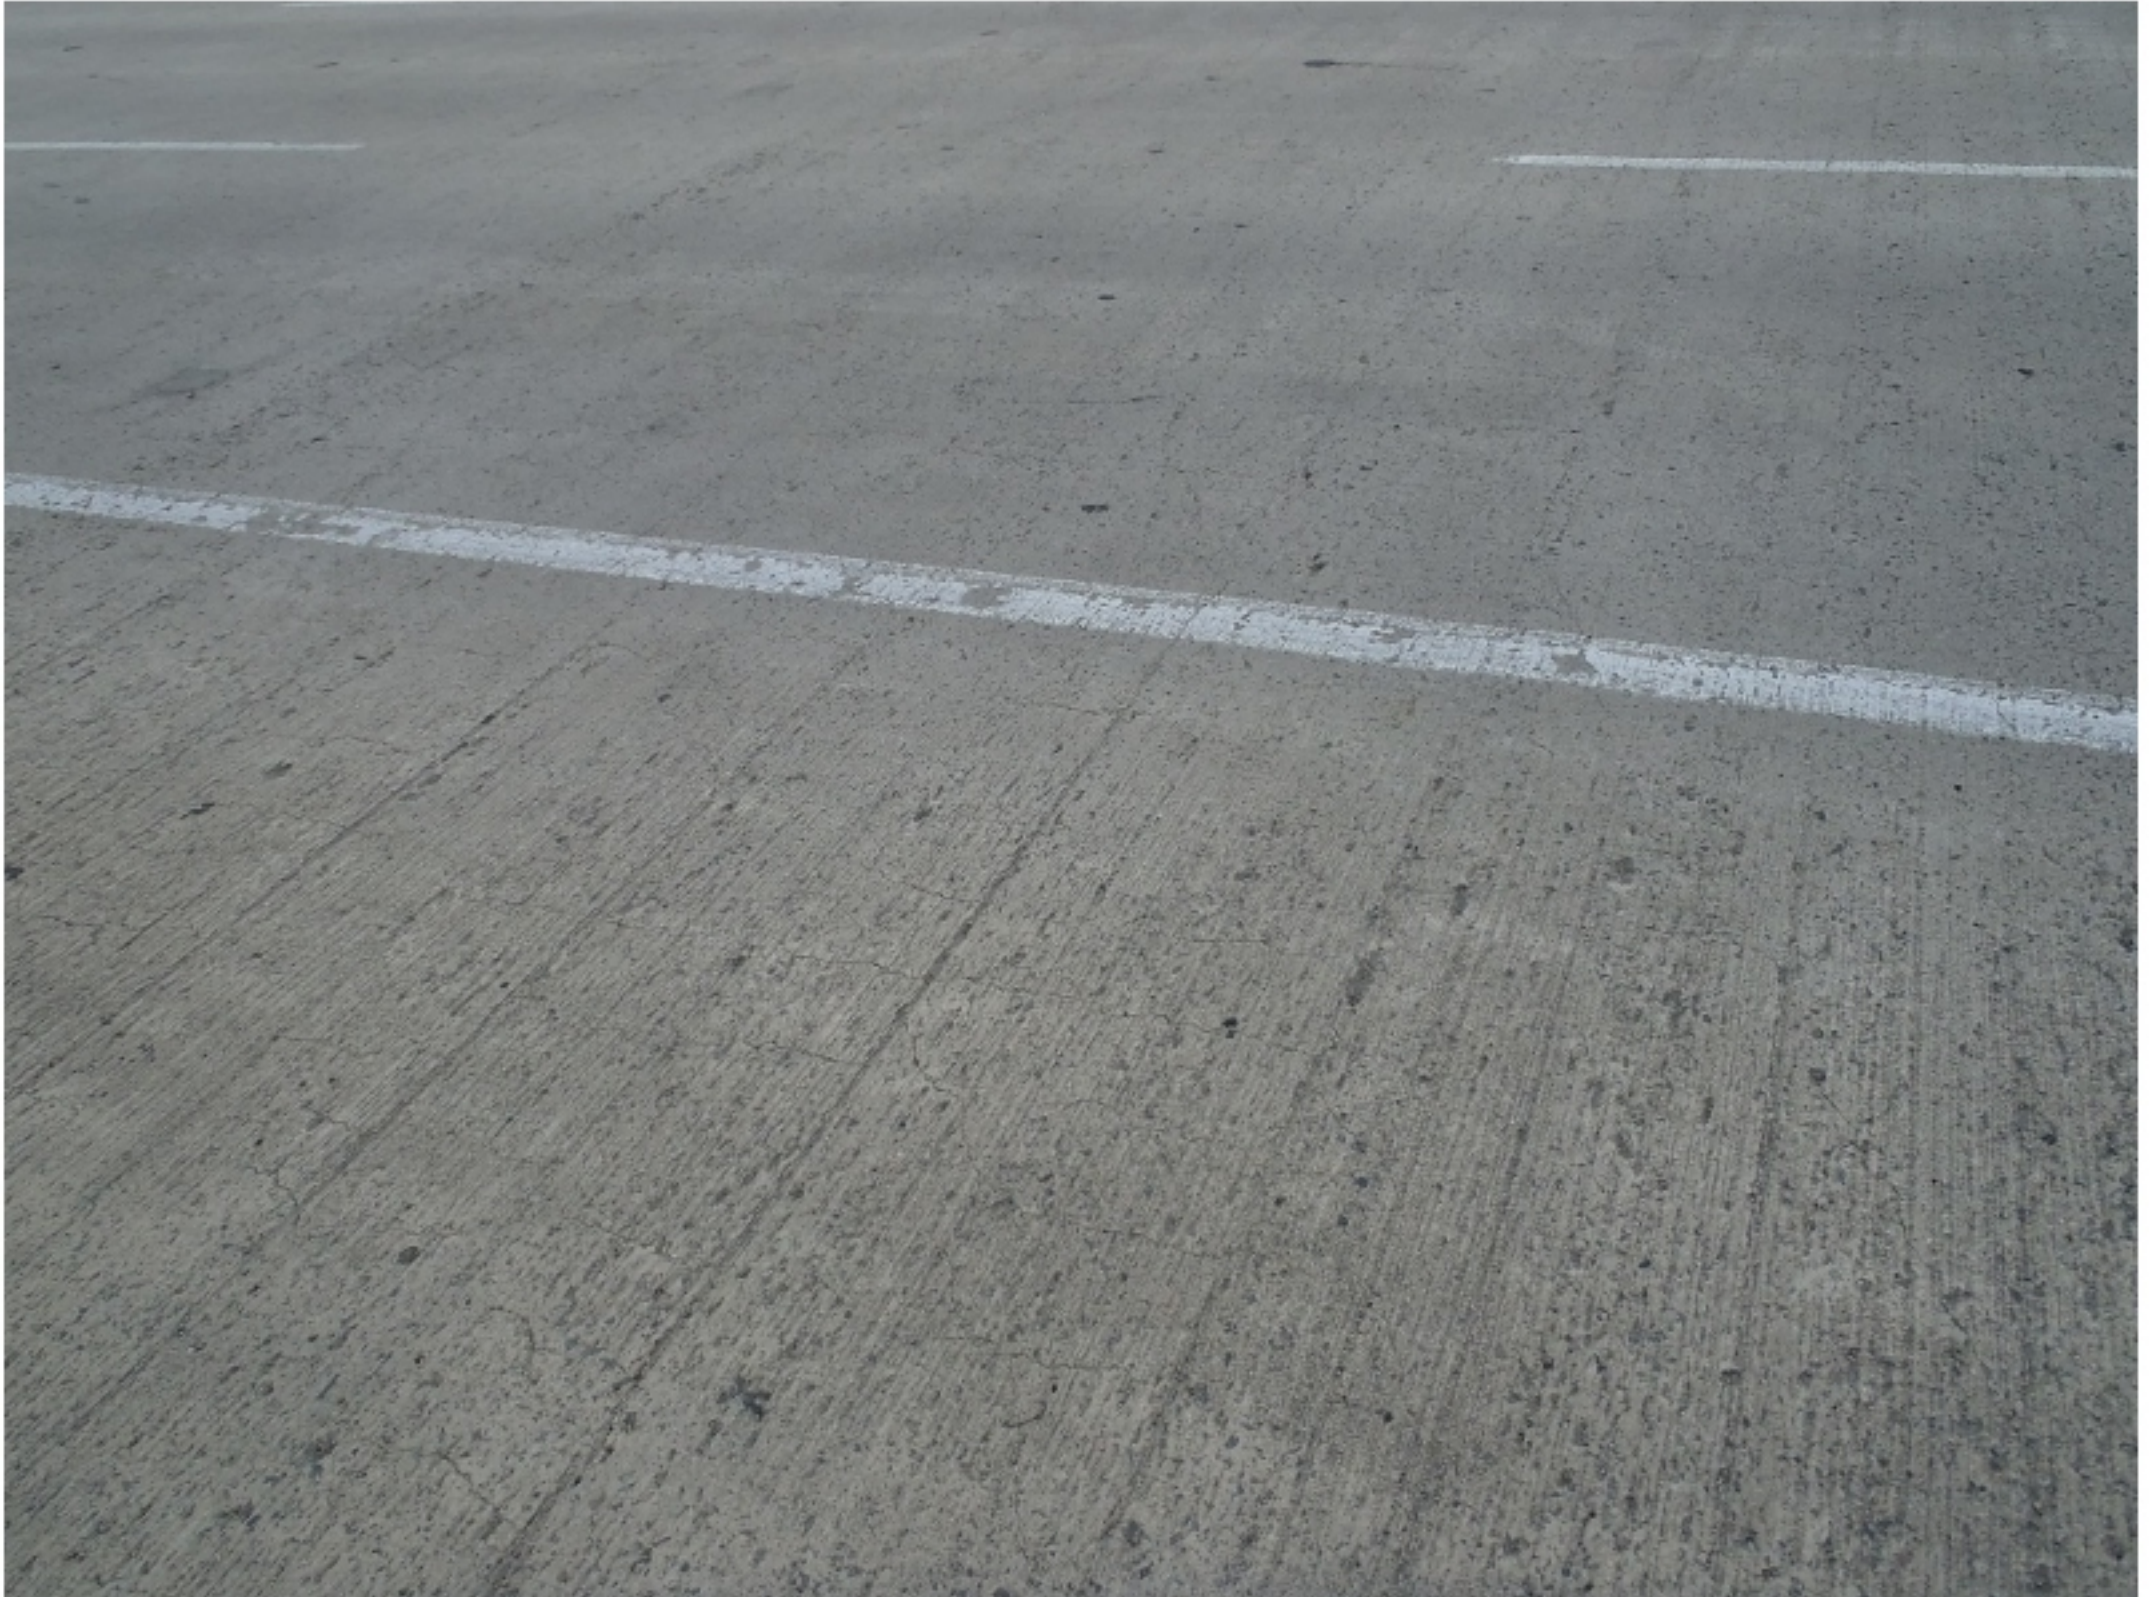
Photo No. 1

TYPICAL CONCRETE DECK SURFACE CONDITION, NOTE THE THIN CRACKS

Treat the entire bridge concrete deck and

all approach and departure slabs with

methacrylate resin to seal all cracks.

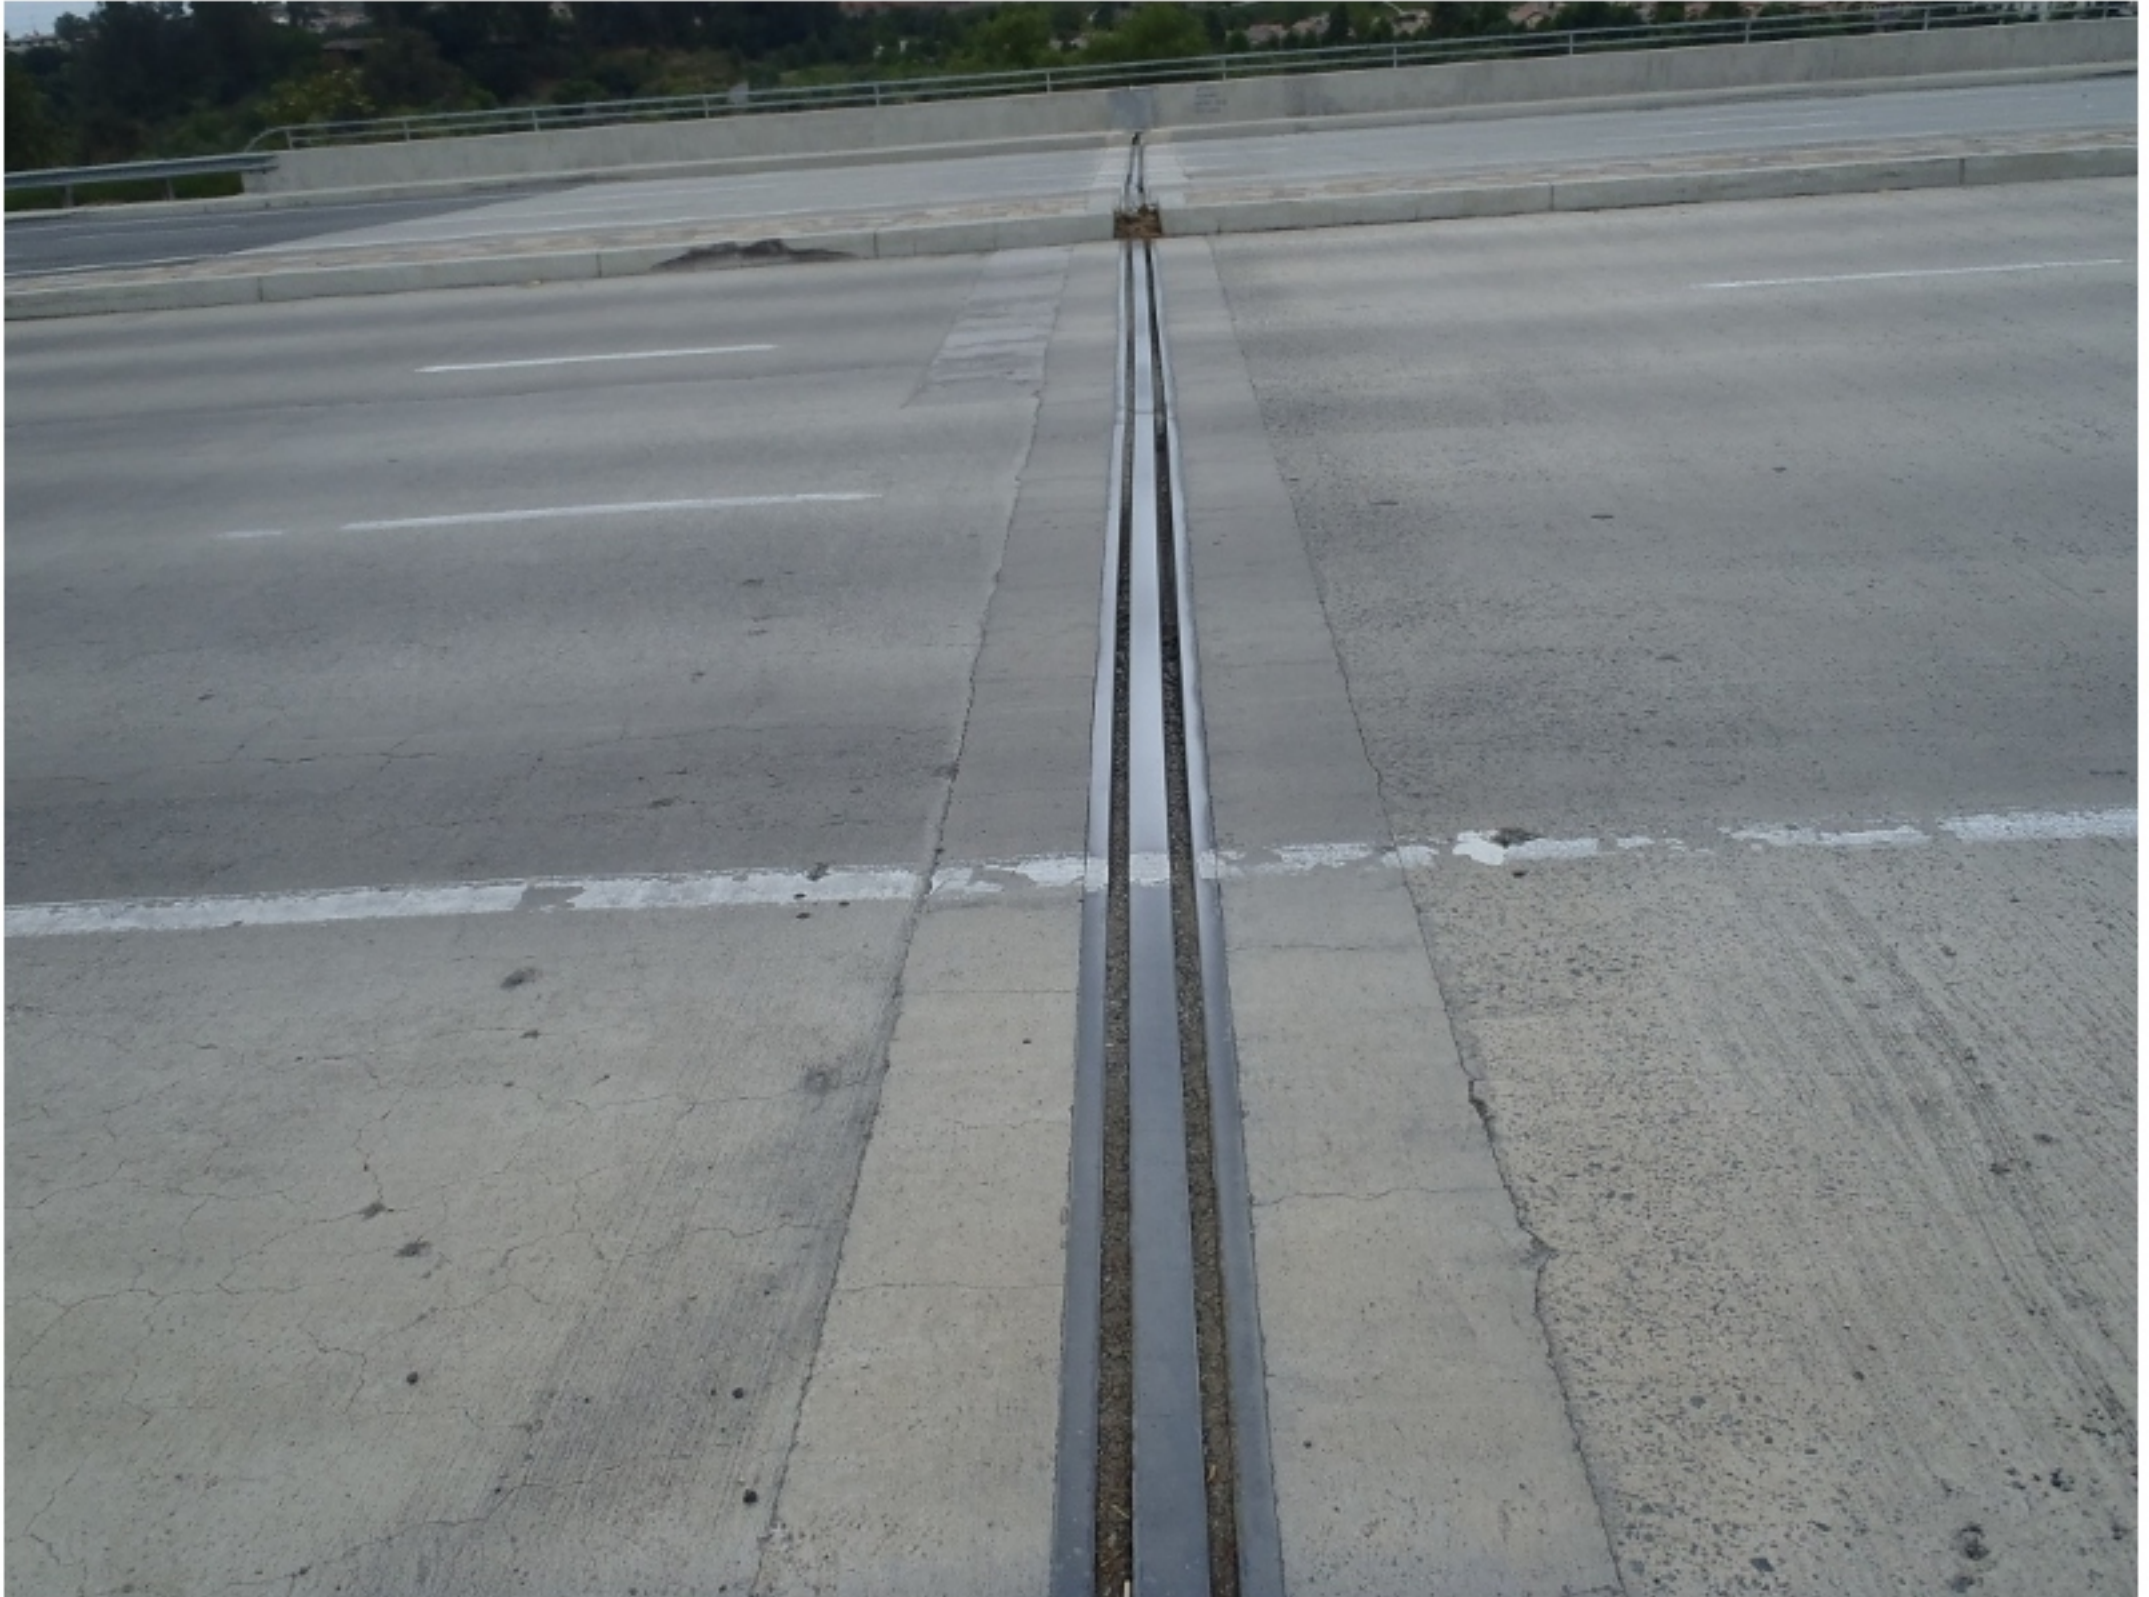
Photo No. 1

(303)									
There were no significant defects noted.									
312		Bearing-Enclosed	2	2	each	2	0	0	0
(312)									
The enclosed bearings are located at the southern and northern abutments. There were no significant defects noted.									
321		Approach Slab-RC	2	520	sq.m	270	230	20	0
1130		Cracking (RC and Other)	2	250		0	230	20	0
(321-1130)									
There are map pattern and several longitudinal cracks on the approach and departure slabs, especially on those located at northern side near Abutment 6, 0.03 to 0.08 inches wide with spacing 12 inches to 4 feet.									
331		Railing-RC	2	473	m	463	10	0	0
1130		Cracking (RC and Other)	2	10		0	10	0	0
(331-1130)									
There are 4 to 6 vertical cracks on the concrete barriers 0.03 to 0.05 inches wide.

JOINT CONDITION AT SOUTHERN ABUTMENT, NORTH BOUND SIDE

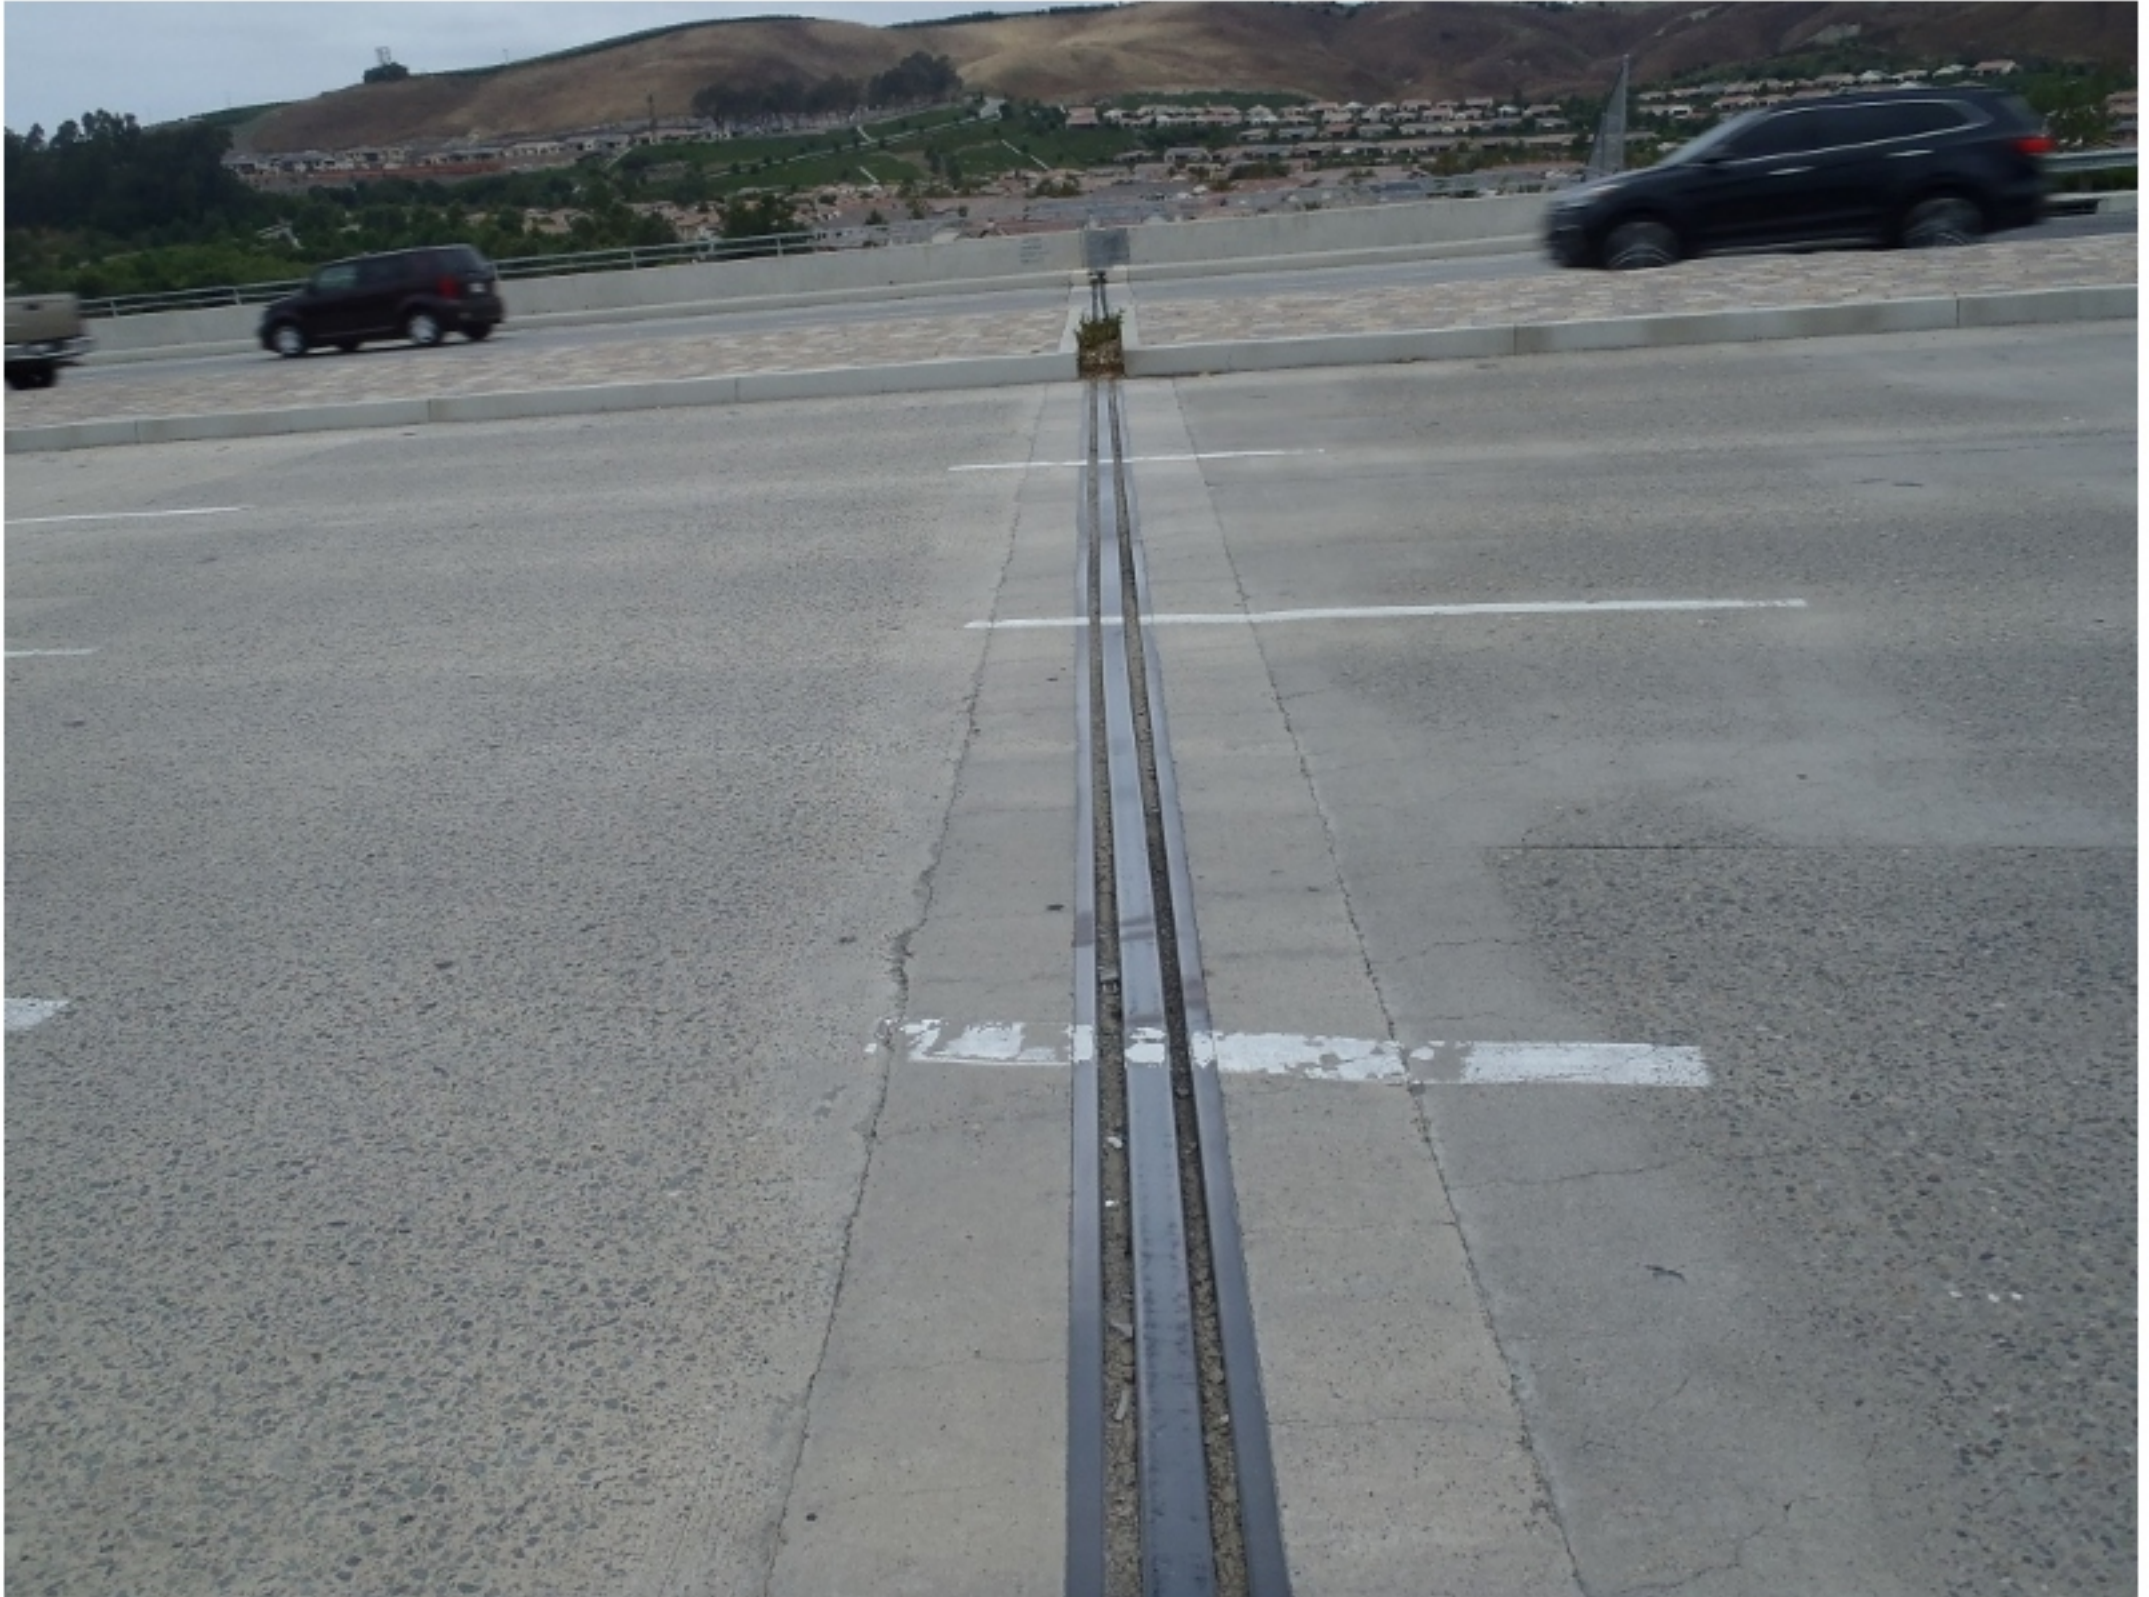
Photo No. 1

JOINT CONDITION AT NORTHERN ABUTMENT, NORTH BOUND SIDE

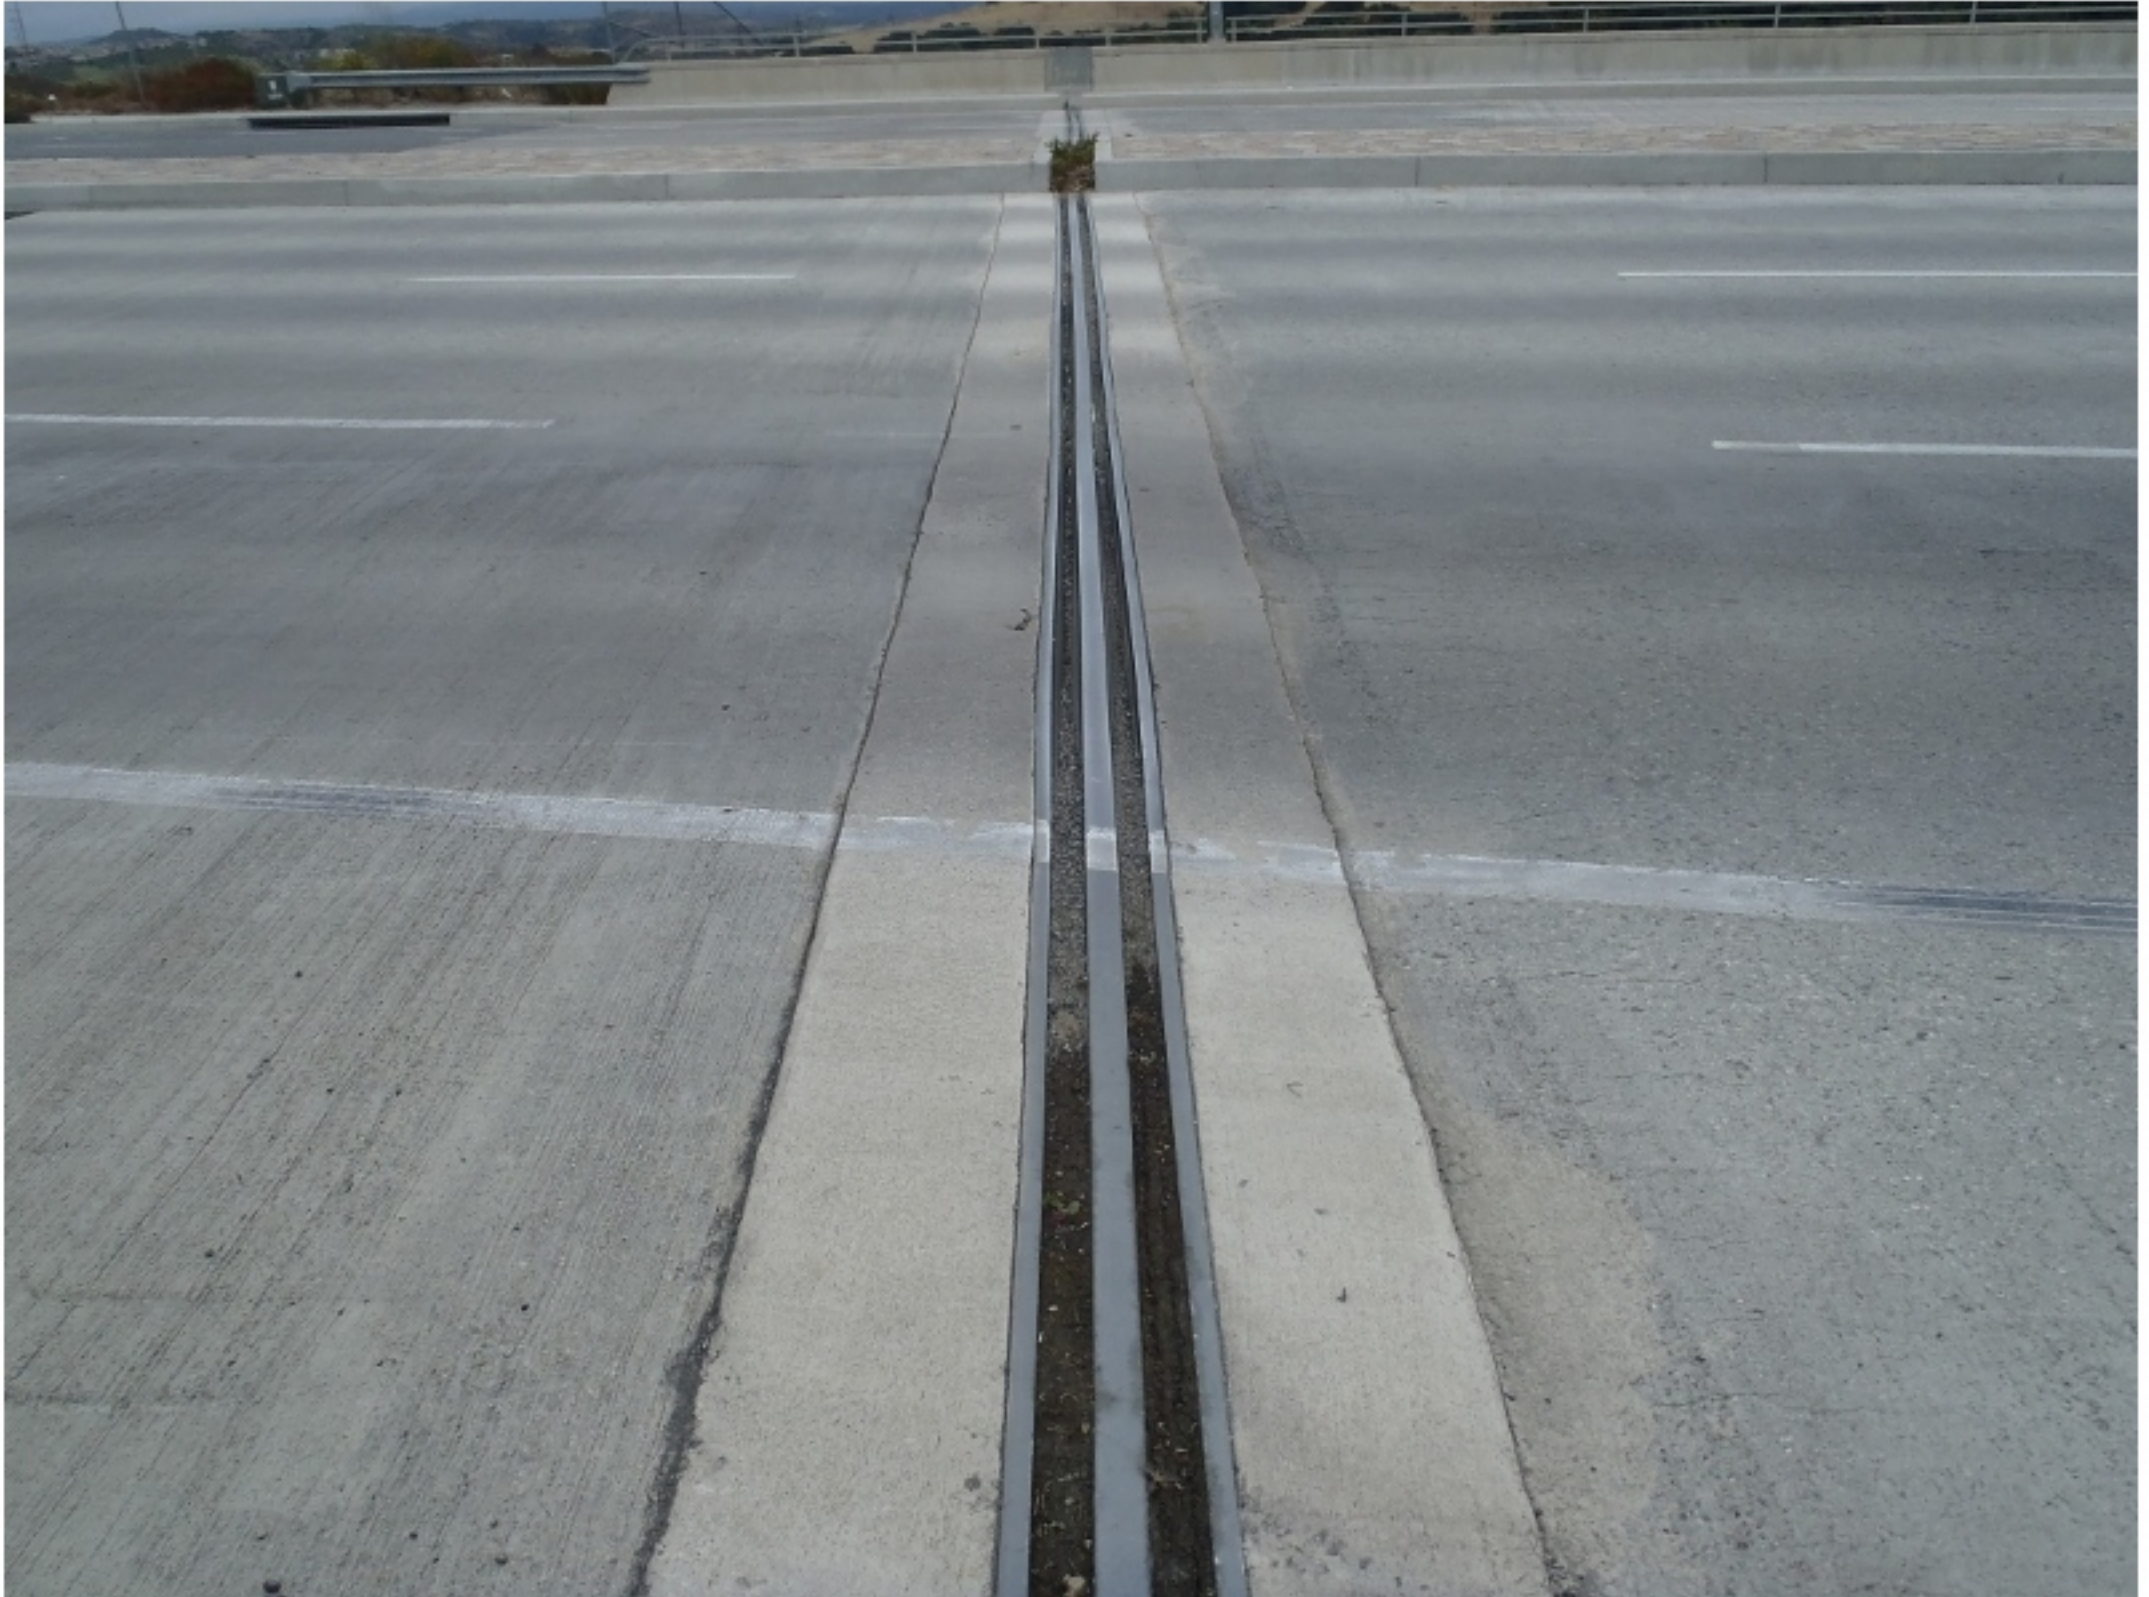
Photo No. 1

JOINT CONDITION AT NORTHERN ABUTMENT, SOUTH BOUND SIDE

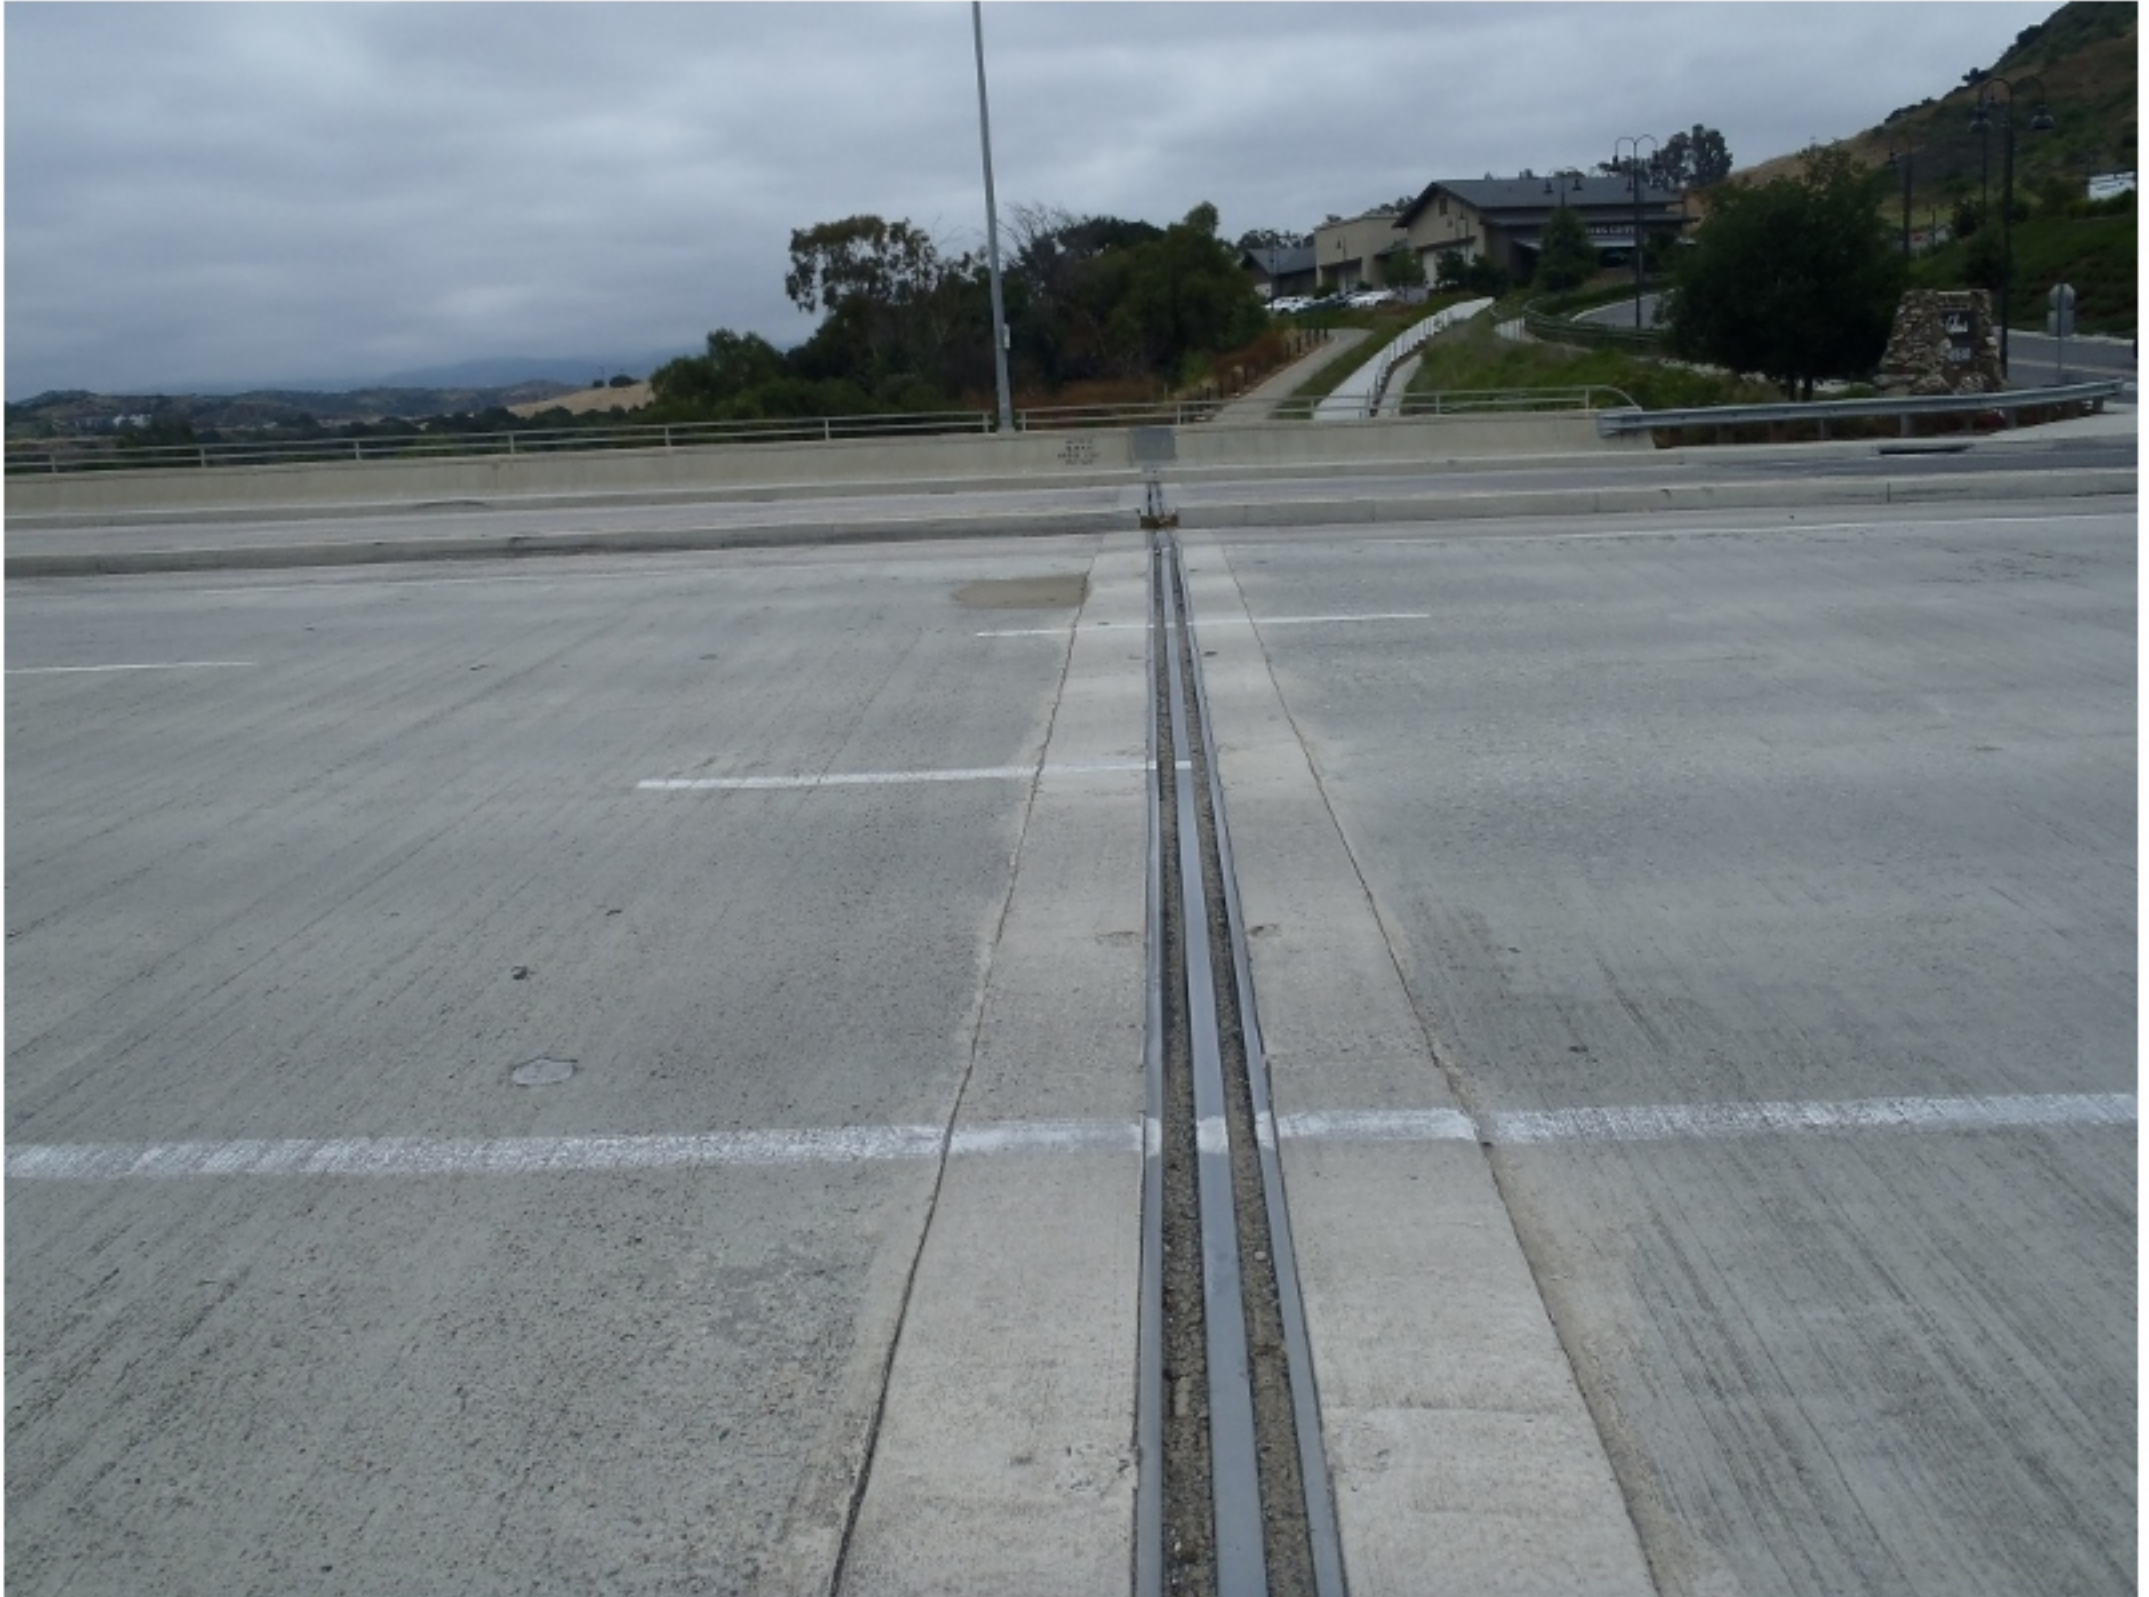
Photo No. 1
JOINT CONDITION AT SOUTHERN ABUTMENT, SOUTH BOUND SIDE

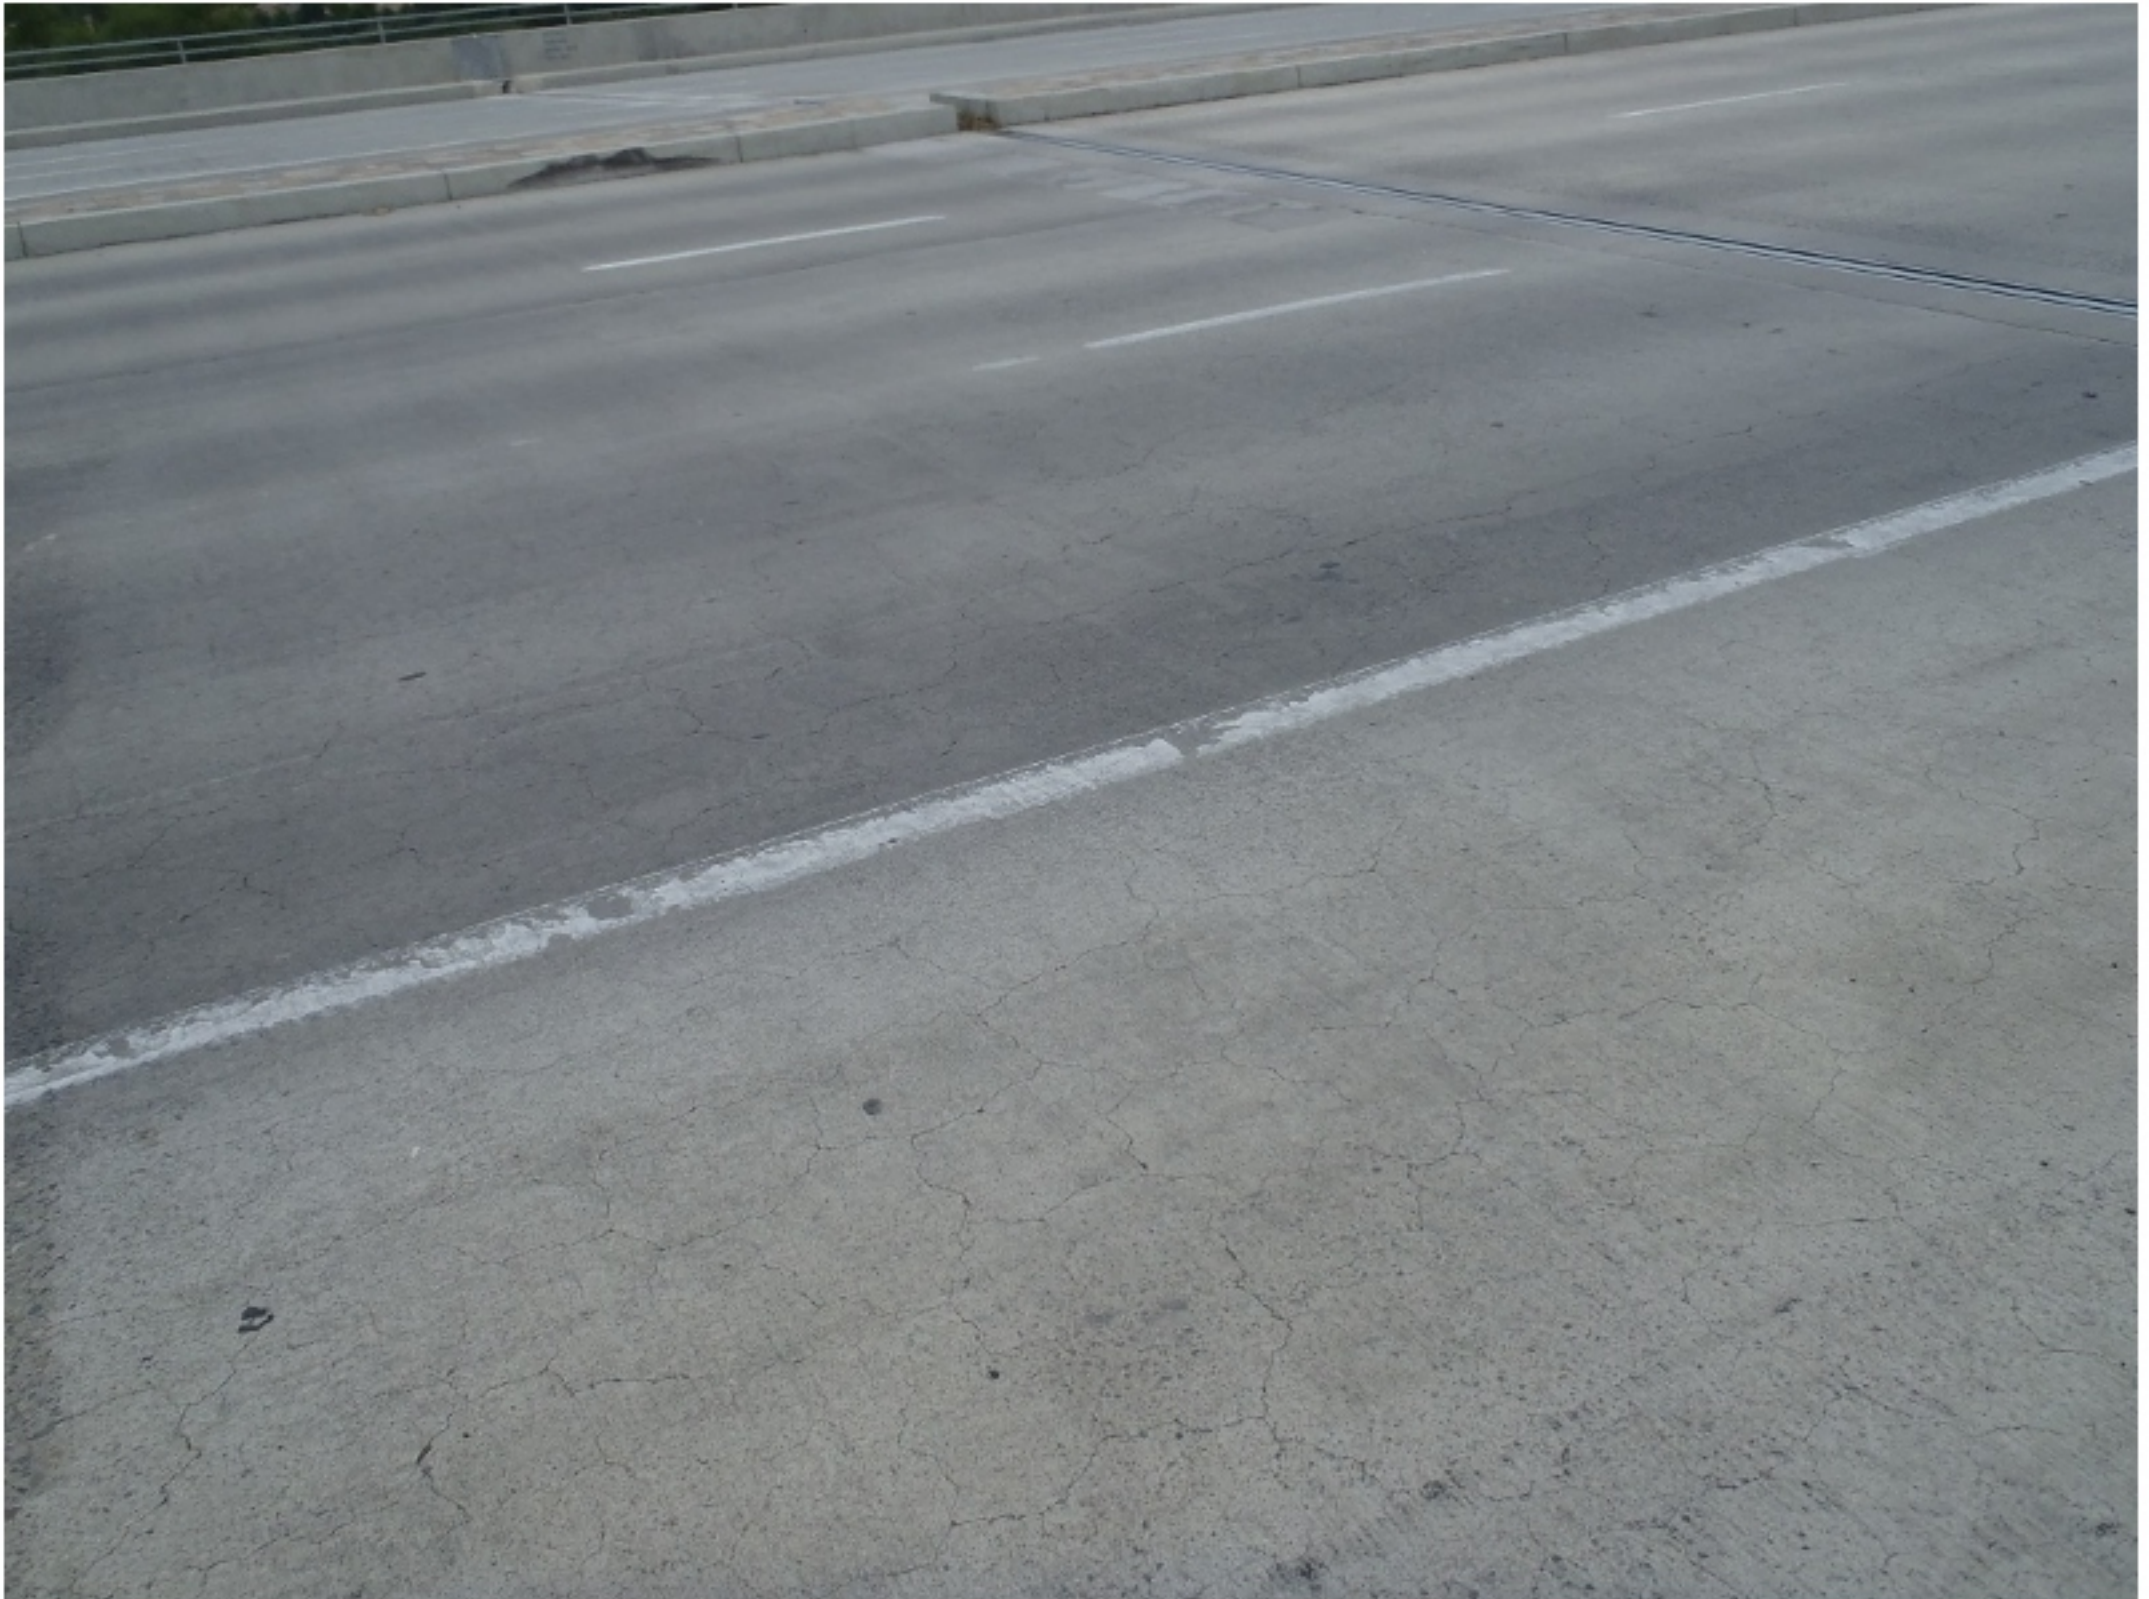
Photo No. 1

MINOR CRACKS ON NORTH BOUND APPROACH SLABS
