DEPARTMENT OF TRANSPORTATION
 Structure Maintenance & Investigations

Bridge Number : 55C0628
Facility Carried: ANTONIO PARKWAY
Location : 0.2 MI. N/O ORTEGA HWY
City :
Inspection Date : 06/26/2019

Bridge Inspection Report

STRUCTURE NAME: SAN JUAN CREEK

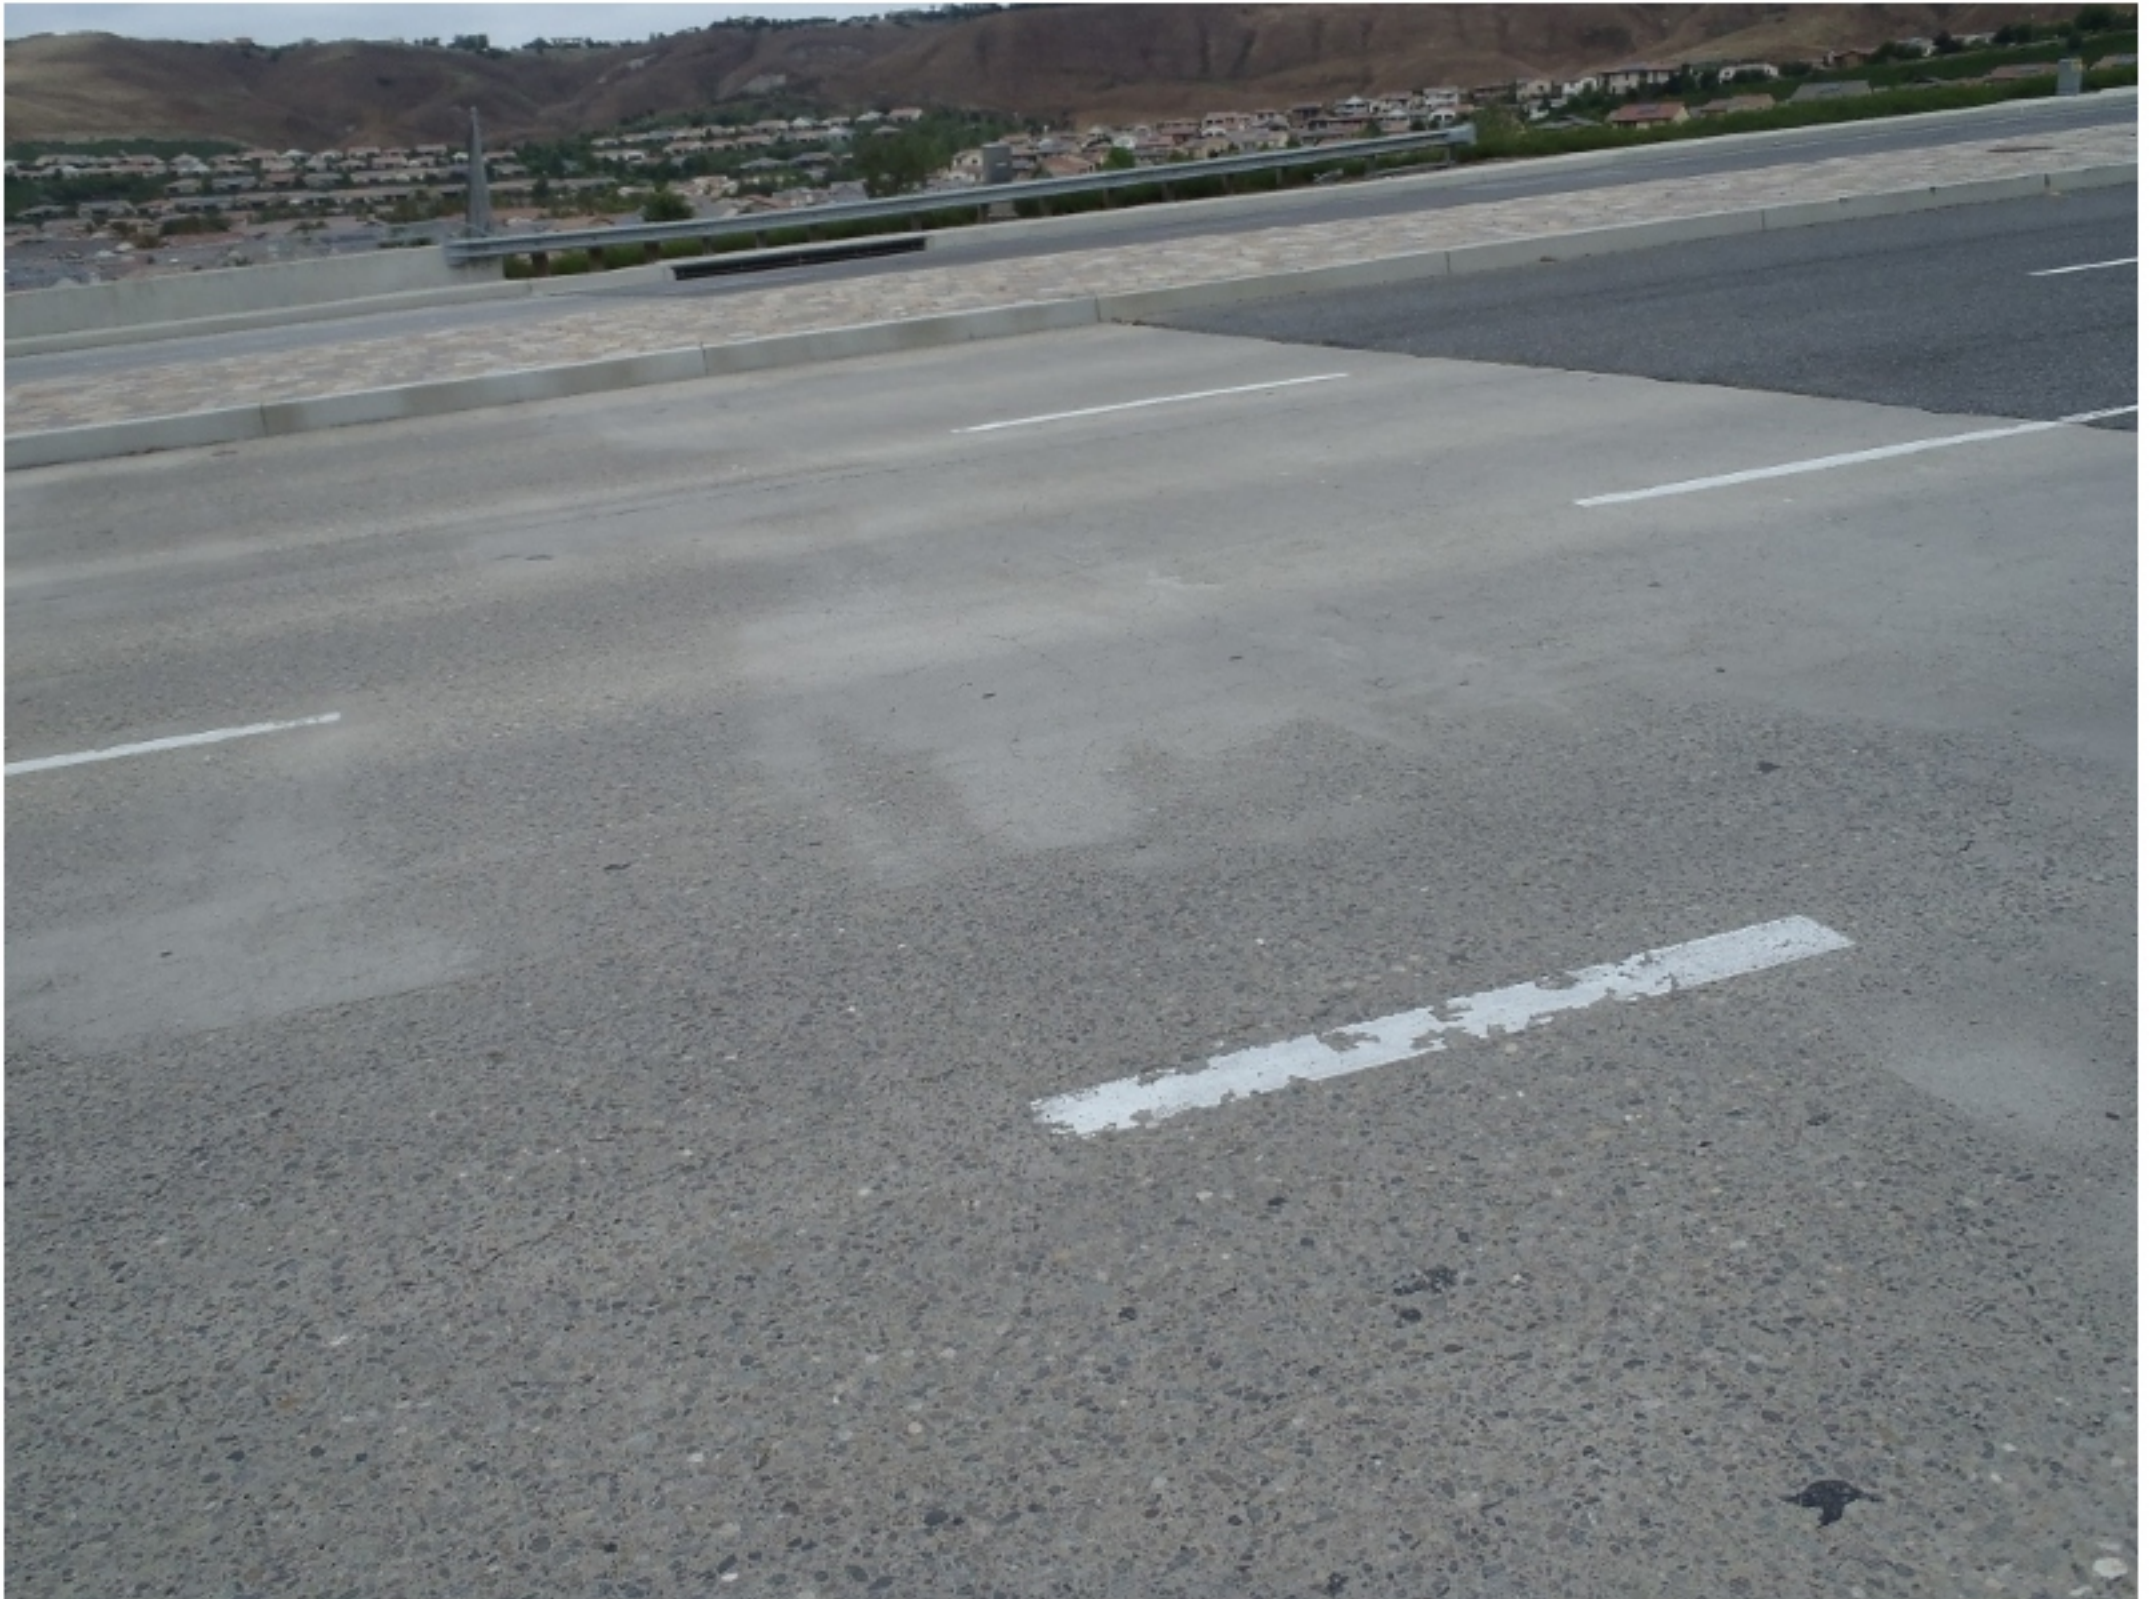
Photo No. 1

THIN CRACKS ON SOUTH BOUND APPROACH SLABS

Treat the entire bridge concrete deck and

all approach and departure slabs with

methacrylate resin to seal all cracks.

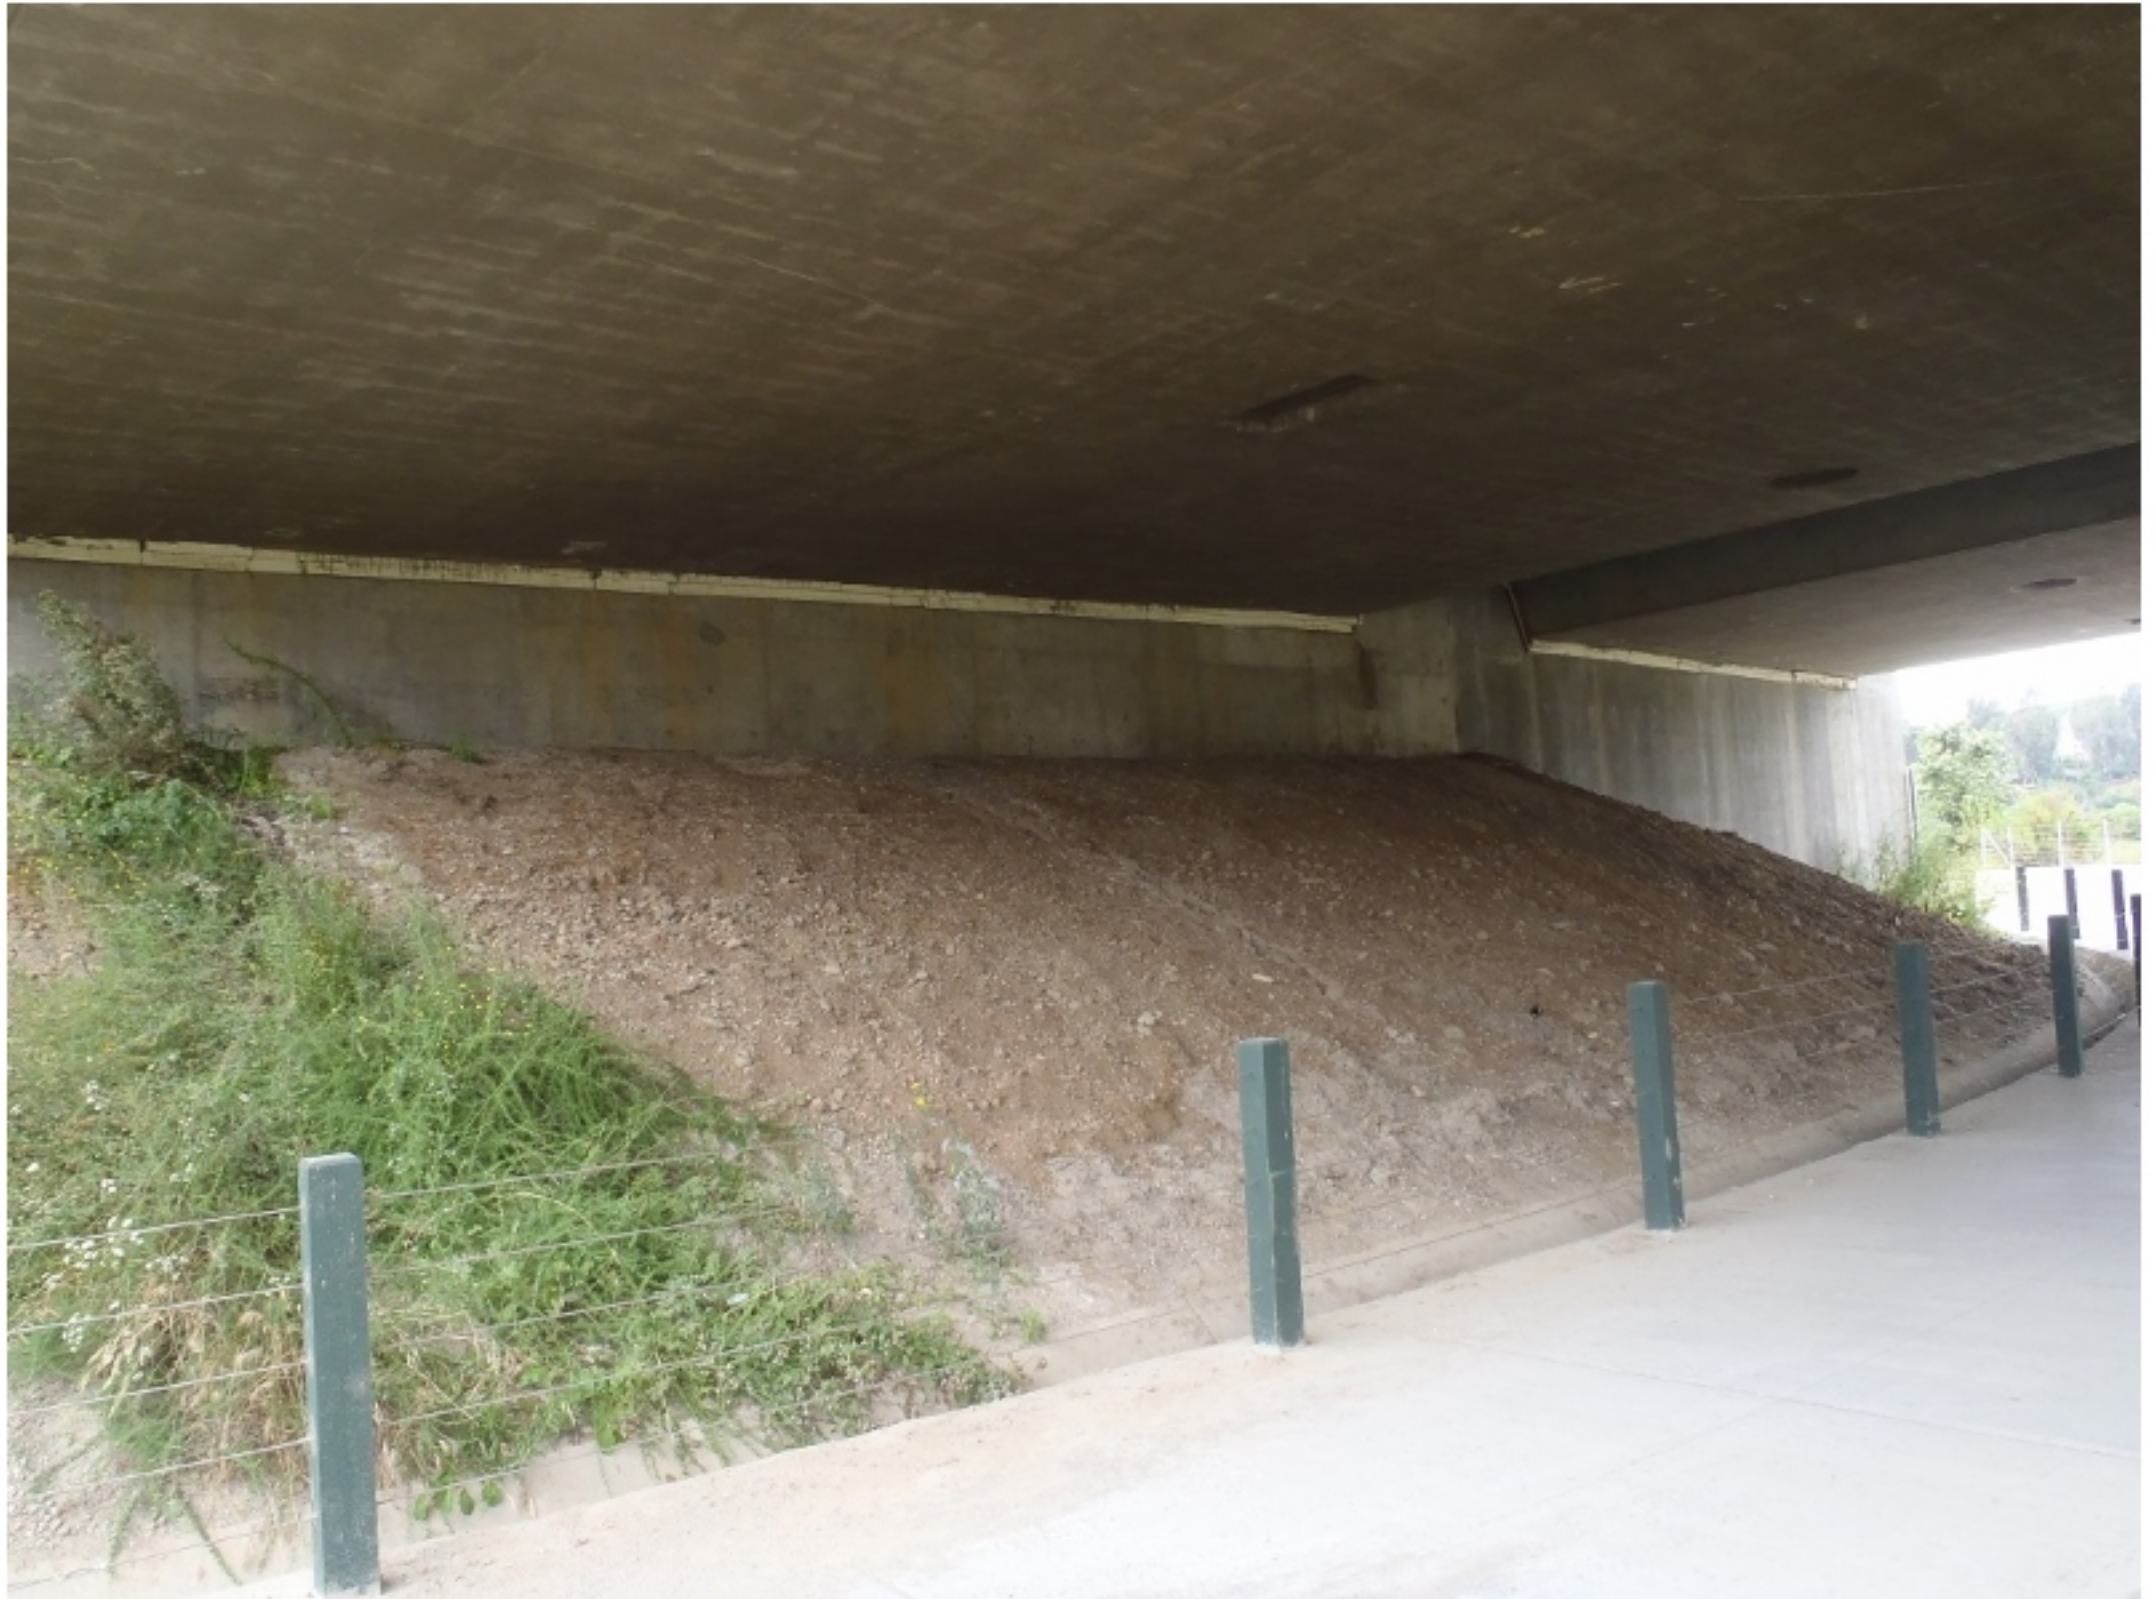
(205) There were no significant defects noted.									
215		Abutment-RC	2	81	m	76	5	0	0
	1130	Cracking (RC and Other)	2	5		0	5	0	0
(215) There were no significant defects noted. Monolithic wingwalls are included in the total quantity.									
(215-1130) There are vertical cracks on the abutmental walls, 10 at Abutment 6 and 6 at Abutment 1, up to 0.05 inches wide.									
220		Pile Cap/Footing-RC	2	56	m	56	0	0	0

(220) The footing caps are exposed at both abutments, 115 feet at north abutment (Abutment 6) and 67 feet at south abutment (Abutment 1). There were no significant defects noted.									
225		Pile-Steel	2	1	ea.	1	0	0	0

Photo No. 1
UNDER VIEW ALONG SOUTHERN ABUTMENT (ABUTMENT 1), LOOKING WEST

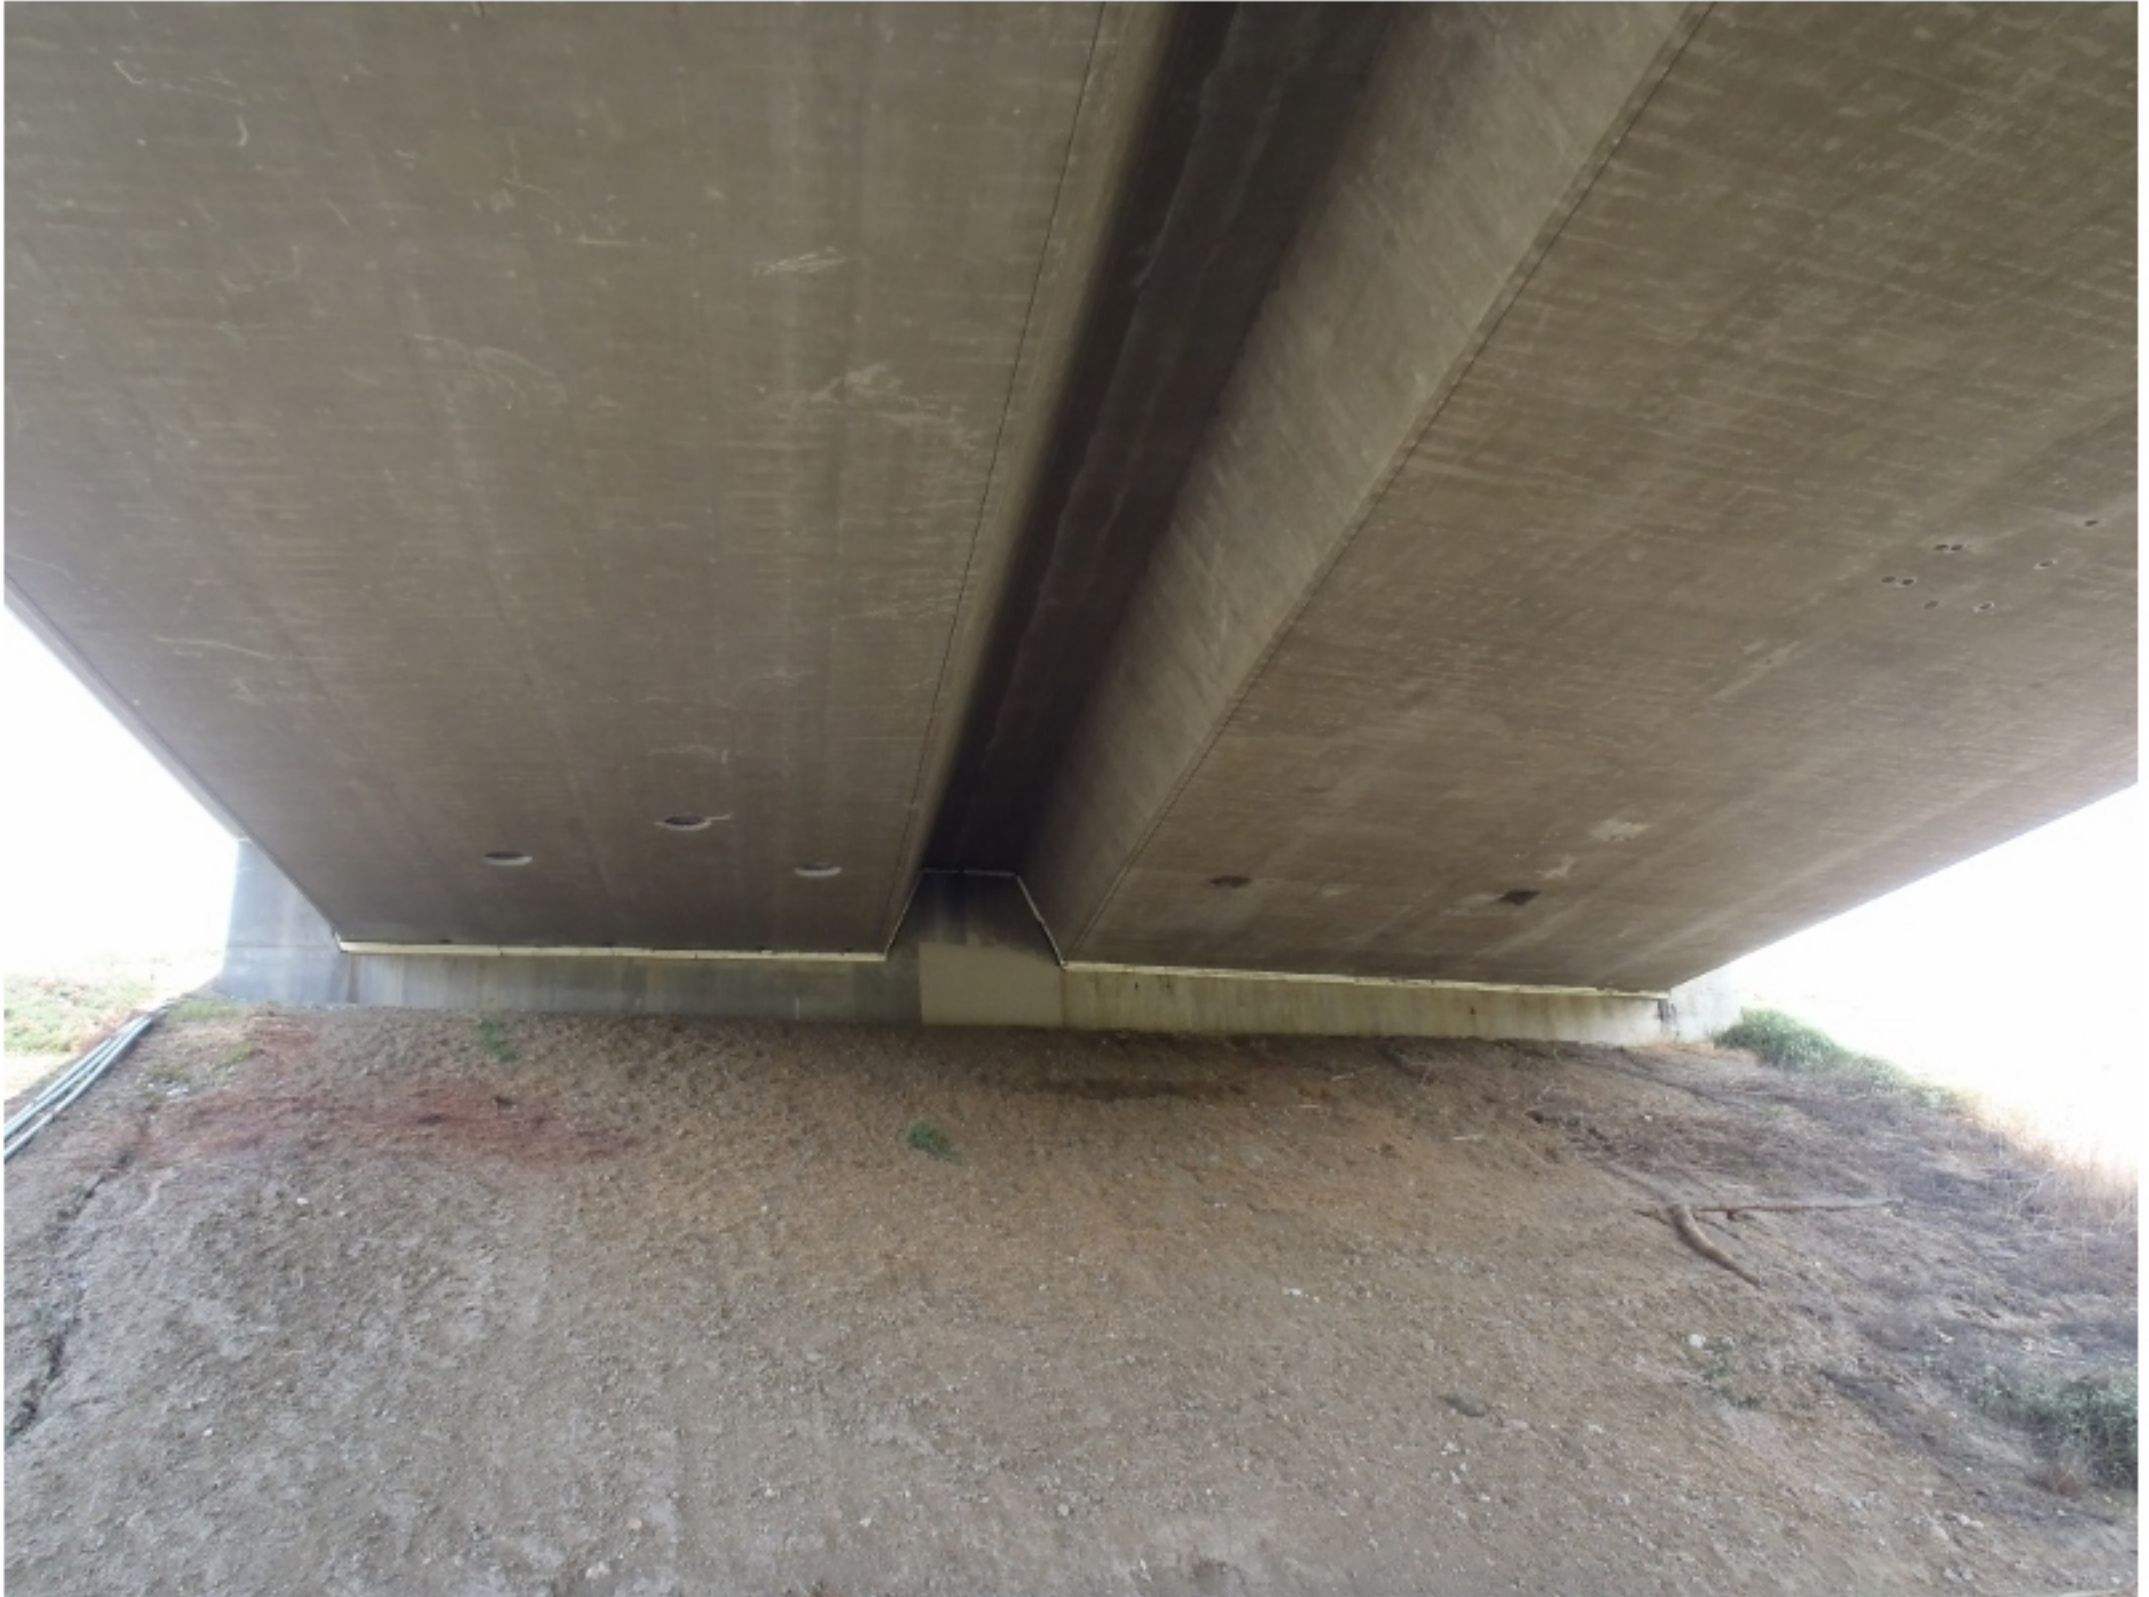
Photo No. 1

UNDER VIEW TOWARD NORTHERN ABUTMENT (ABUTMENT 6), LOOKING NORTH
