DEPARTMENT OF TRANSPORTATION
Structure Maintenance & Investigations

Bridge Number : 55C0628
Facility Carried: ANTONIO PARKWAY
Location : 0.2 MI. N/O ORTEGA HWY
City :
Inspection Date : 05/24/2017

Bridge Inspection Report

STRUCTURE NAME: SAN JUAN CREEK

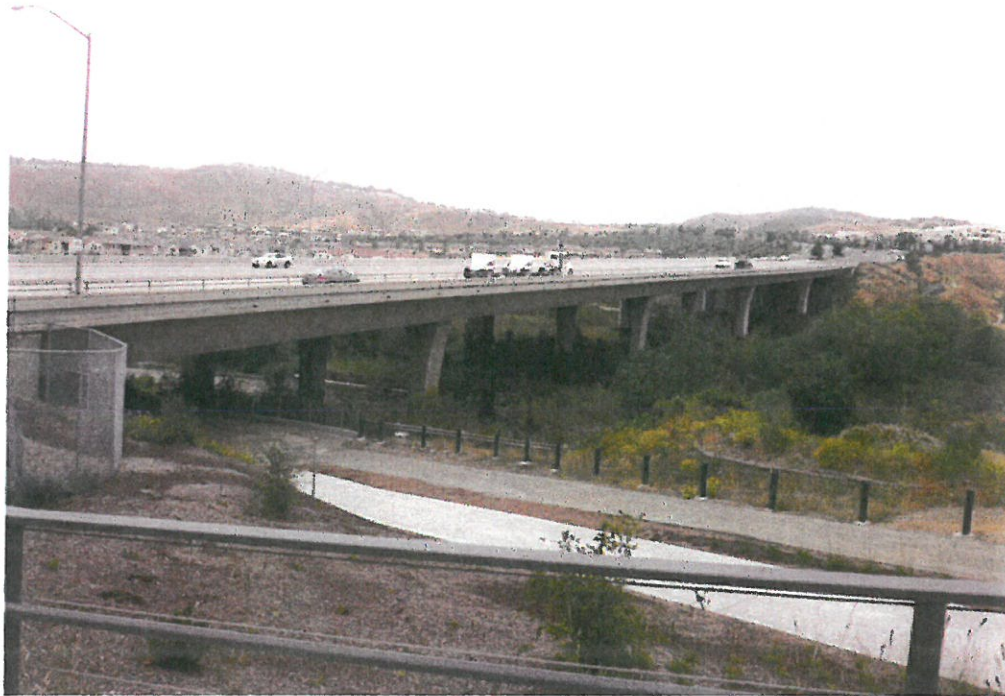
Photo No. 1

Elevation View looking North-West

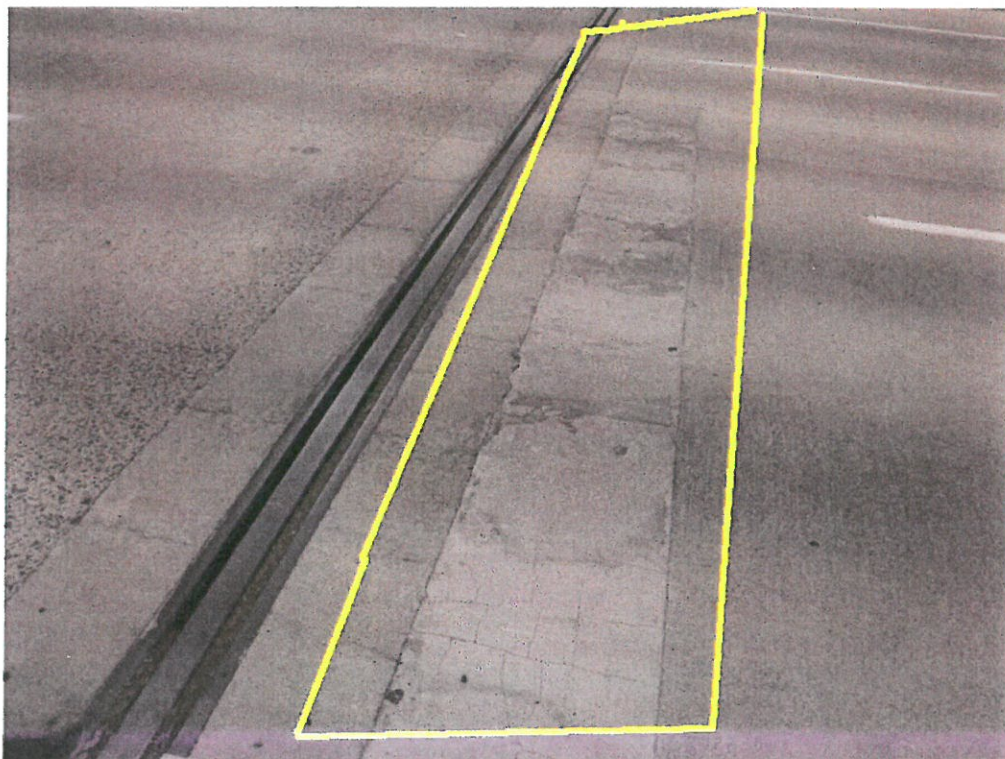
(303)										
There were no significant defects noted.										
312			Bearing-Enclosed	2	2	each	2	0	0	0
(312)										
There were no significant defects noted.										
321			Approach Slab-RC	2	520	sq.m	253	257	10	0
1080			Delamination/Spall/Patched Area	2	17		0	17	0	0
1130			Cracking (RC and Other)	2	250		0	240	10	0
(321-1080)										
The approach slabs of northbound lanes 1 & 2 have a sound patched area 1.5 feet L X 25 feet W. (see the attached photo no. 2)										
The departure slab of southbound lane 1 has a sound patched area 1.5 feet L X 10 feet W.										
(321-1130)										
The departure slab at southbound lane 2 has a longitudinal full length crack, up to 0.08 inches wide. (see the attached photo no. 7)										
The departure slabs of northbound lanes have map and longitudinal cracks, 0.05 inches wide and 12 inches apart.										
The approach slabs of southbound lanes have three longitudinal cracks, up to 0.05 inches wide.

Approach slabs at south end of NB lanes 1 and 2 has sound patched area 1.5' ftX 25 ft.

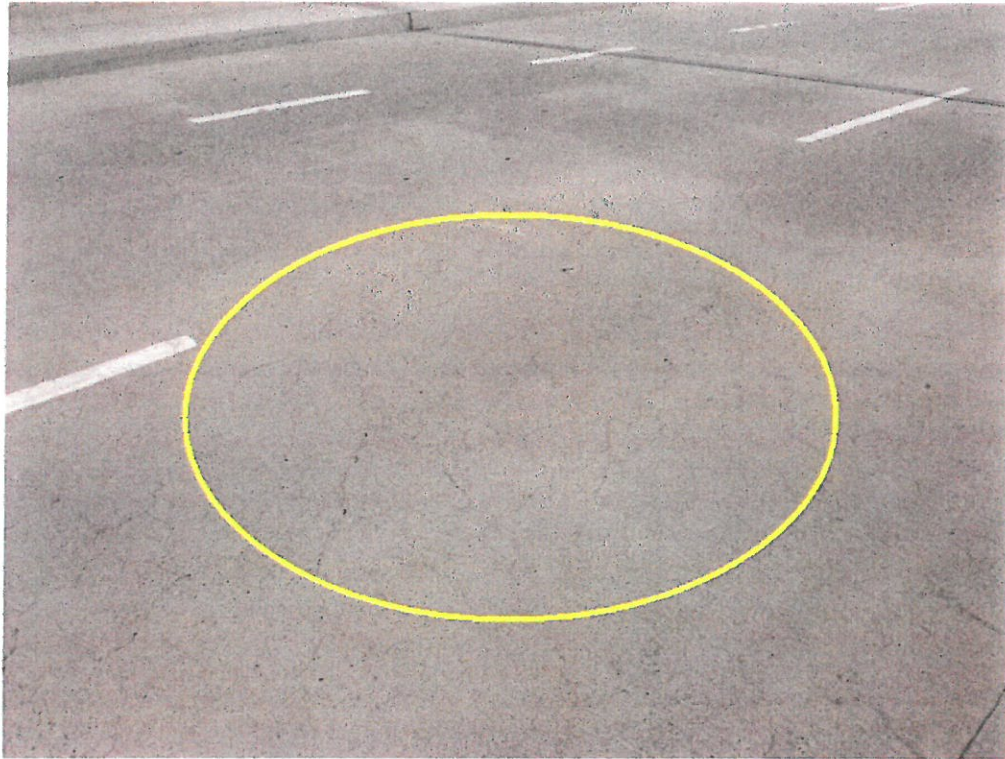
Photo No. 3
map cracks at the deck

Clean and seal the concrete deck cracks,

approach and departure slabs cracks by

coating the bridge deck with

methacrylate.

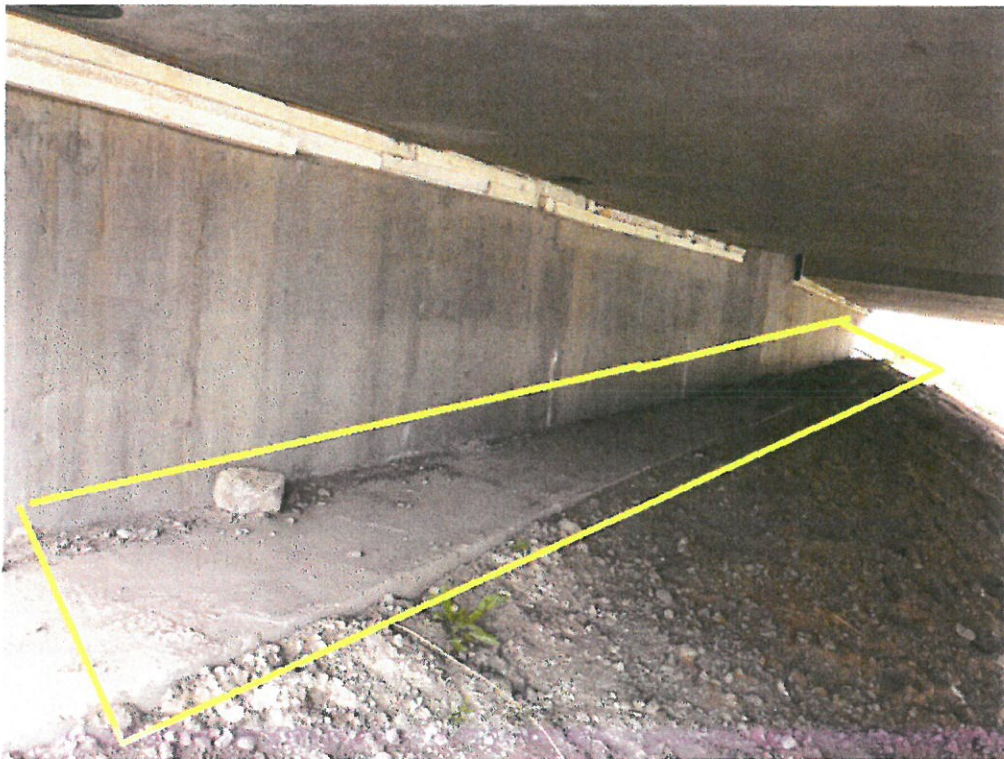
(220)										
There were no significant defects noted.										
The footing cap is exposed at both Abutments., 35 m at north Abutment and 21 m at the south Abutment.										
225			File-Steel	2	1	ea.	1	0	0	0

Photo No. 4
Exposed footing at south and north Abutments.

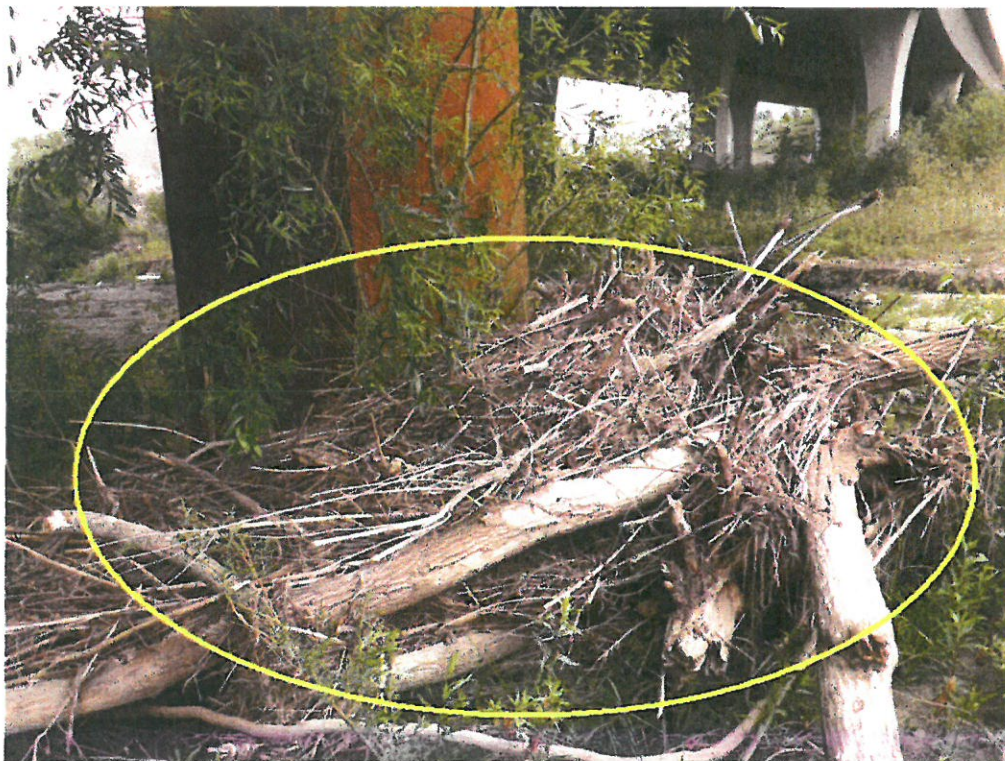
Photo No. 6

Debris 6 feet H X 10 feet W X 5 feet D is noticed in front of column 3 in Bent 2. (see the attached photo no. 6)

Debris in front of column 3 Bent 2.

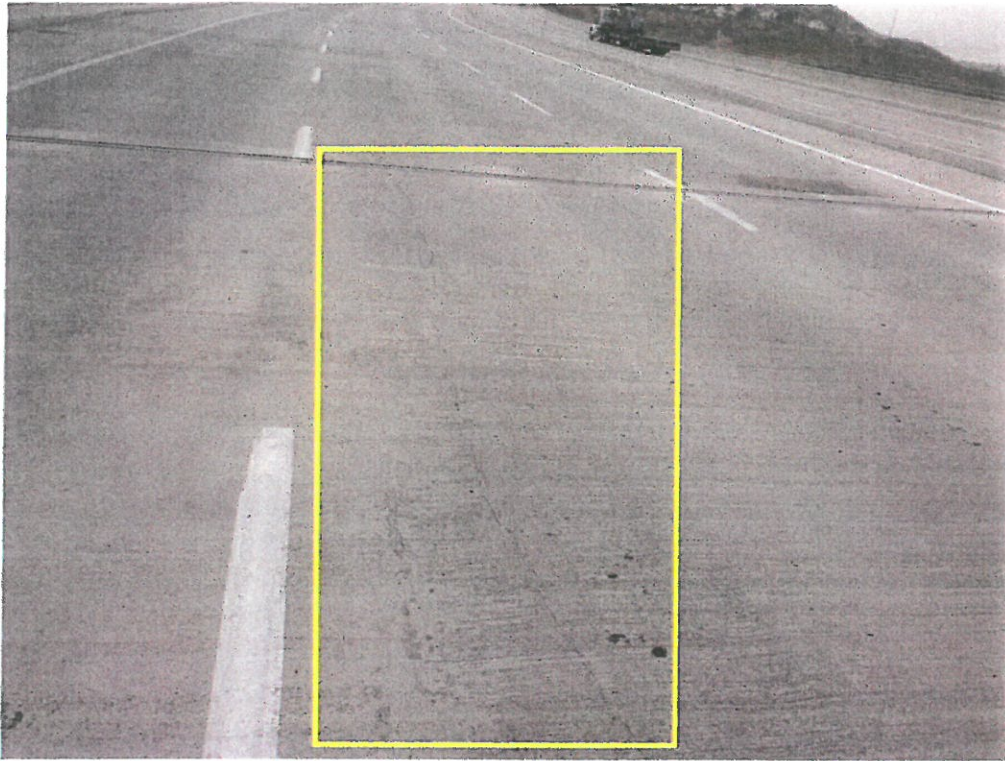
Photo No. 7

A longitudinal crack 0.08 inches wide at departure slab of SB lane 2.
