Bridge Number : 55C0631  
Facility Carried: HARBOR BOULEVARD  
Location : 0.2 MI N/O WARNER AVENUE  
City :  
Inspection Date : 06/28/2017

**Bridge Inspection Report**

**STRUCTURE NAME: SANTA ANA RIVER CHANNEL (HARBOR BLVD)**

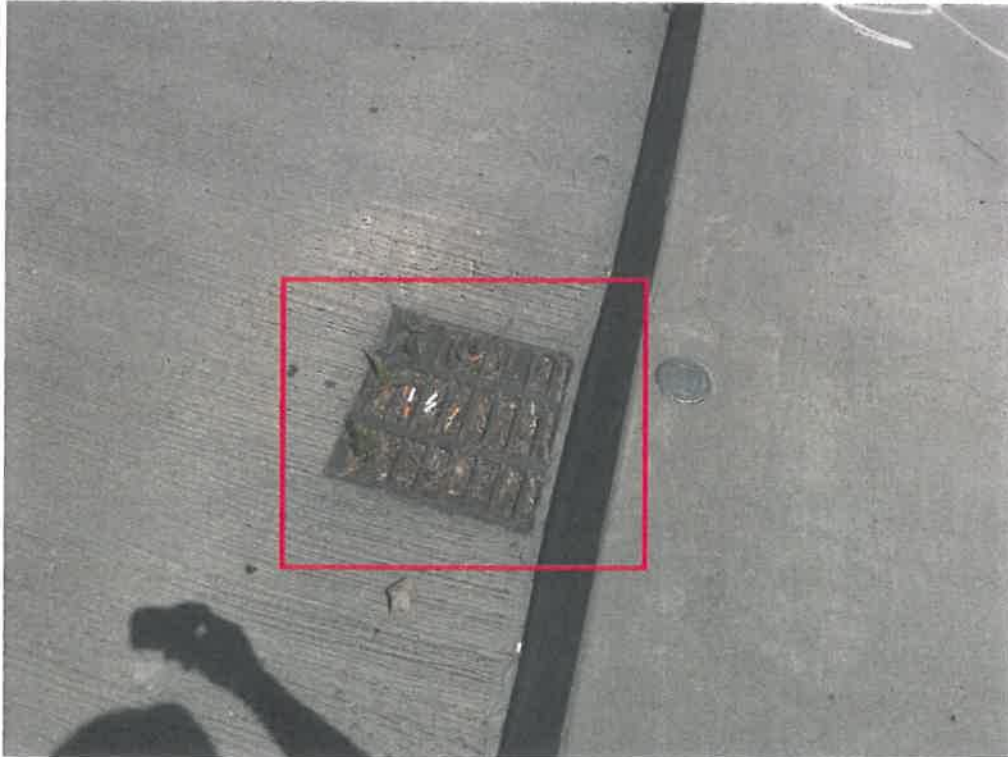
Photo No. 1

The deck drains are clogged and one cover is missing in the southbound 50 feet from north end. (see the attached photo no. 1)

Deck drains are clogged

Open all the deck drains those were clogged at the west side.

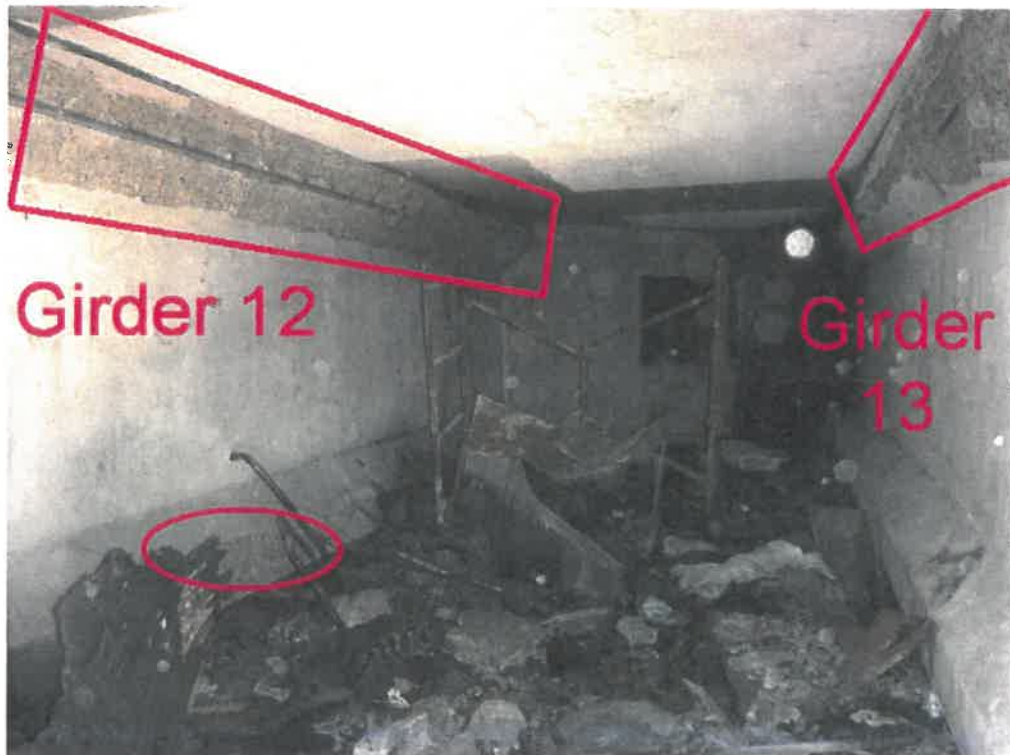
Photo No. 2

* mostly transverse cracks, up to 0.04 inches wide at 2 feet spaced apart in many locations.										
109		Girder/Beam-PS Conc.	2	1680	m	1654	6	20	0	
	1080	Delamination/Spall/Patched Area	2	26		0	6	20	0	
(109-1080)										
The are damaged girders due to fire at span 5 as follow: (see the attached photos no. 2 to 5)										
Girder 12 has a spall 30 feet long L X 8 inches W X 6 inches D at the top flange with exposed rebar; and a spall 20 inches X 6 inches X 2 inches at the bottom flange.										
Girder 13 has a spall 30 feet long L X 8 inches W X 6 inches D at the top flange with exposed rebar.										
Girder 14 has a spall 20 feet long L X 8 inches W X 6 inches D at the top flange with exposed rebar.										
210		Pier Wall-RC	2	176	m	172	4	0	0	
	1130	Cracking (RC and Other)	2	4		0	4	0	0

Spalls due to fire at span 5 , Girders 12 & 13; up 30 ft X 8 in. X 6 in.

Patch the damaged girders due to fire at span 5 as follow:

Girder 12 has a spall 30 feet long L X 8 inches W X 6 inches D at the top flange with exposed rebar; and a spall 20 inches X 6 inches X 2 inches at the bottom flange.

Girder 13 has a spall 30 feet long L X 8 inches W X 6 inches D at the top flange with exposed rebar.

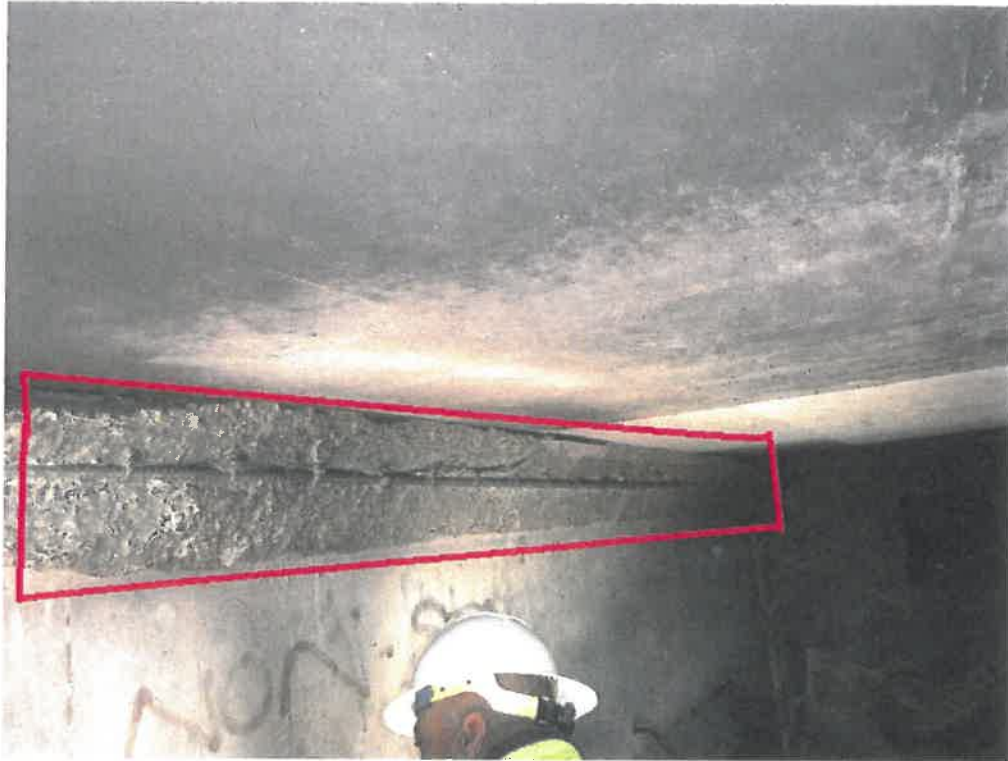
**Photo No. 3**

Spalls due to fire at span 5 , Girder 12 has a spall 30 ft X 8 in. X 6 in.

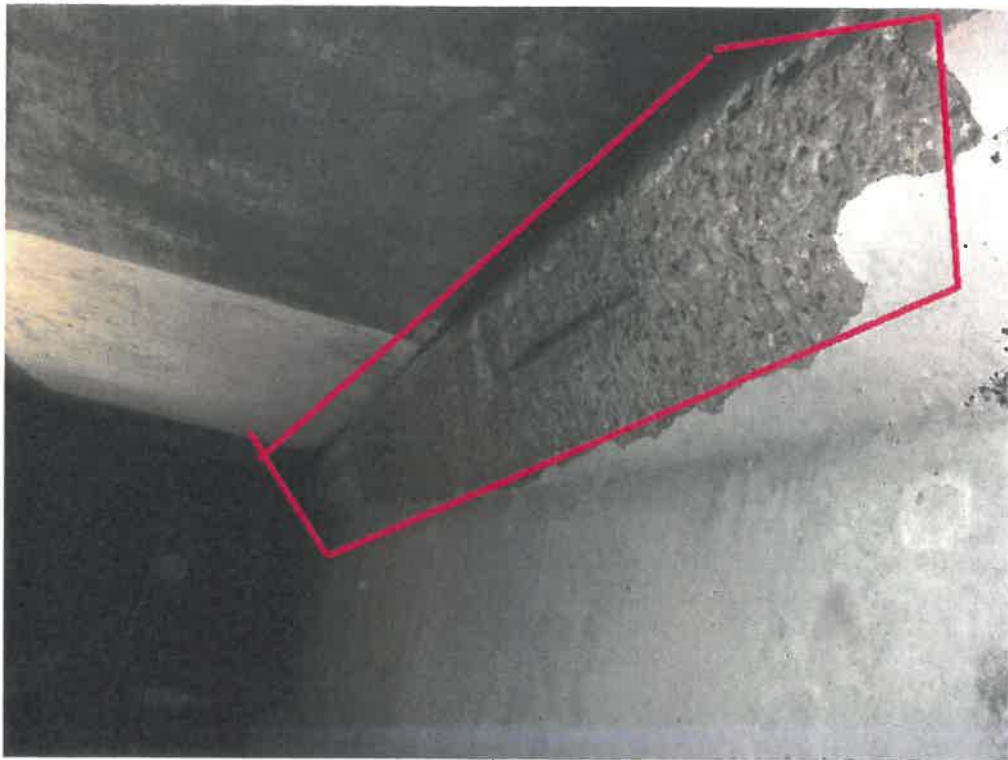
**Photo No. 4**

Spalls due to fire at span 5 , Girders 13 has a spall 30 ft X 8 in. X 6 in.

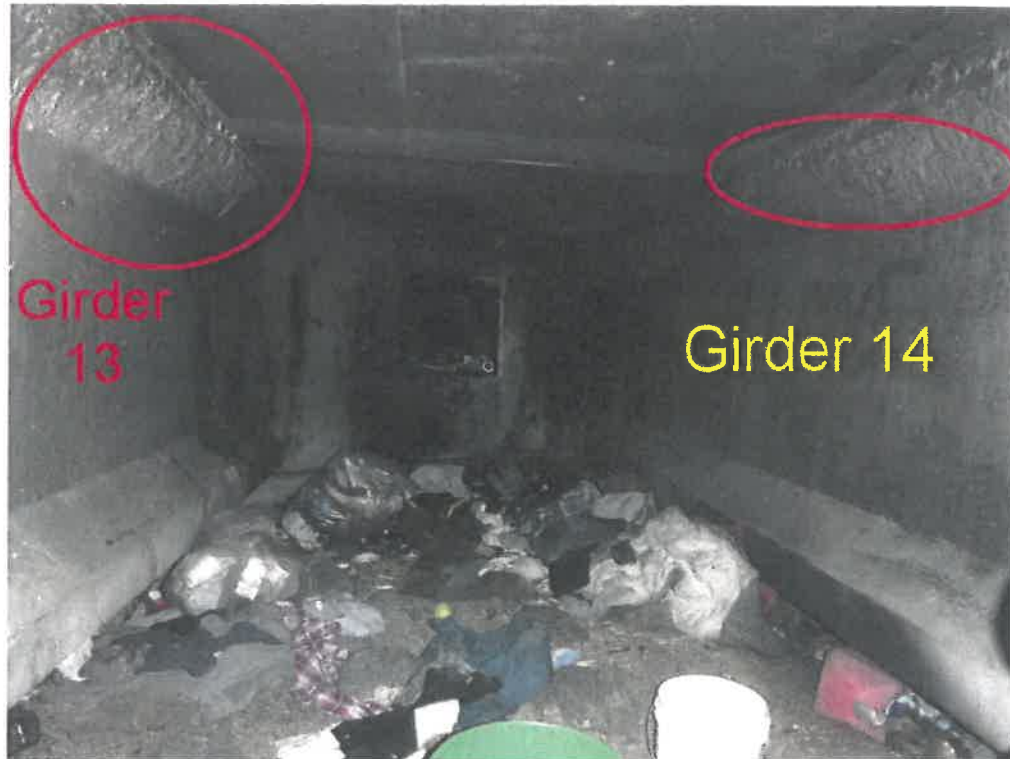
Photo No. 5

Spalls due to fire at span 5 , Girders 13& 14 have a spalls up to 30 ft X 8 in. X 6 in.

Girder 14 has a spall 20 feet long L X 8 inches W X 6 inches D at the top flange with exposed rebar.

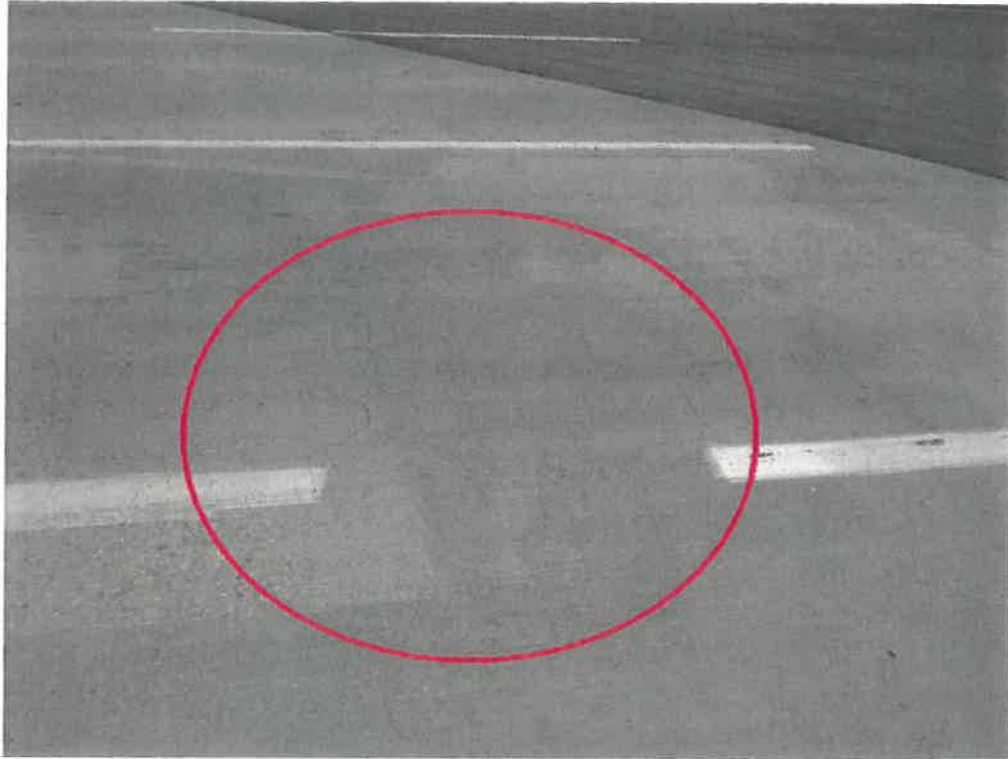
**Photo No. 7**

(312)									
There were no significant defects noted.									
321		Approach Slab-RC	2	444	sq.m	294	150	0	0
1130		Cracking (RC and Other)	2	150		0	150	0	0
(321-1130)									
The approach and departure slabs at the south side have several longitudinal cracks, 2 feet long and up to 0.05 inches wide. (see the attached photos no. 7 & 8)									
331		Railing-RC	2	240	m	225	15	0	0
1130		Cracking (RC and Other)	2	15		0	15	0	0
(331-1130)									
Both concrete rails have several vertical cracks, up to 0.04 inches wide.

**Approach and departure slabs have transverse cracks.**

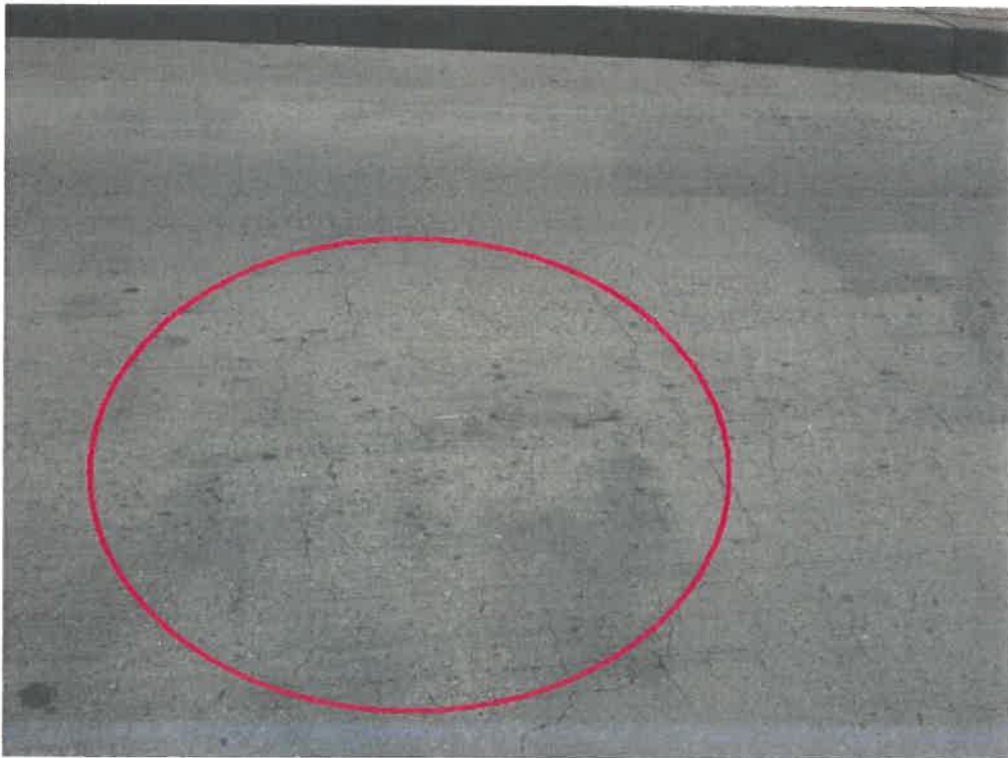
**Photo No. 8**

**Approach and departure slabs have transverse cracks.**
