**Bridge Report Transmittal Sheet****Batch**    **46626****County of Orange**

Bridge Number : 55C0637  
Facility Carried: CROWN VALLEY PKWY  
Location : 0.5 MI E/O MARGUERITE PW  
City :  
Inspection Date : 08/31/2018

**Bridge Inspection Report**

**STRUCTURE NAME:** ARROYO TRABUCO

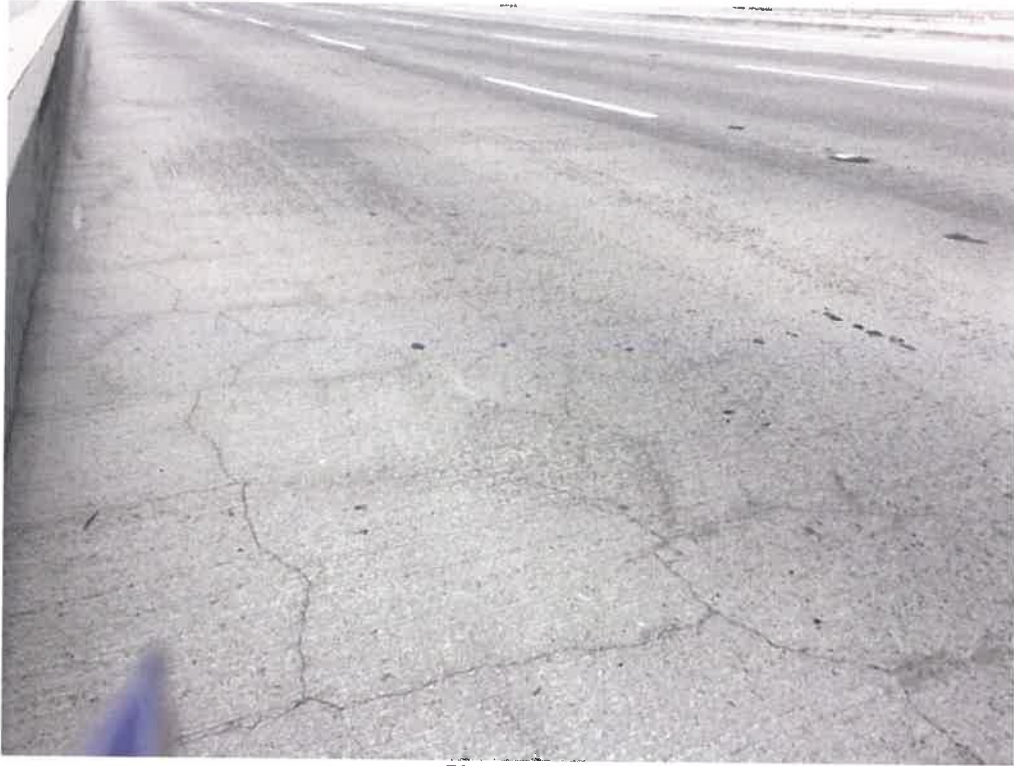
**Photo No. 1**

There are random longitudinal to diagonal cracks, up to 0.1 inch wide and 10.0 feet long throughout the entire deck. There are especially map pattern cracks, up to 0.1 inch wide and 6.0 inches spaced apart heavily on westbound lane 1 next to median throughout the entire length.

**map pattern cracks heavily mainly on lane 1 westbound, next to center median.**

There are longitudinal cracks 50.0 feet long and up to 0.1 inch wide in both directions above bents #2, #3, and #4; and also, there are few longitudinal cracks 3.0 ft long and up to 0.05 inches wide scattering throughout the deck. The work-recommendation has been made to seal deck cracks with Methacrylate.

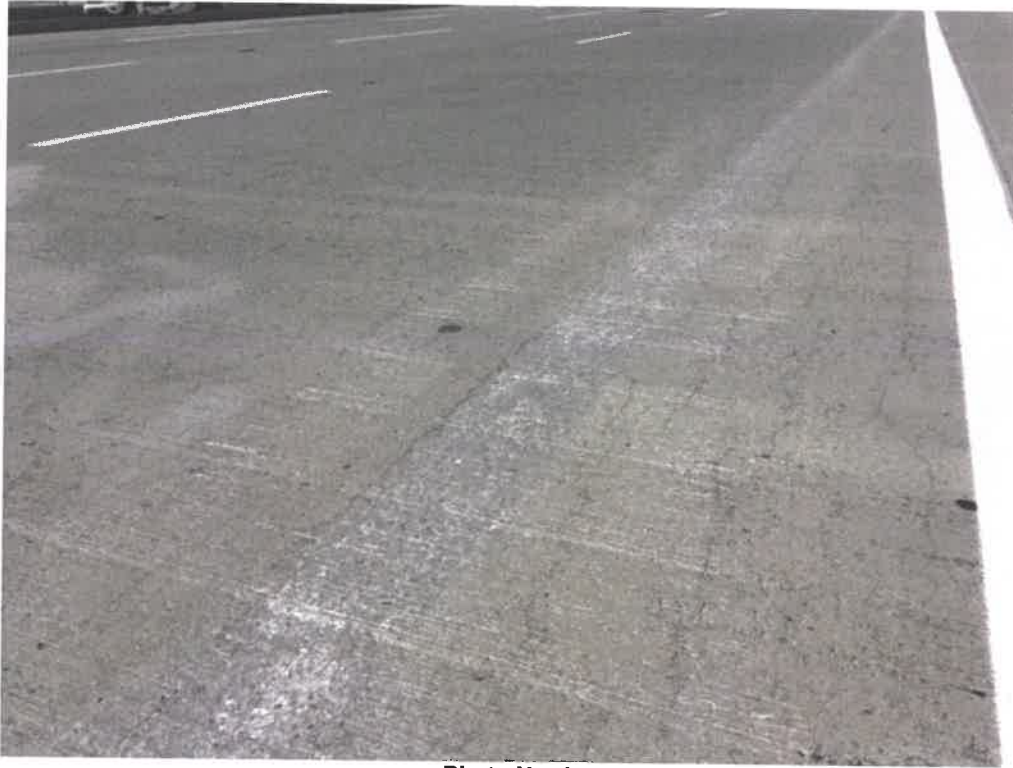
Photo No. 1

Longitudinal cracks through out entire bridge, heavily on westbound.

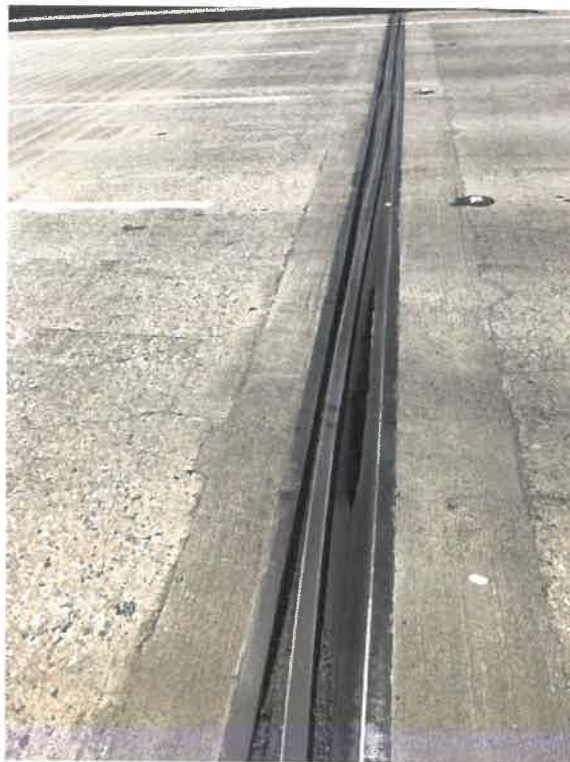
**Photo No. 1**

Westbound, the middle metal members of the Assembly-Joint are broken, snapped right between lanes #2 and #3 on eastbound at both abutment joints. In addition, The entire rubber strip seal of ELI 303 are twisted, cracked and missing at both abutments. The work-recommendation has been made in the previous bridge inspection report.

**Westerly Abutment Joint Seal was damaged and it's inspected on 3/14/2019**

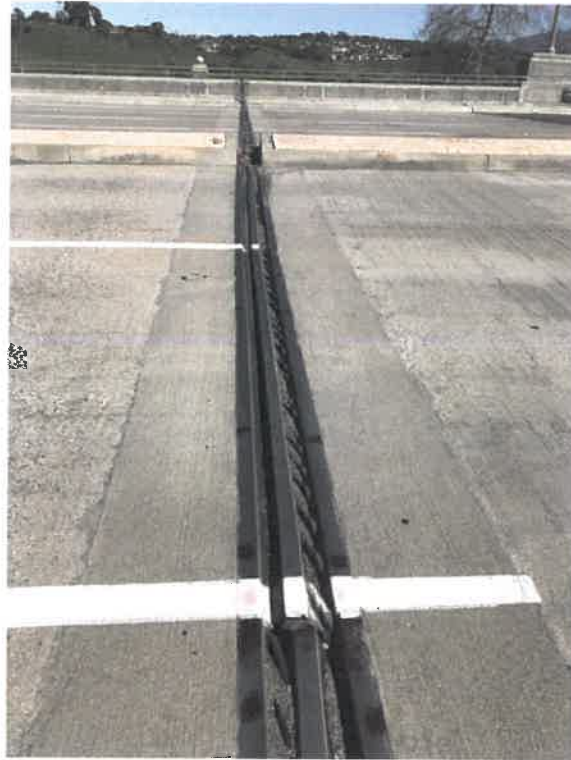
Photo No. 1

Joint Seal at hinge was damaged and inspected on 3/14/2019

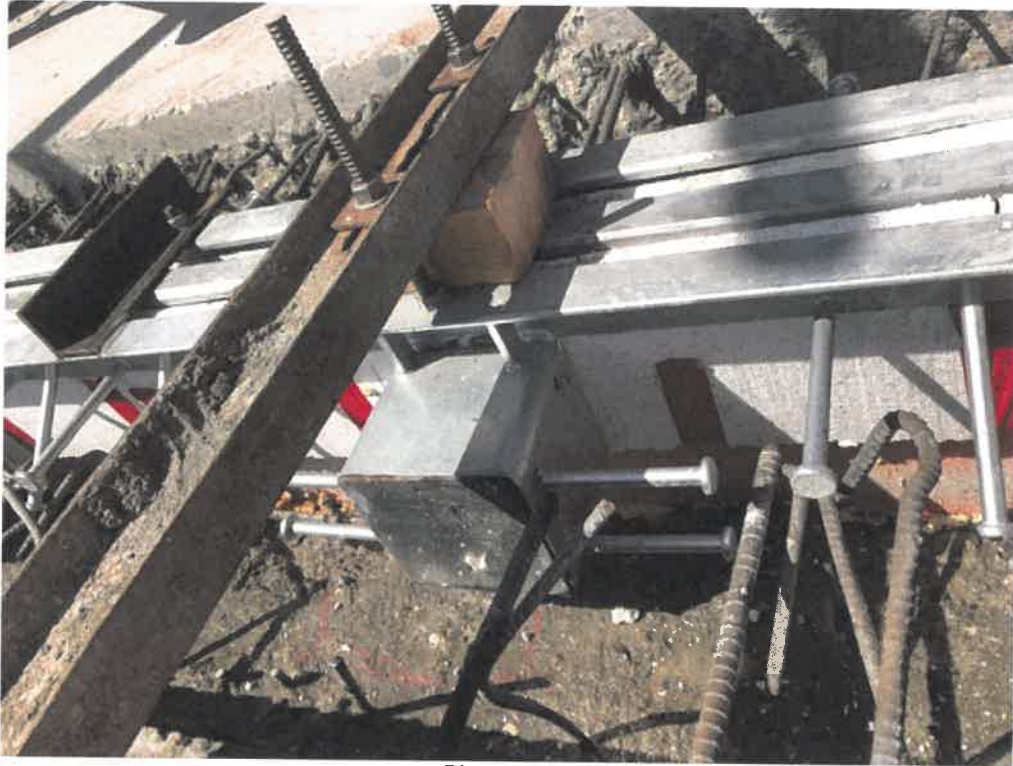
Photo No. 1

Details of joint seal replacement

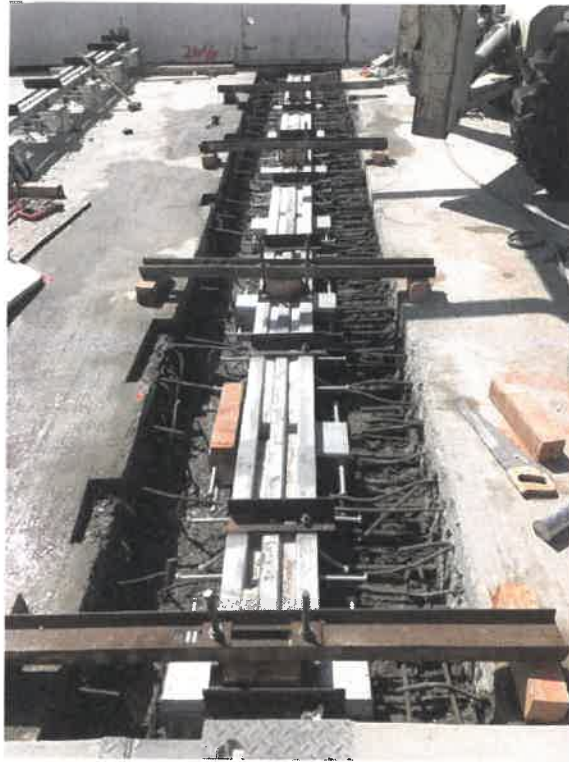
**Photo No. 1**

**Joint Seal at abutment joint locations and hinges are under replacing 3/25/19**

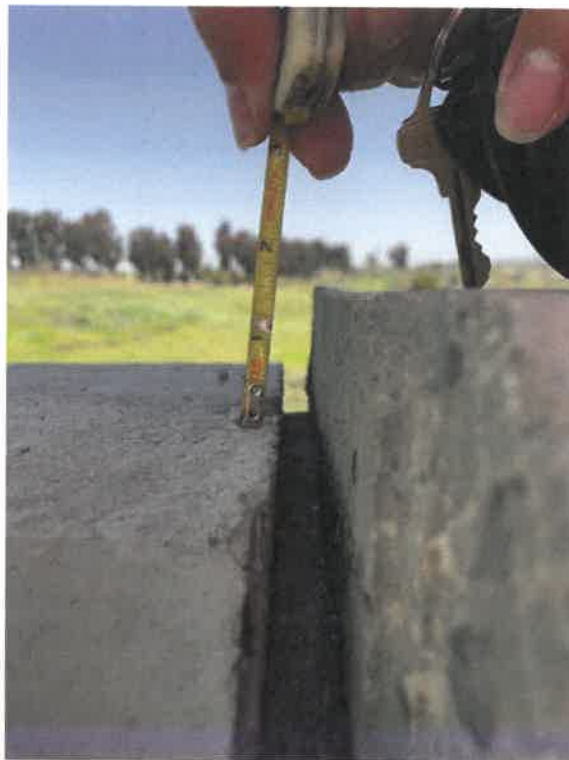
**Photo No. 1**

**Westbound, northerly top rail sidewalk has about 1.0"-1.75" drop at abutment 1.**

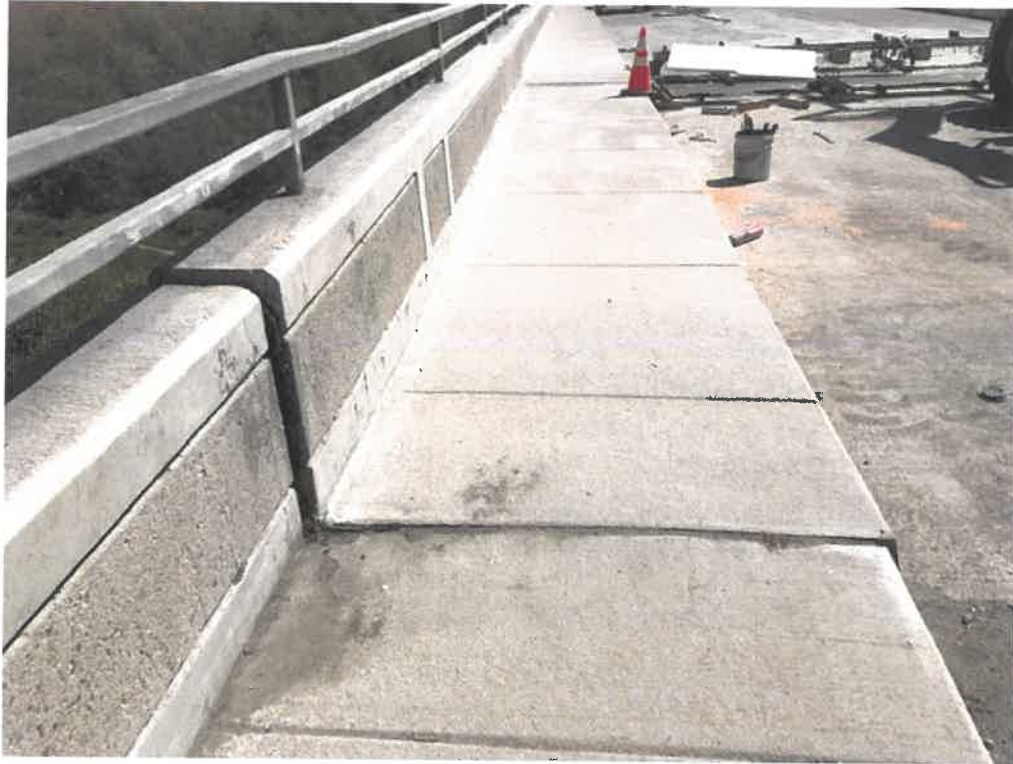
Photo No. 1

Westbound, northerly rail sidewalk has about 1.0"-1.75" settlement at abutment 1.

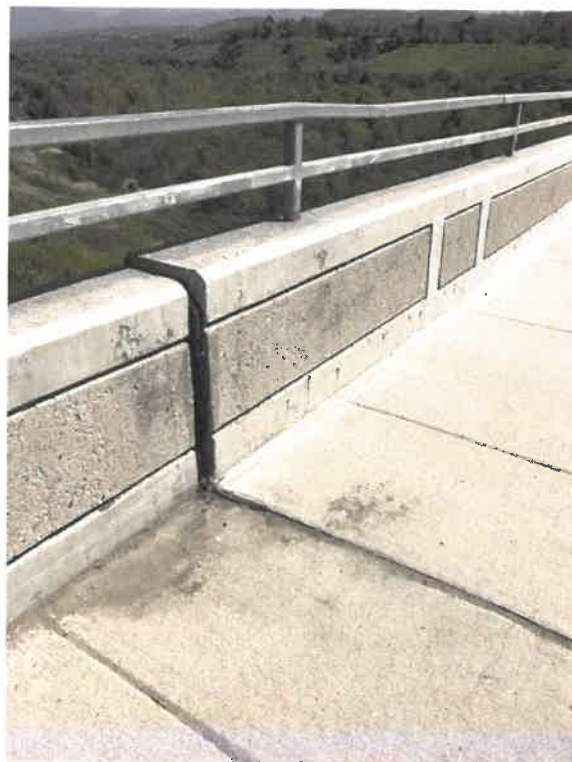
Photo No. 1

Westbound, northerly rail sidewalk has about 1.0"-1.75" settlement at abutment 1.

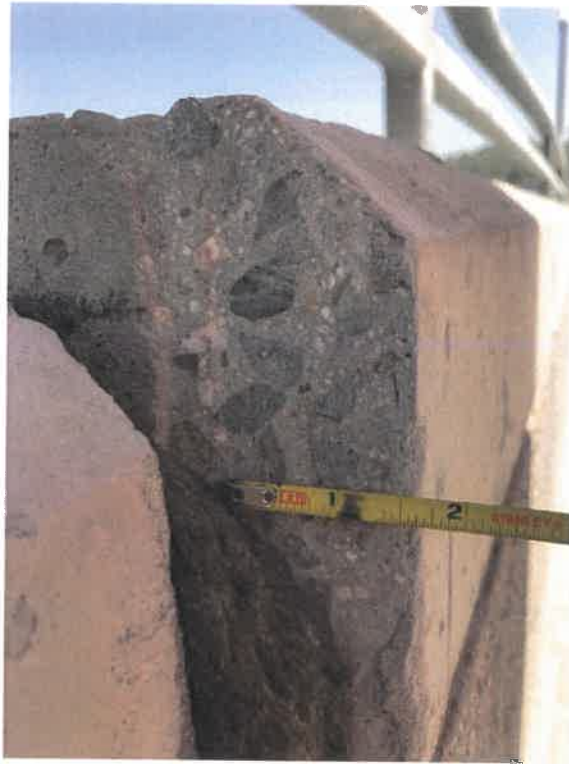
Photo No. 1

Westbound, northerly rail sidewalk has about 1.0"-1.75" settlement at abutment 1.
