DEPARTMENT OF TRANSPORTATION
Structure Maintenance & Investigations

Bridge Number : 55C0651
Facility Carried: OSO PARKWAY POC
Location : 0.4 MI. E/O ANTONIO PKWY
City :
Inspection Date : 04/30/2018

Bridge Inspection Report

STRUCTURE NAME: OSO PARKWAY POC

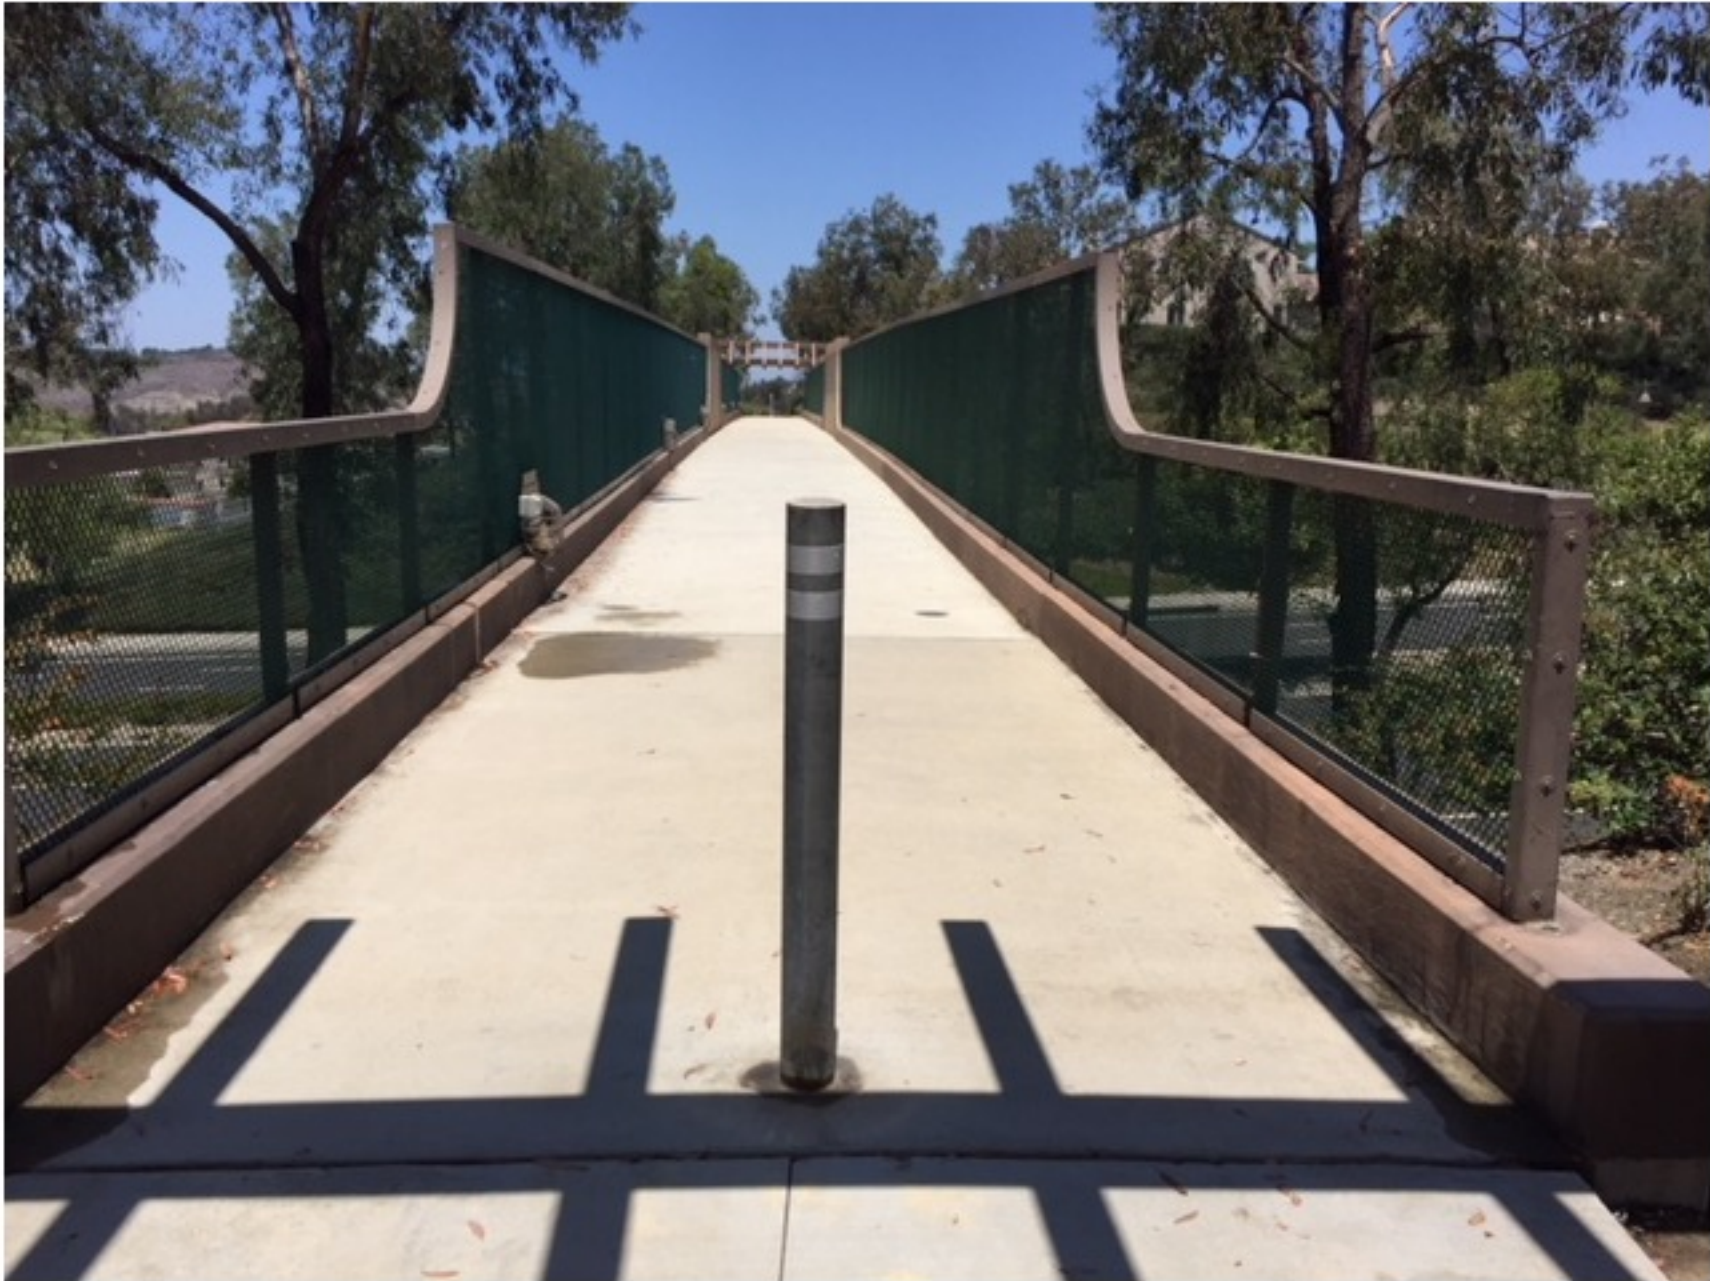
Photo No. 1
Elevation looking west

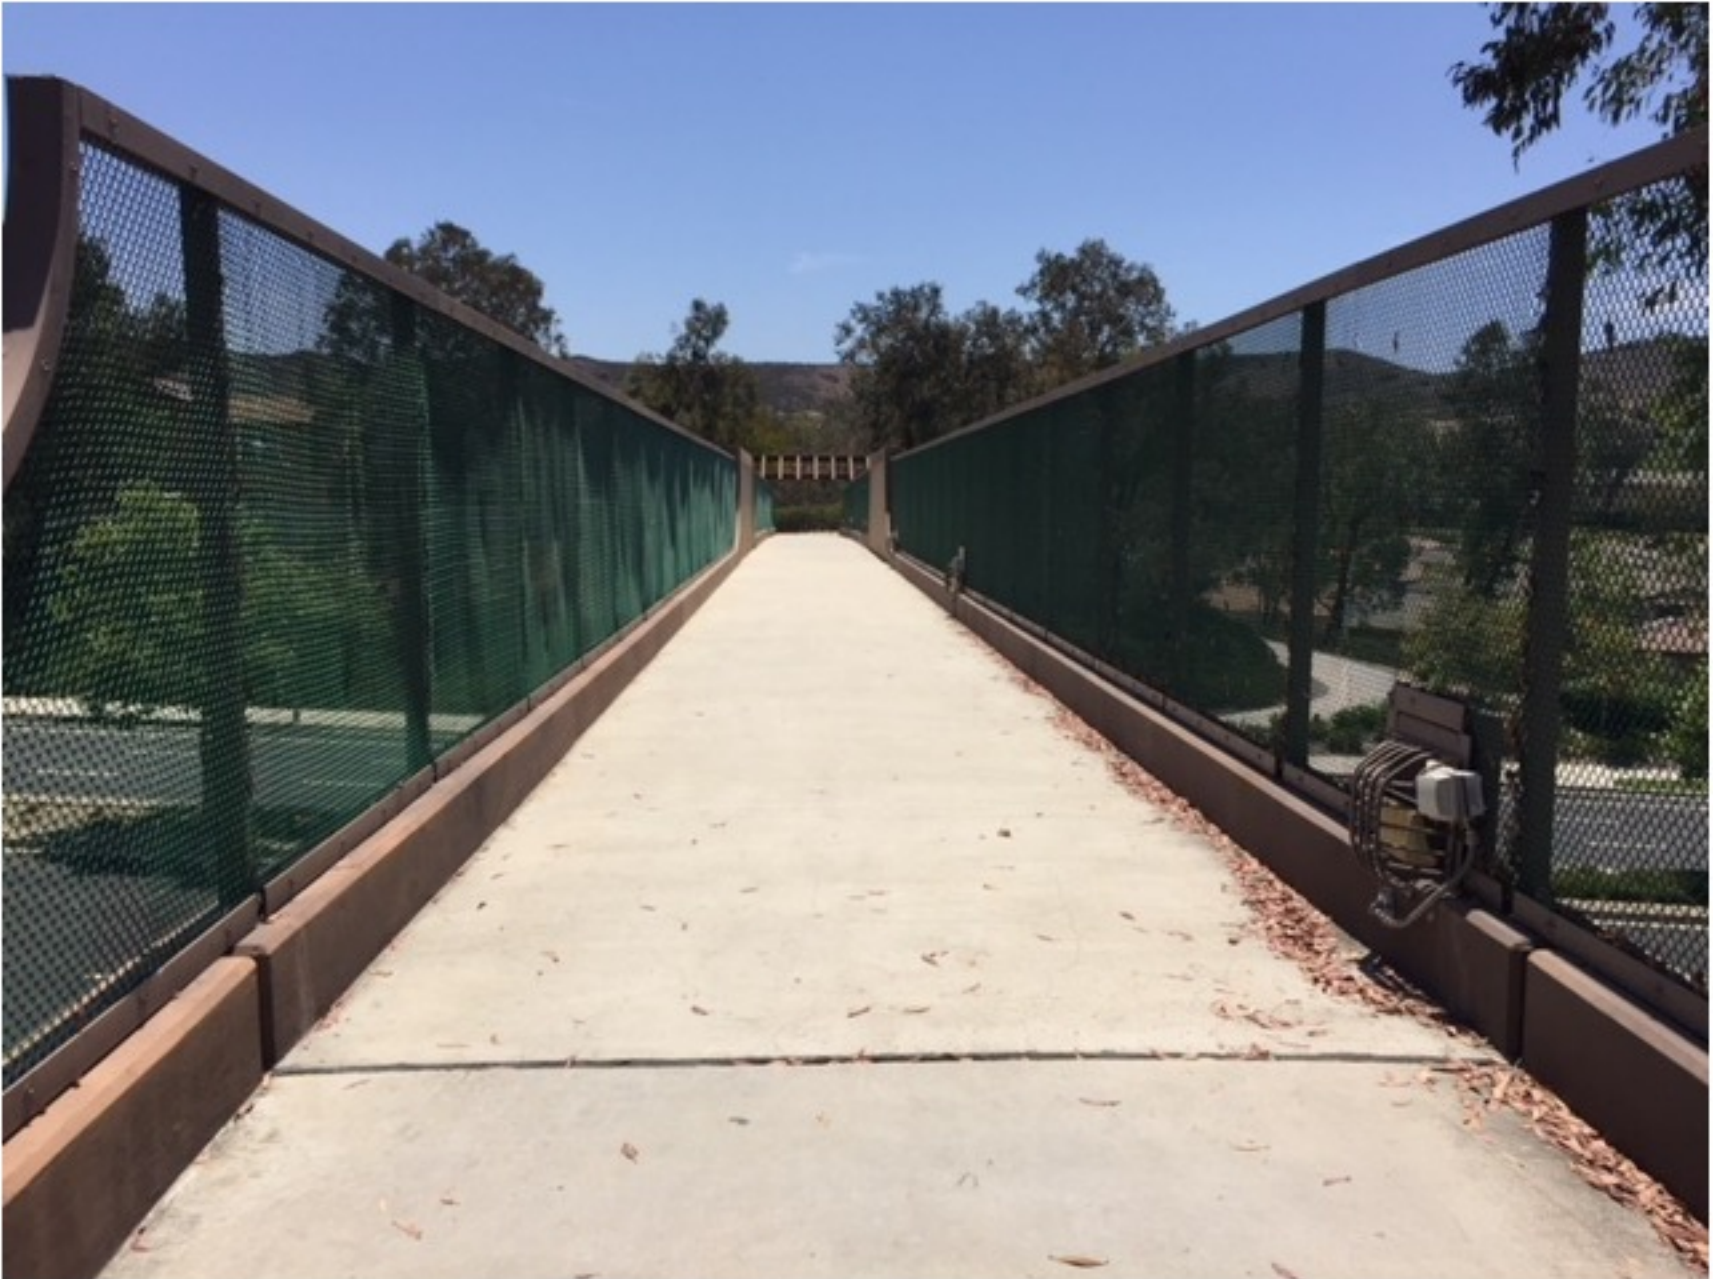
Photo No. 1
Deckview looking east

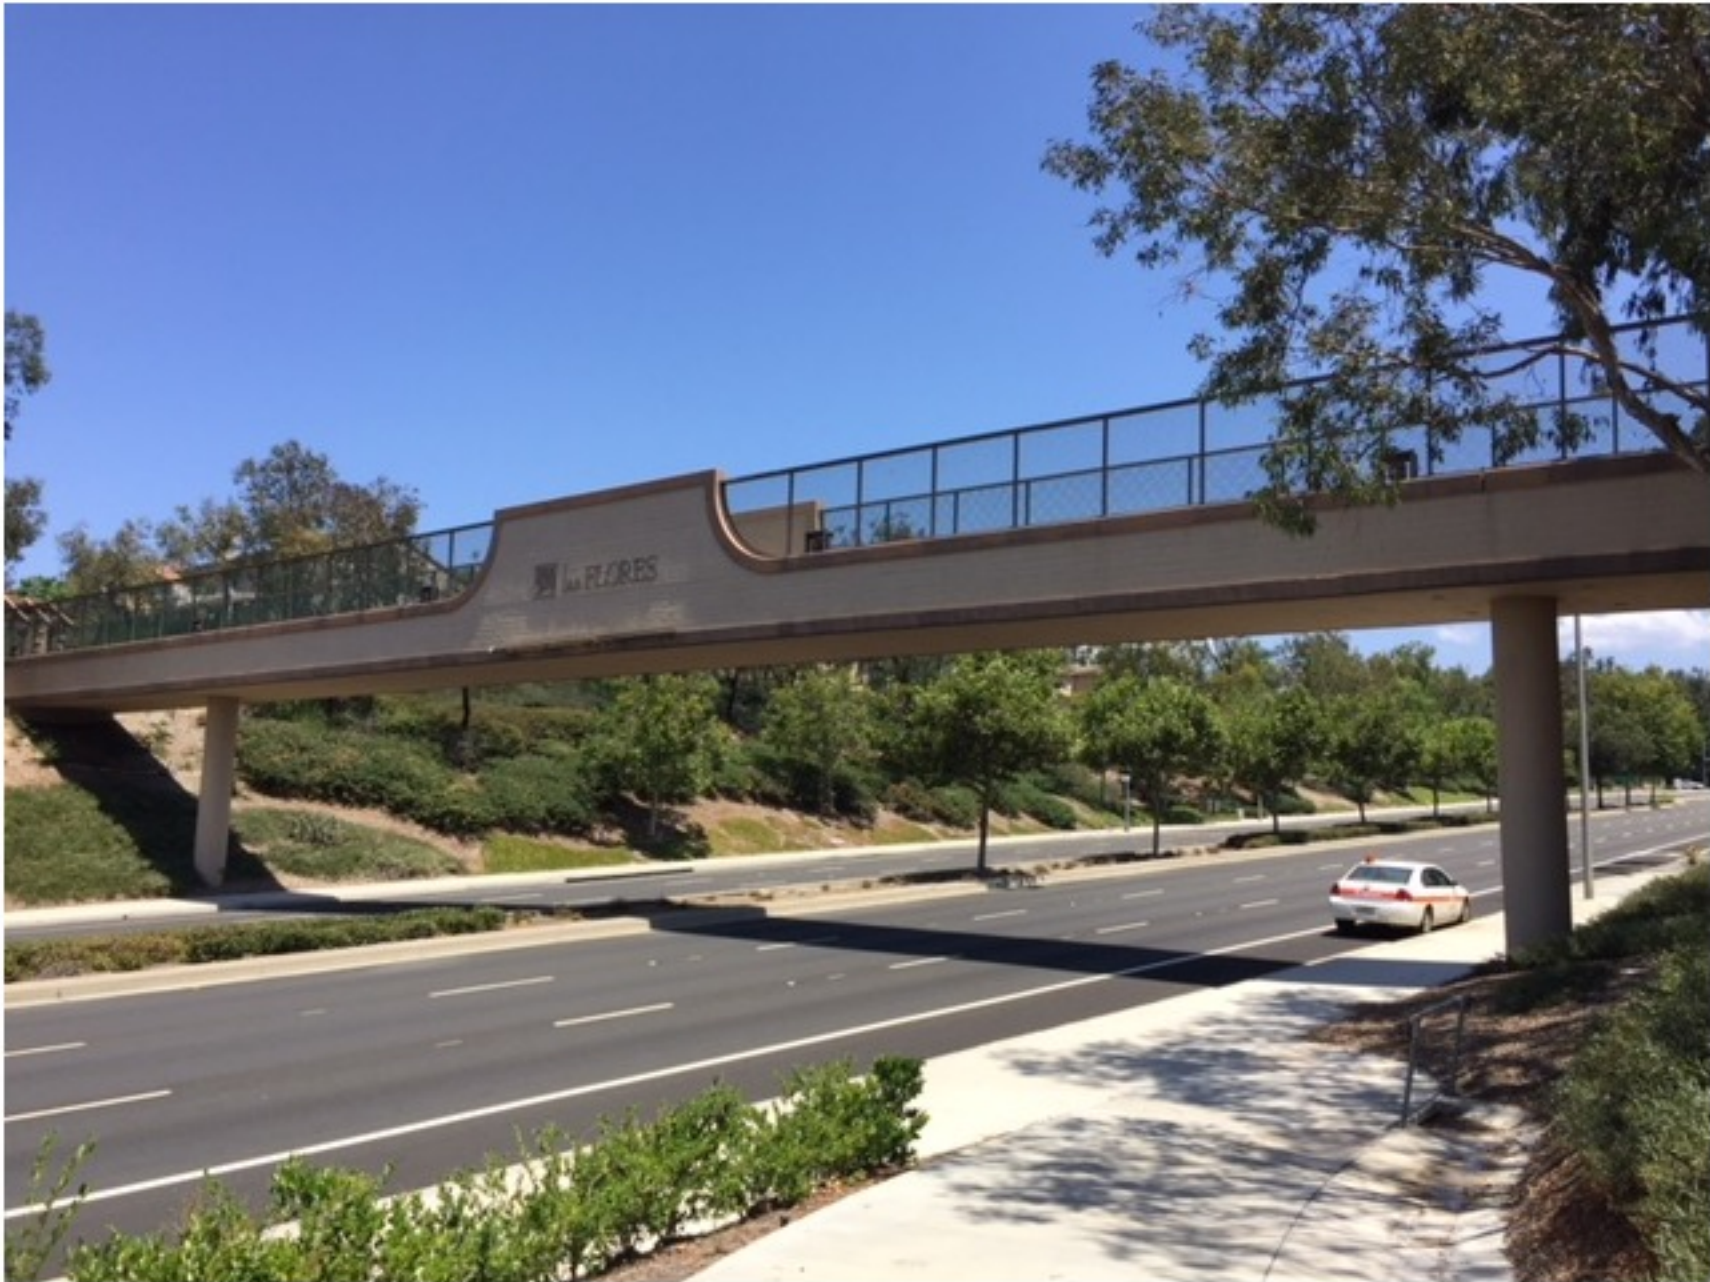
Photo No. 1
Elevation looking south
