DEPARTMENT OF TRANSPORTATION
Structure Maintenance & Investigations

Bridge Number : 55C0652
Facility Carried: PEDESTRIAN OC
Location : 0.04 M W/O SIENNA PKWY
City :
Inspection Date : 04/30/2018

Bridge Inspection Report

STRUCTURE NAME: CROWN VALLEY POC

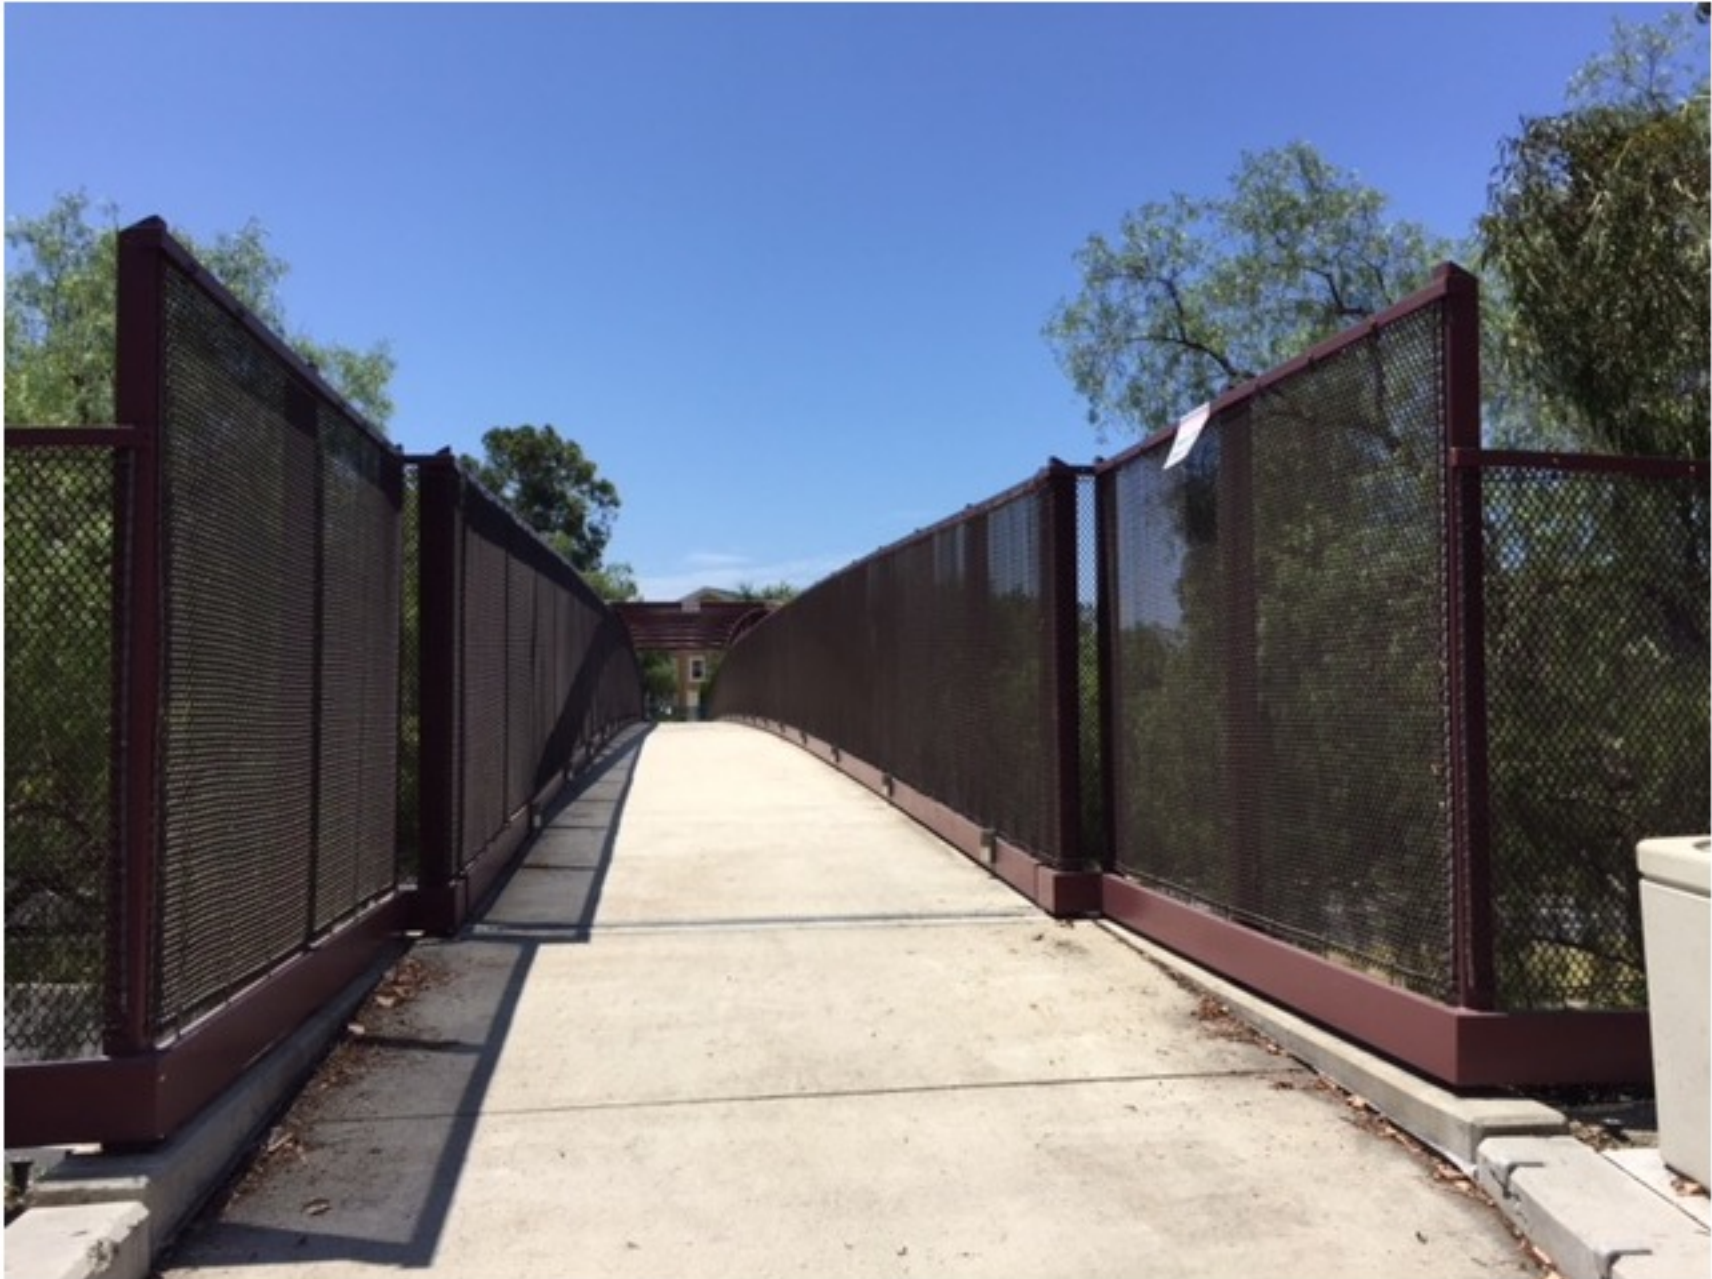
Photo No. 1
Deckview looking west

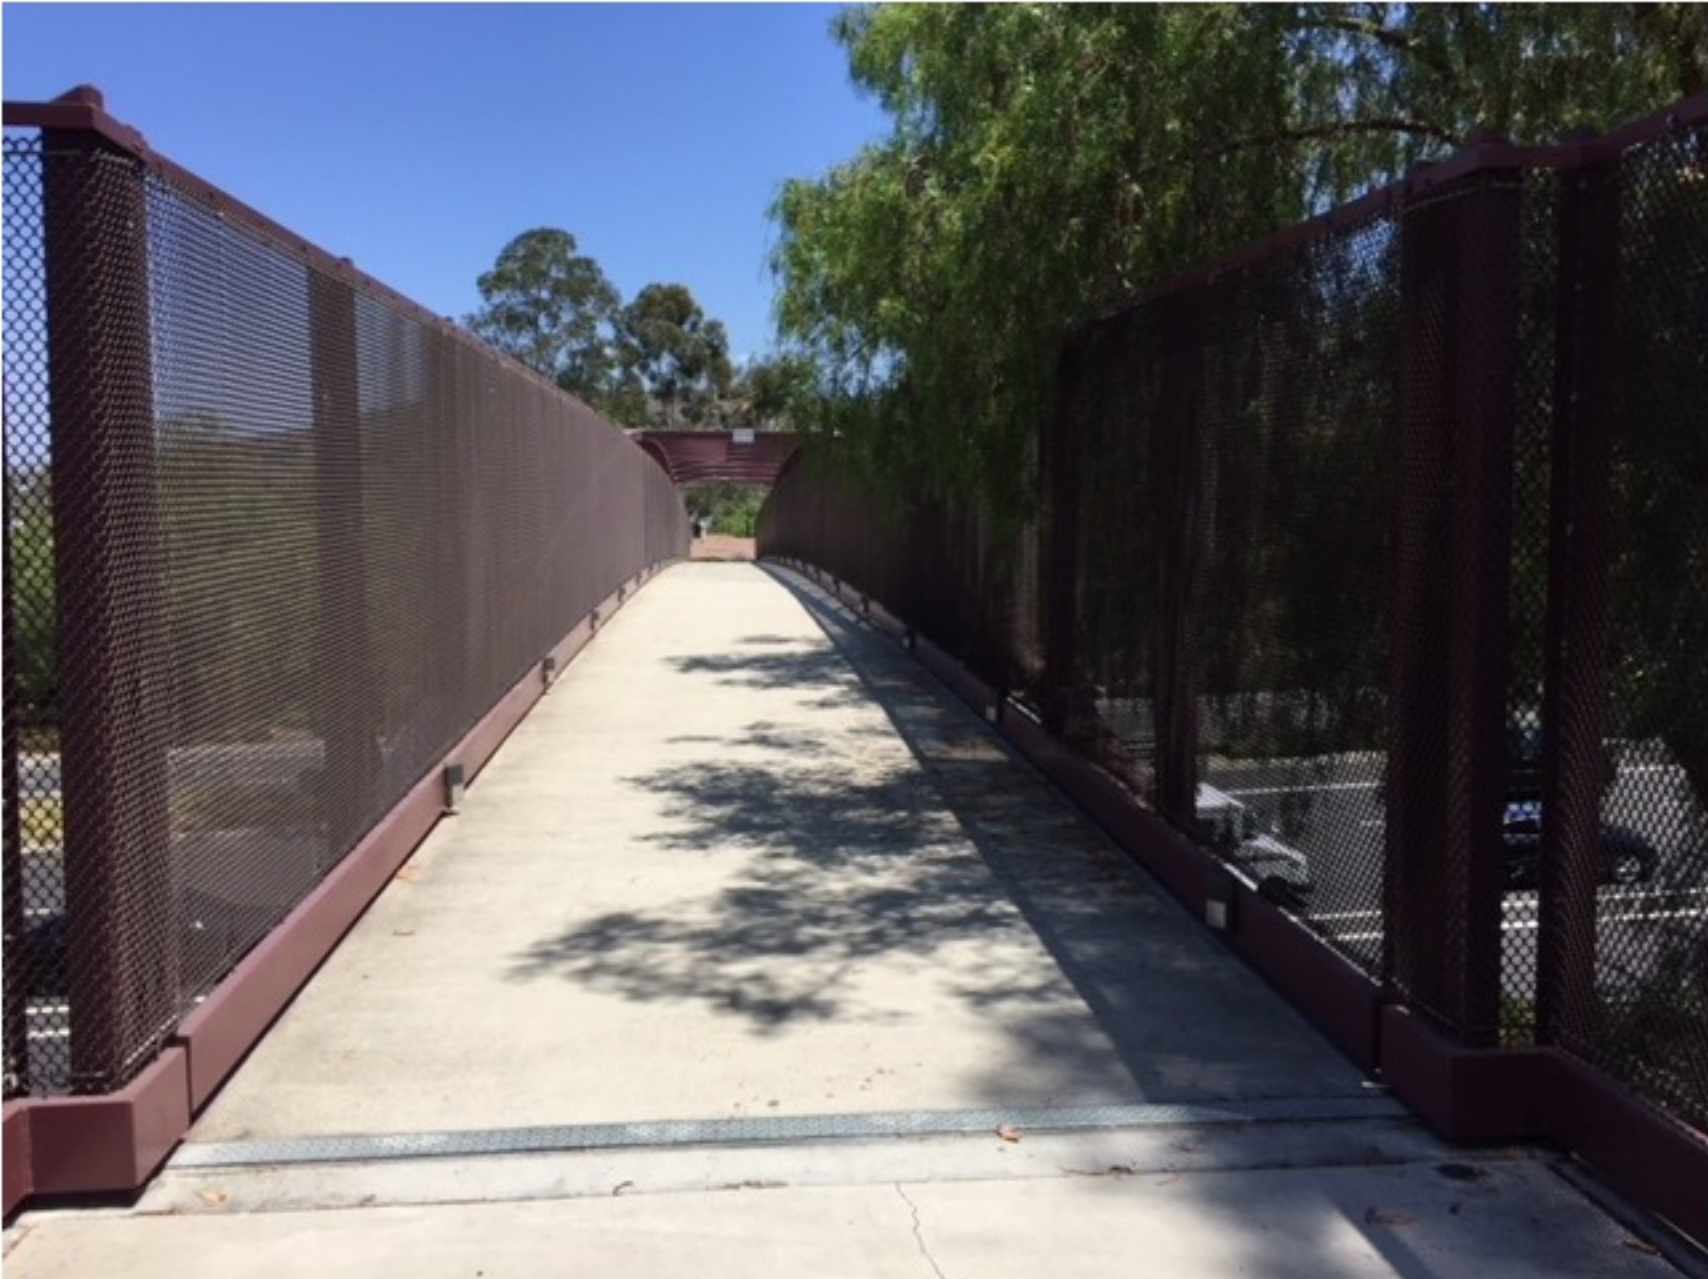
Photo No. 1
Deckview looking east

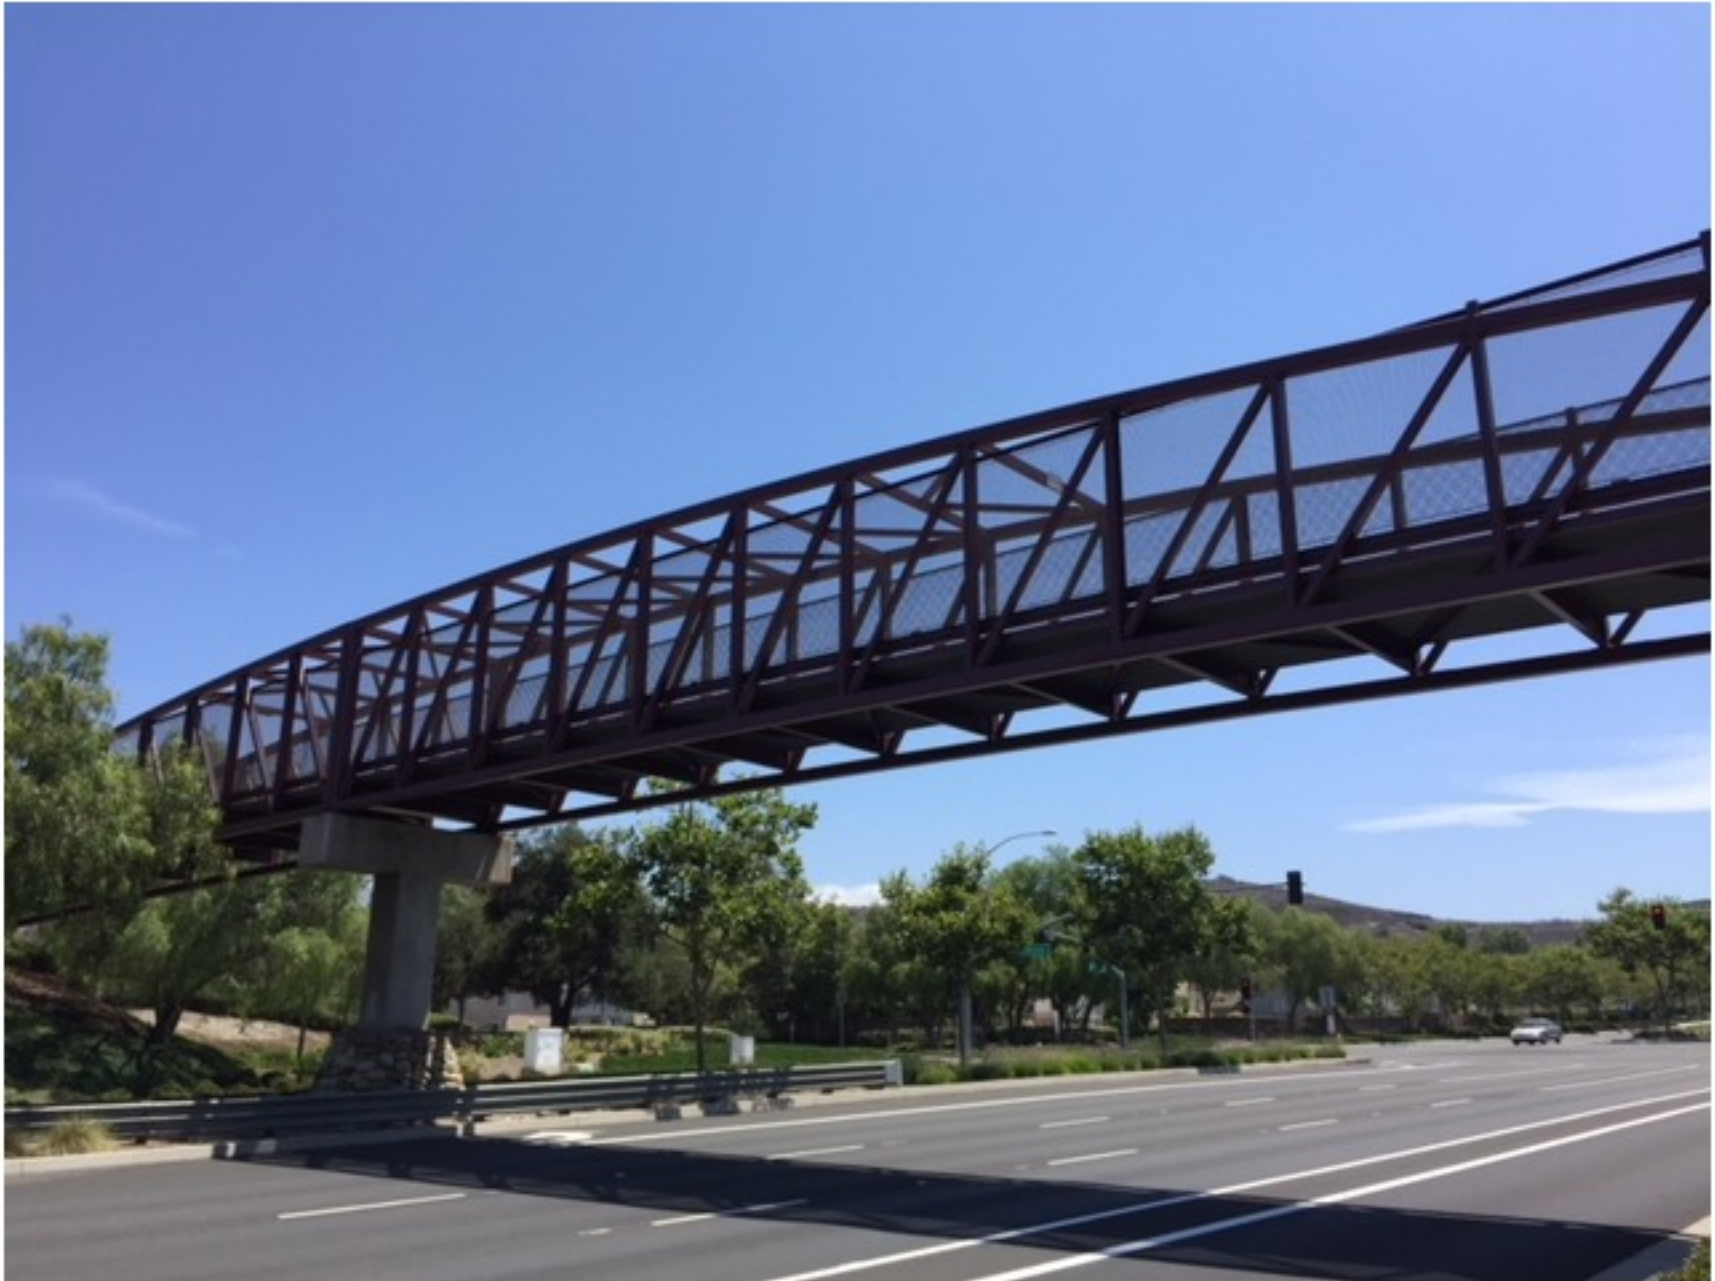
Photo No. 1

Elevation looking northeast

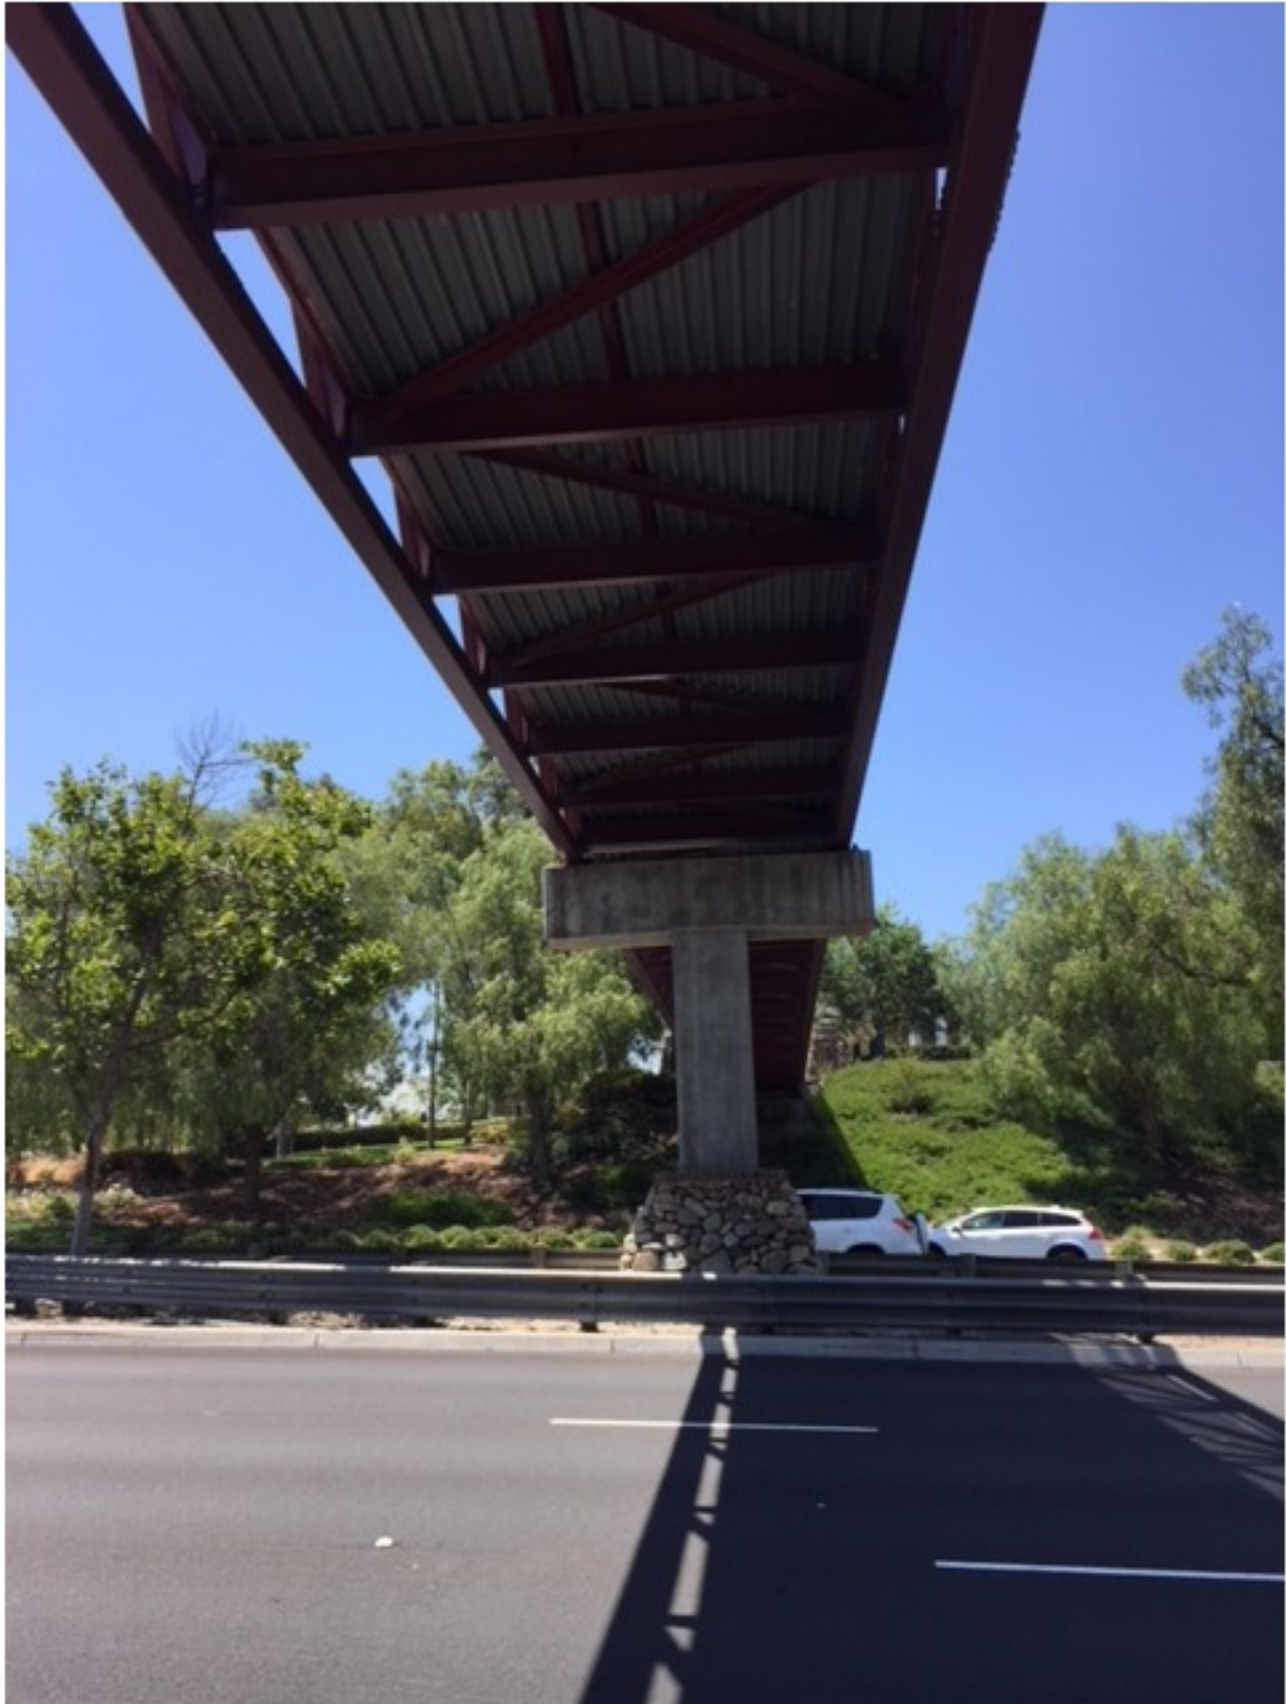
Photo No. 1
Elevation looking north

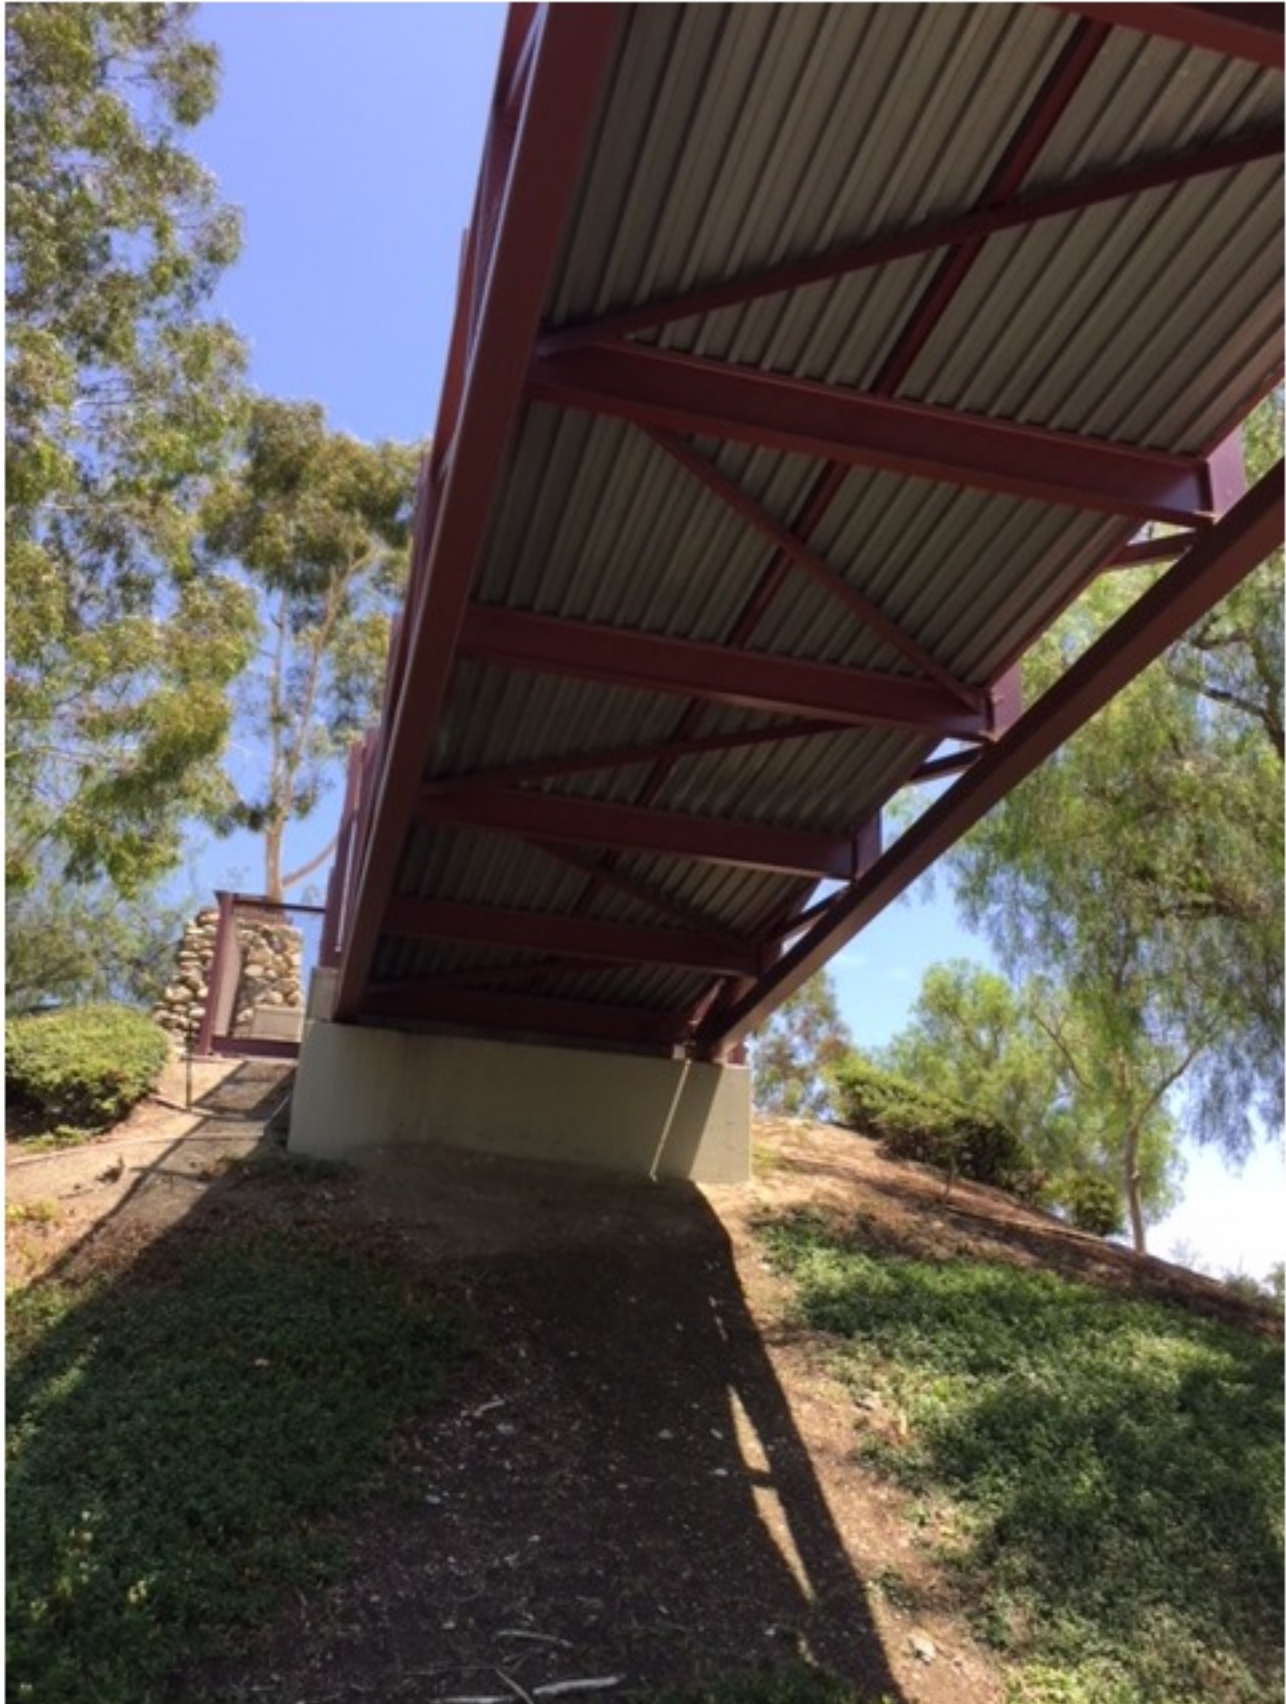
There are minor random hairline transverse deck cracks (less than 0.02 inches wide, 2.0 feet in spacing). The deck soffit is covered by corrugated metal sheets.

Photo No. 1
Deck soffit is covered by corrugated metal sheet
