DEPARTMENT OF TRANSPORTATION
Structure Maintenance & Investigations

Bridge Number : 55C0705
Facility Carried: ANTON BL, PARK CTR
Location : 0.12 MI E OF BRISTOL ST
City :
Inspection Date : 04/29/2018

Bridge Inspection Report

STRUCTURE NAME: SANTA ANA DELHI CHANNEL

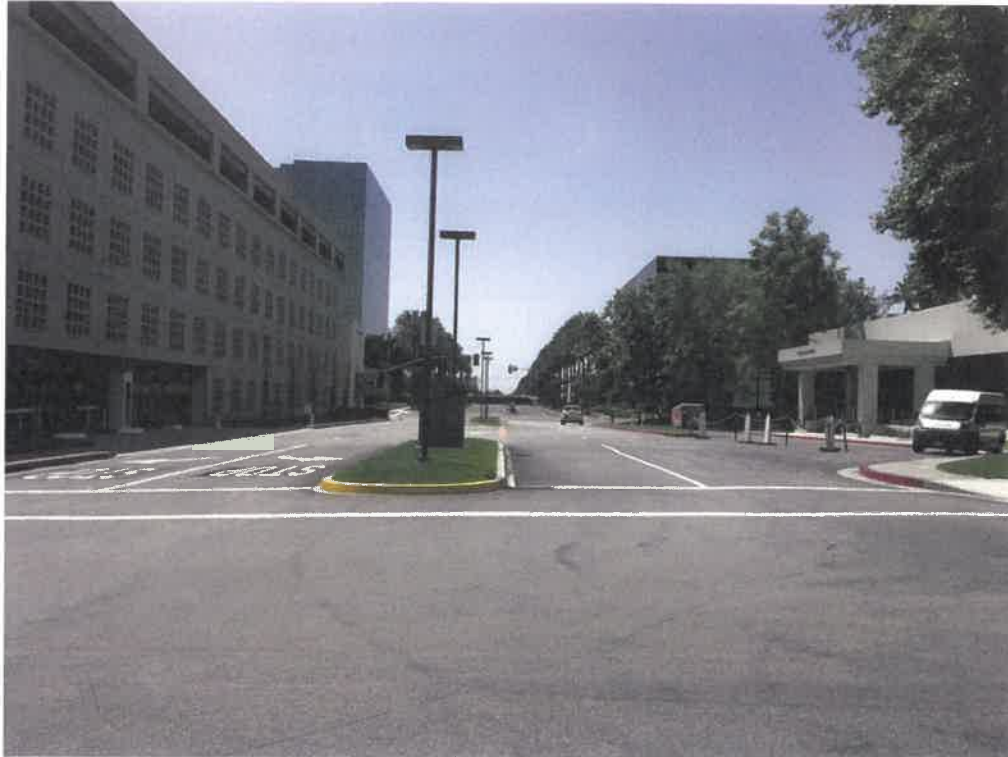
Photo No. 1

Looking south standing at intersection of Anton Blvd and Park Center Dr.

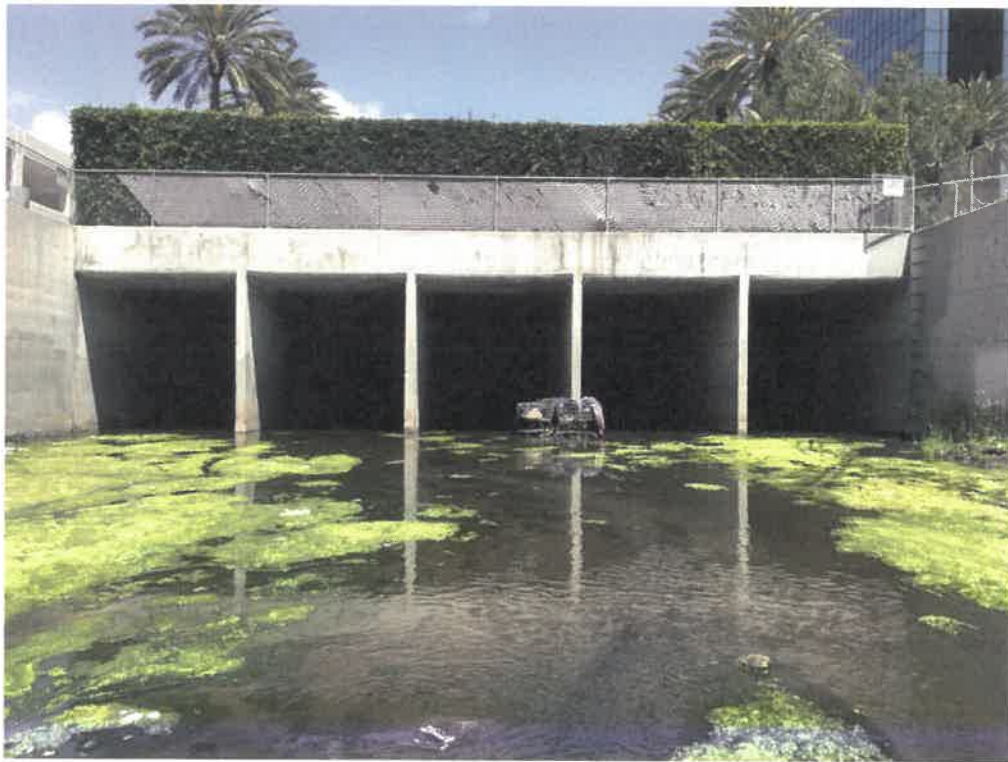
Photo No. 2

Looking north standing south of the culvert.

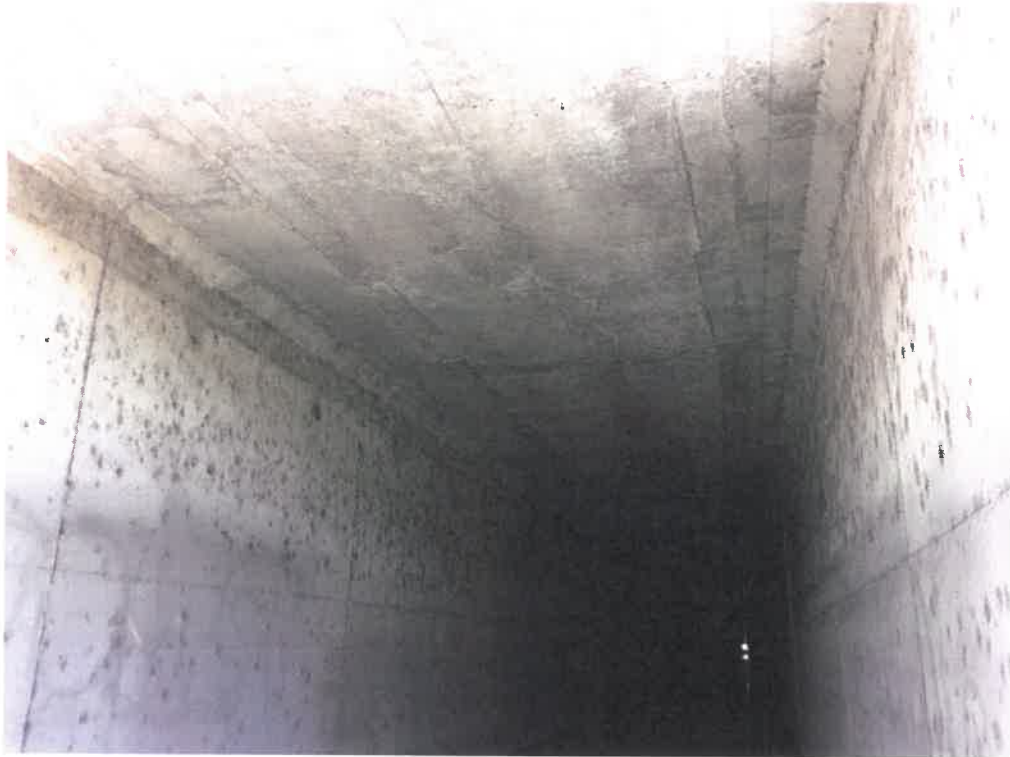
Photo No. 3

Looking north through Barrel 1 standing at the south end.

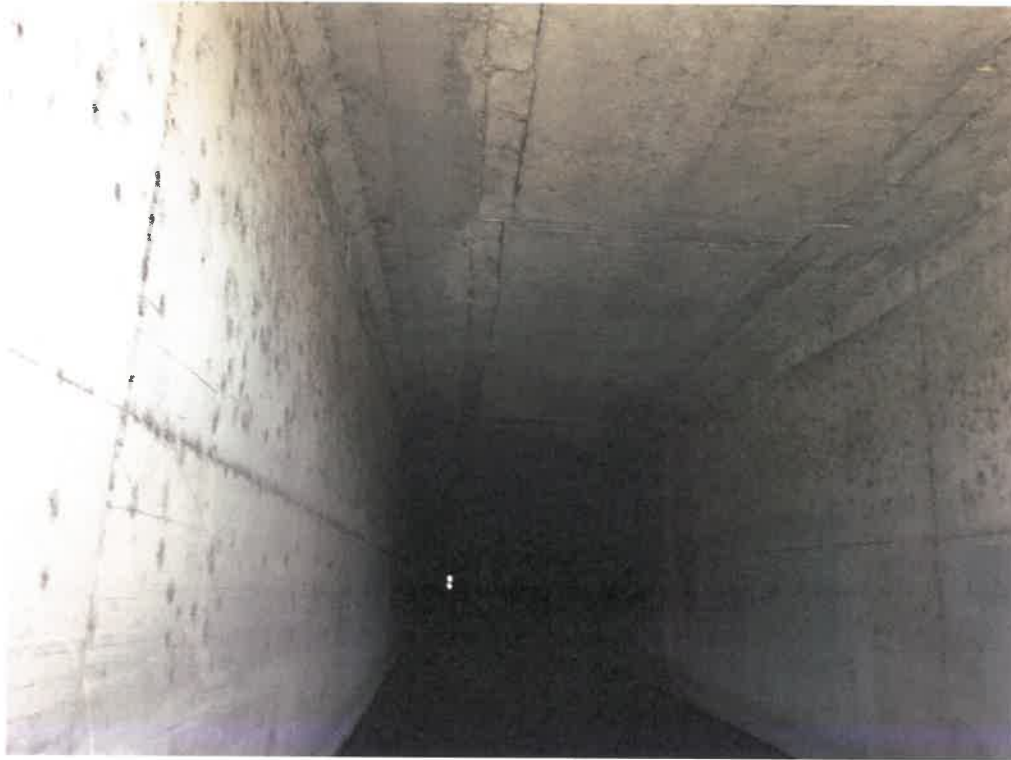
Photo No. 4

Looking north through Barrel 2 standing at the south end.

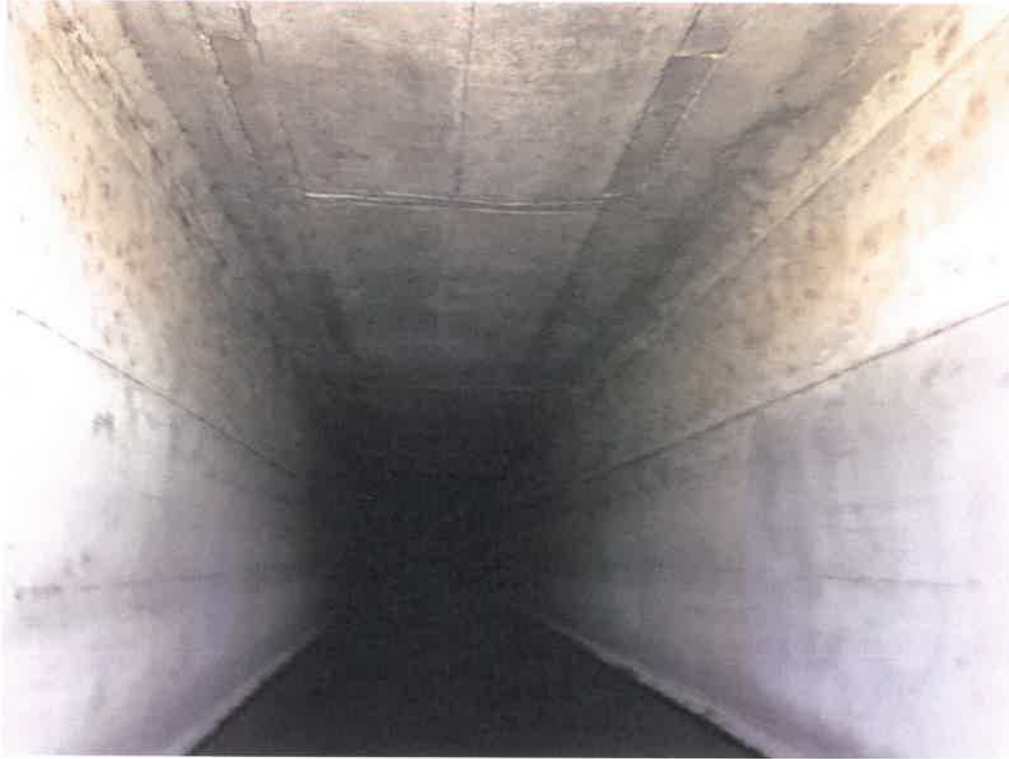
Photo No. 5

Looking north through Barrel 3 standing at the south end.

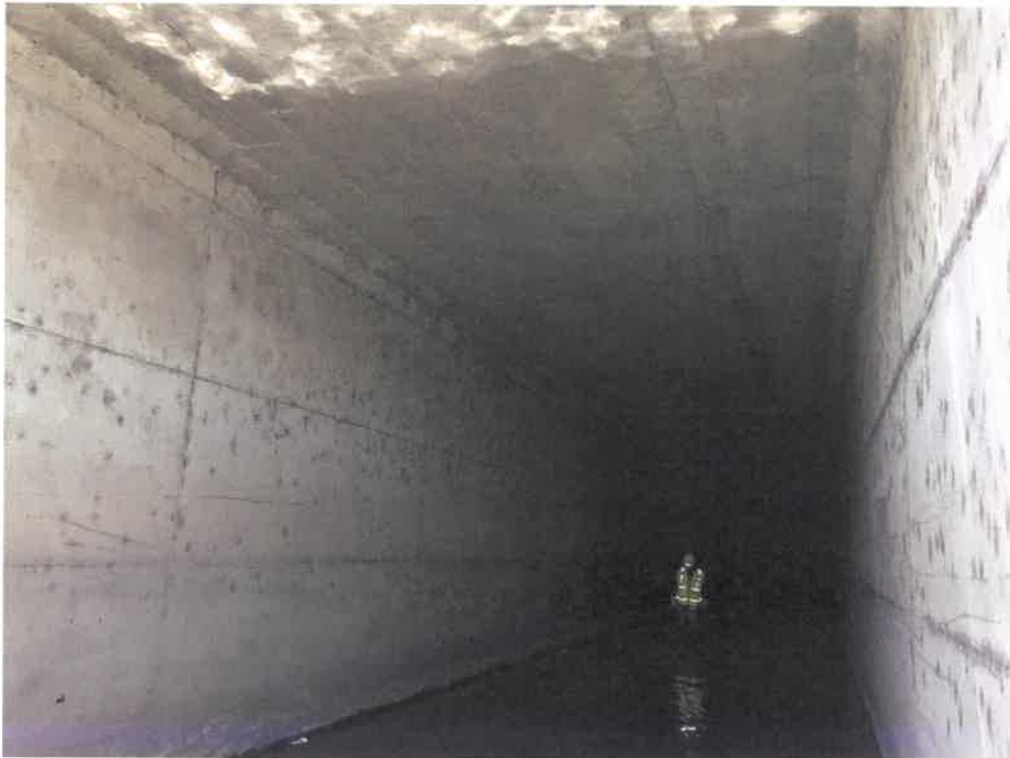
Photo No. 6

Looking north through Barrel 4 standing at the south end.

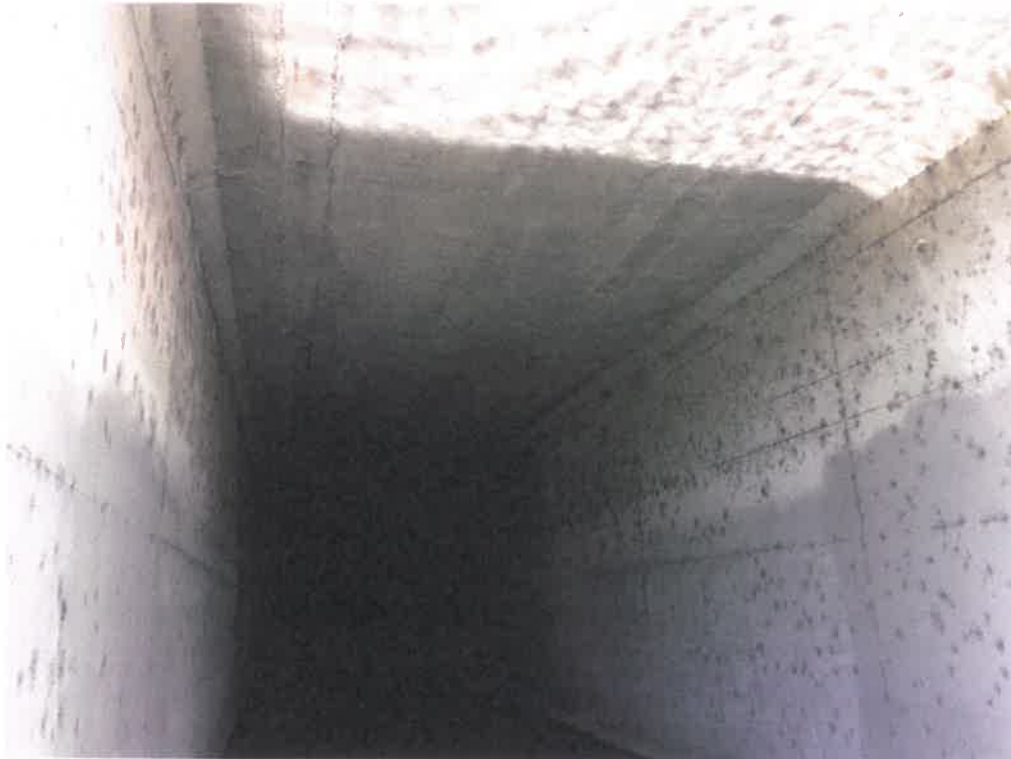
Photo No. 7

Looking north through Barrel 5 standing at the south end.

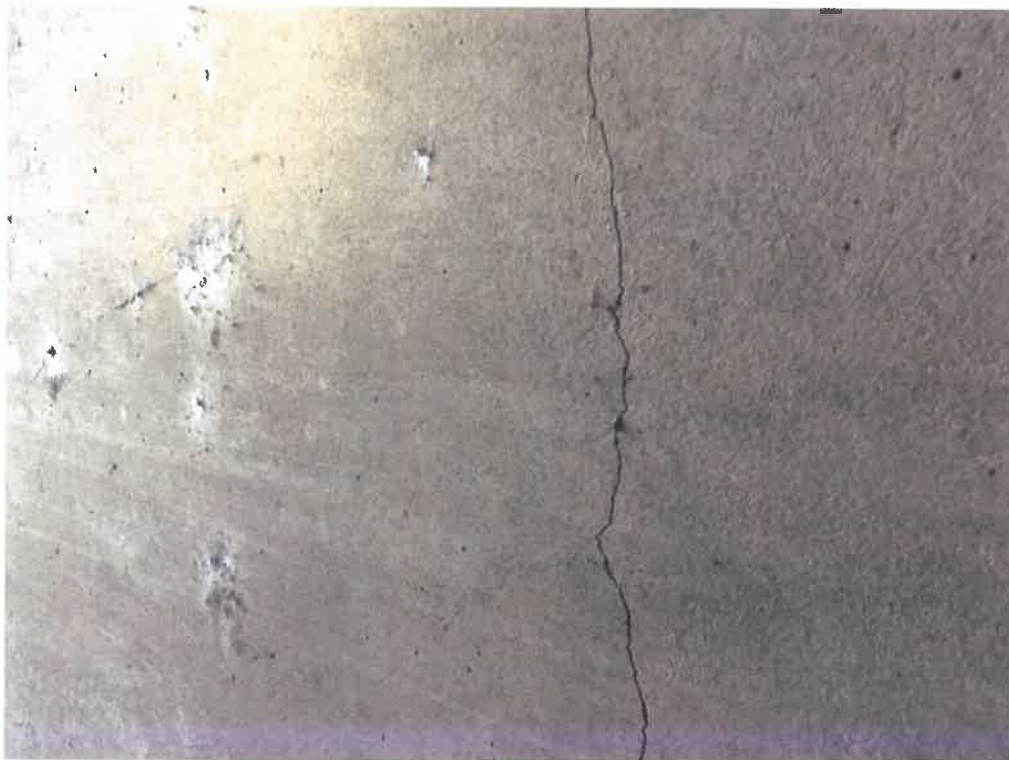
Photo No. 8

All culvert walls in all barrels have vertical cracks, 0.03 inch wide at 10 feet average spacing. At an average of 30 feet these cracks runs transversely into the soffit of the top slab where there are white and gray efflorescence around the crack. See Photos 8 and 9. ($0.10 \text{ CAF} \times 1695 \text{ m} = 170 \text{ m CS2}$)

Typical crack on all walls spaced at 10 feet average.

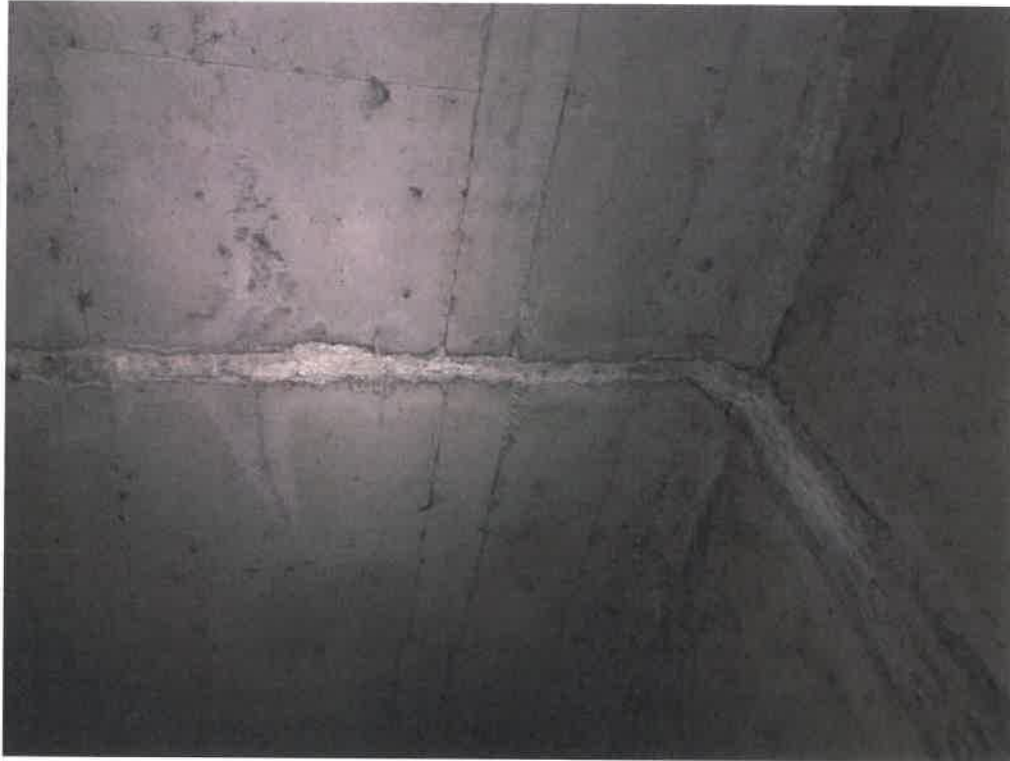
Photo No. 9

Typical soffit and wall crack with white and gray efflorescence at 30 ft average spacing.
