**Bridge Report Transmittal Sheet****Batch 38704****County of Orange**

Bridge Number : 55C0693L  
Facility Carried: COW CAMP ROAD  
Location : 0.4 MI E/O ANTONIO PKWY  
City :  
Inspection Date : 04/28/2018

## Bridge Inspection Report

**STRUCTURE NAME:** NORTHERLY CHIQUITA CANYON

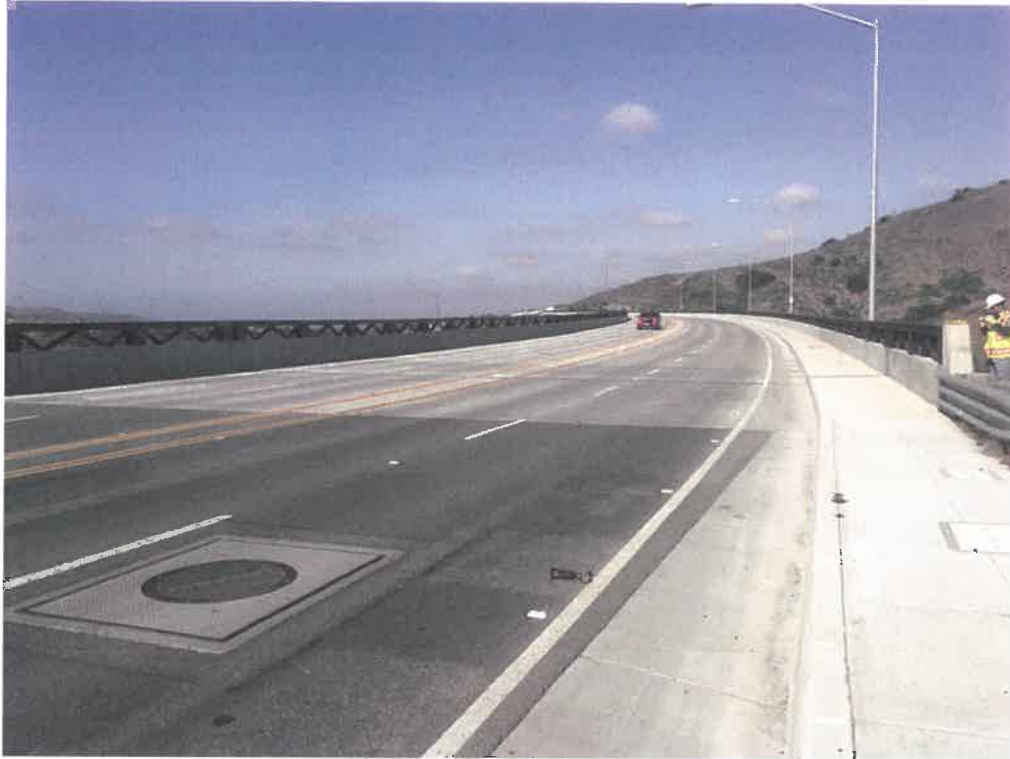
Photo No. 1

Looking west standing east of the bridge.

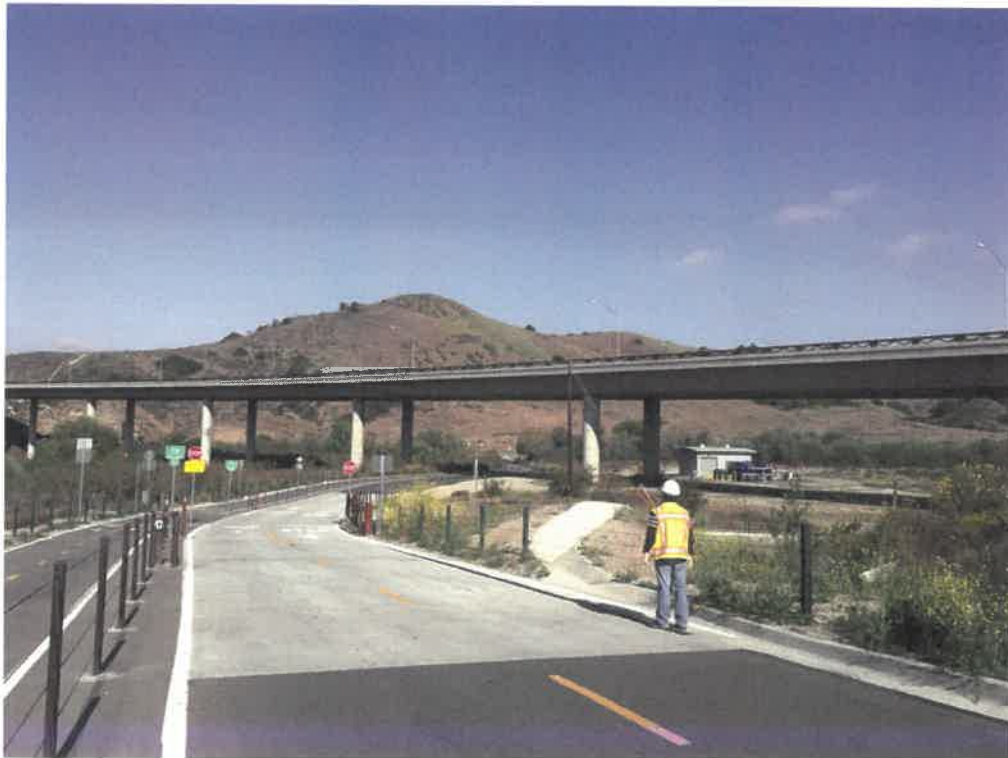
Photo No. 2

Looking north standing south of the bridge.

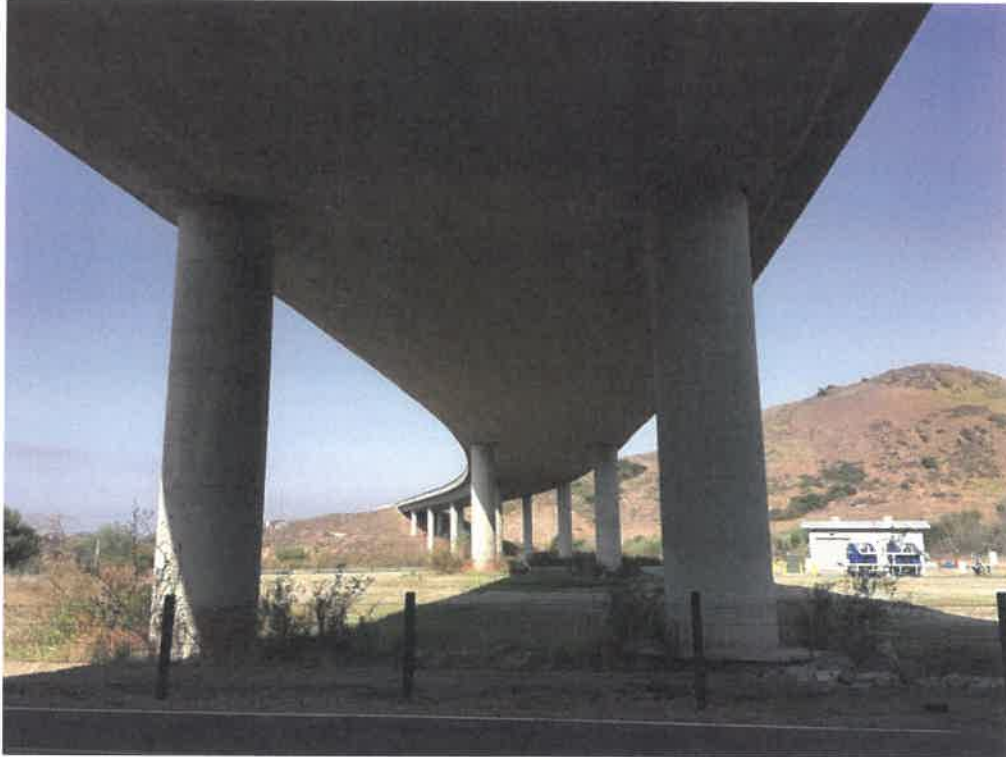
Photo No. 3

Looking west standing under Span 8.

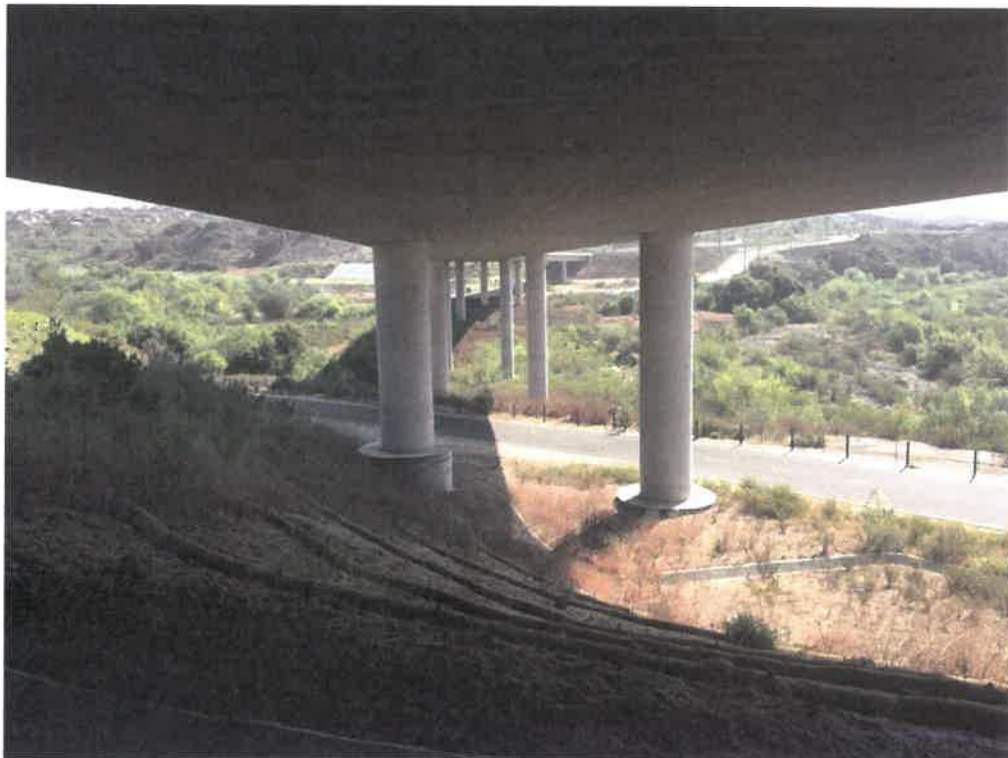
Photo No. 4

Looking east standing in front of Abutment 1.
