**Bridge Report Transmittal Sheet****Batch** **54810****County of Orange**

Bridge Number : 56C0636  
Facility Carried: GREEN RIVER DRIVE  
Location : 0.1 MI W/O GREEN RIVER R  
City :  
Inspection Date : 09/10/2019

**Bridge Inspection Report**

**STRUCTURE NAME:** SANTA ANA RIVER (GREEN RIVER GOLF CLUB DR)

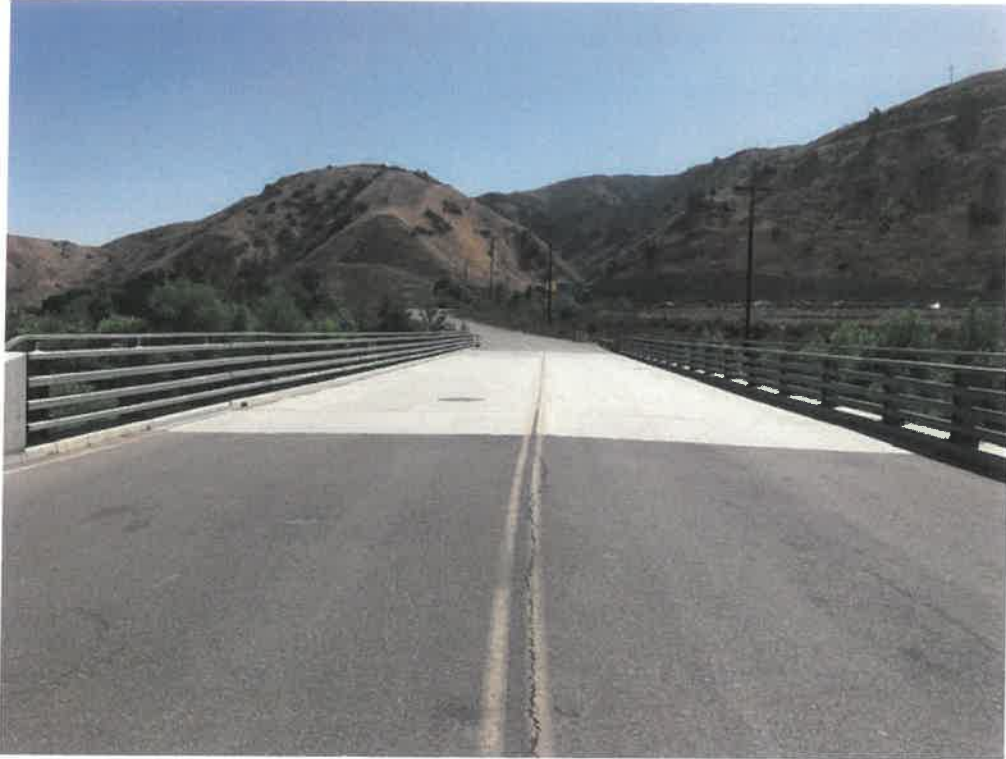
Photo No. 1

Deckview looking east

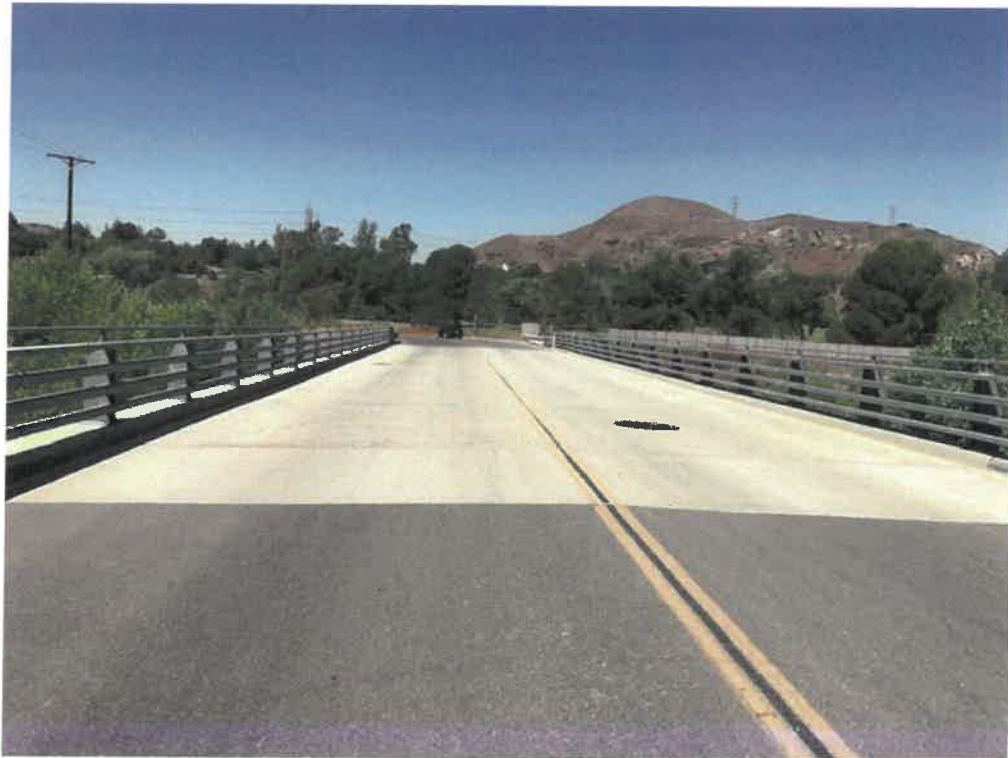
Photo No. 1

Deckview looking west

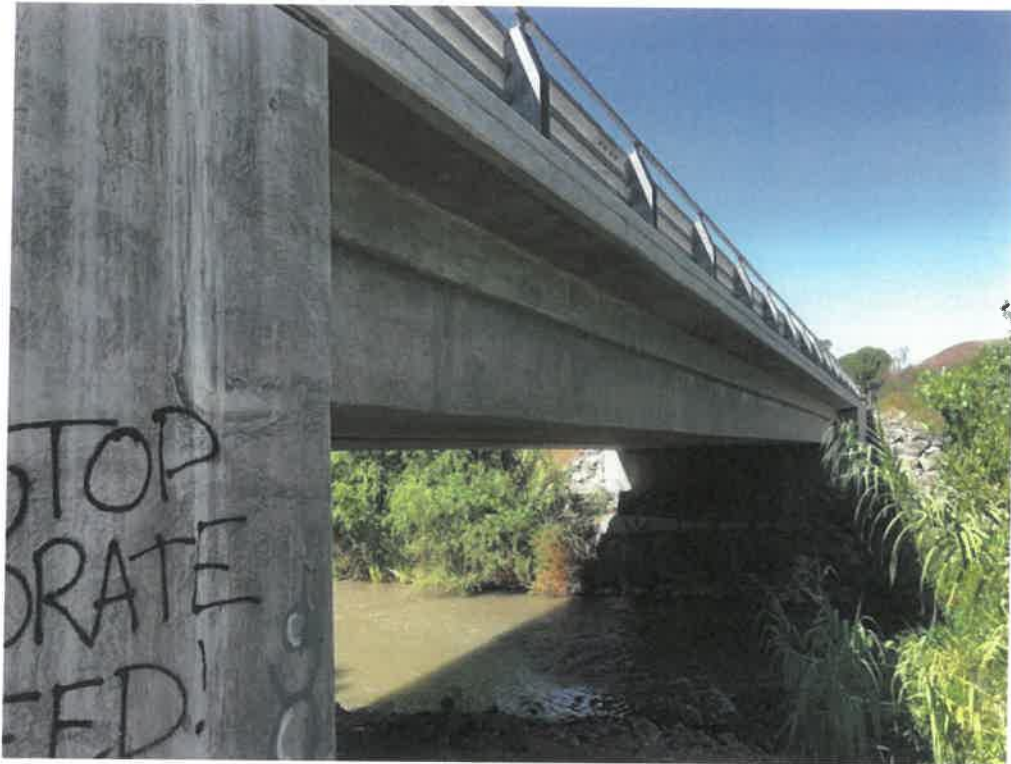
Photo No. 1

Elevation looking southwest

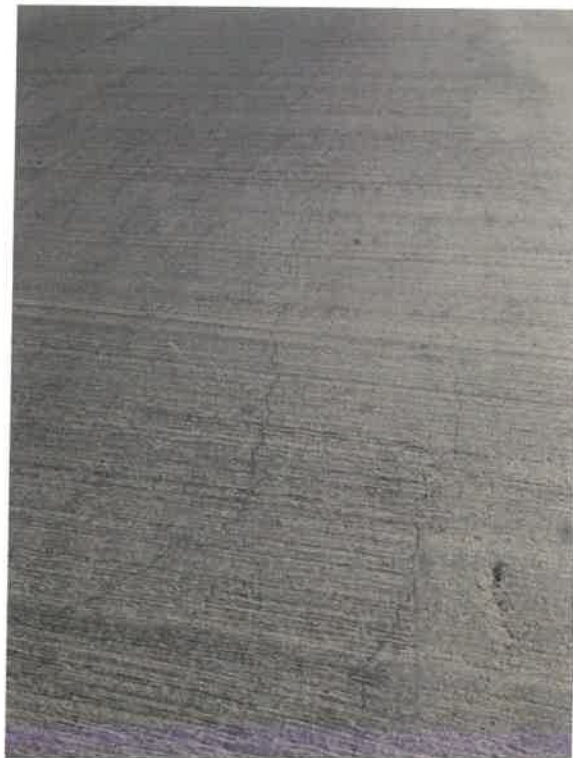
103 - PHOTO> Deck-Details

The deck surface has longitudinal cracks (0.03 inch wide) at 12 inches spacing covering approximately 10 percent of entire deck area. Cracks are concentrated at the easterly 40 feet of the bridge. (48 sq. meters CS2)

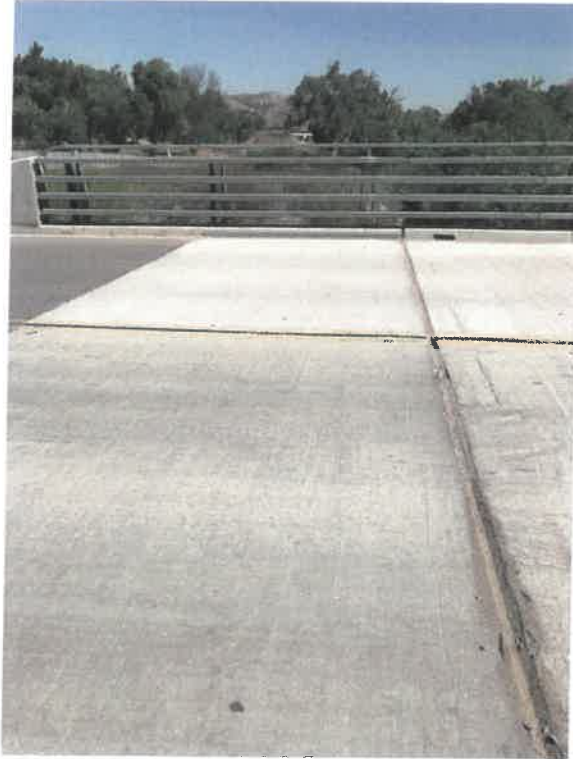
500 - PHOTO> Approach

Both approach slabs has longitudinal cracks along length, 0.03 inch wide. The westerly slab has eight cracks and the easterly slab has two cracks. (10 cracks x 10 feet = 100 square feet, 10 sq. meters CS2)
