**Bridge Report Transmittal Sheet****Batch**    **41415****County of Orange**

**Bridge Number** : 56C0636  
**Facility Carried**: GREEN RIVER DRIVE  
**Location** : 0.1 MI W/O GREEN RIVER R  
**City** :  
**Inspection Date** : 04/28/2018

**Bridge Inspection Report**

**STRUCTURE NAME:** SANTA ANA RIVER (GREEN RIVER GOLF CLUB DR)

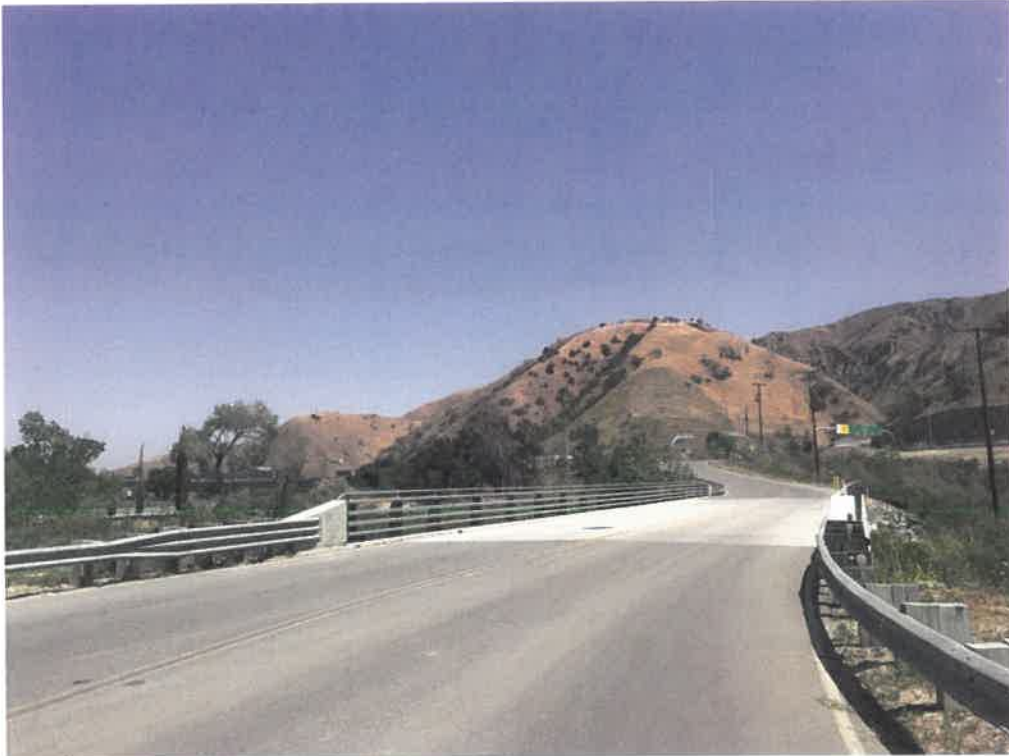
Photo No. 1

Looking easterly standing west of the bridge.

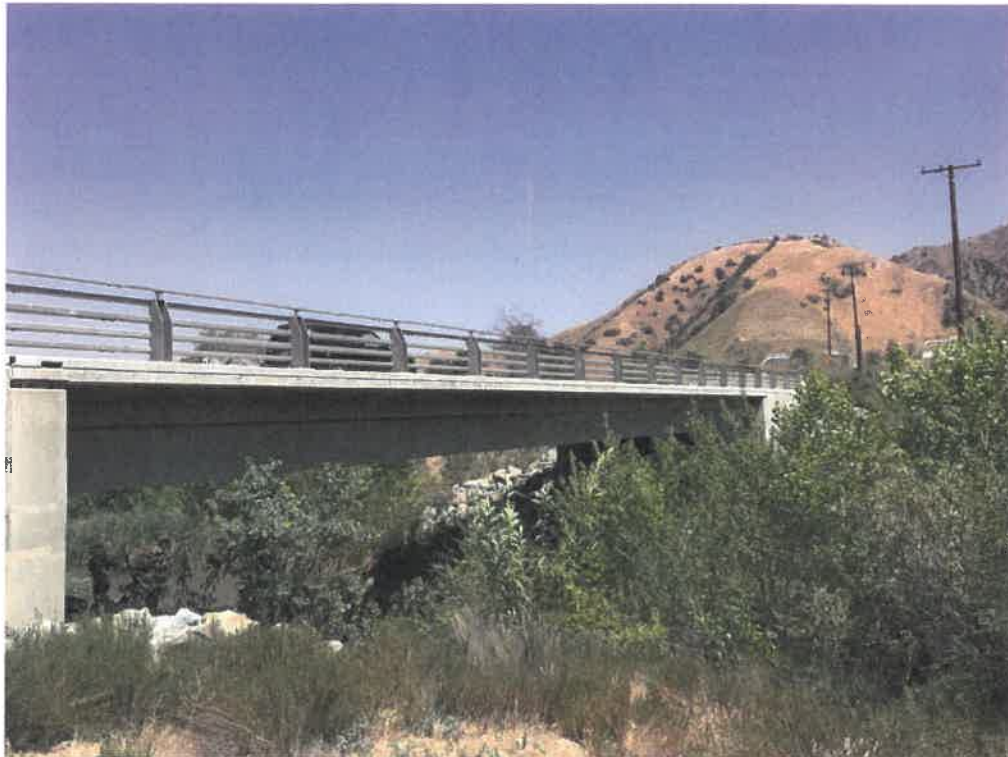
**Photo No. 2**

**Looking northeasterly at south side standing southeast of Abutment 1.**

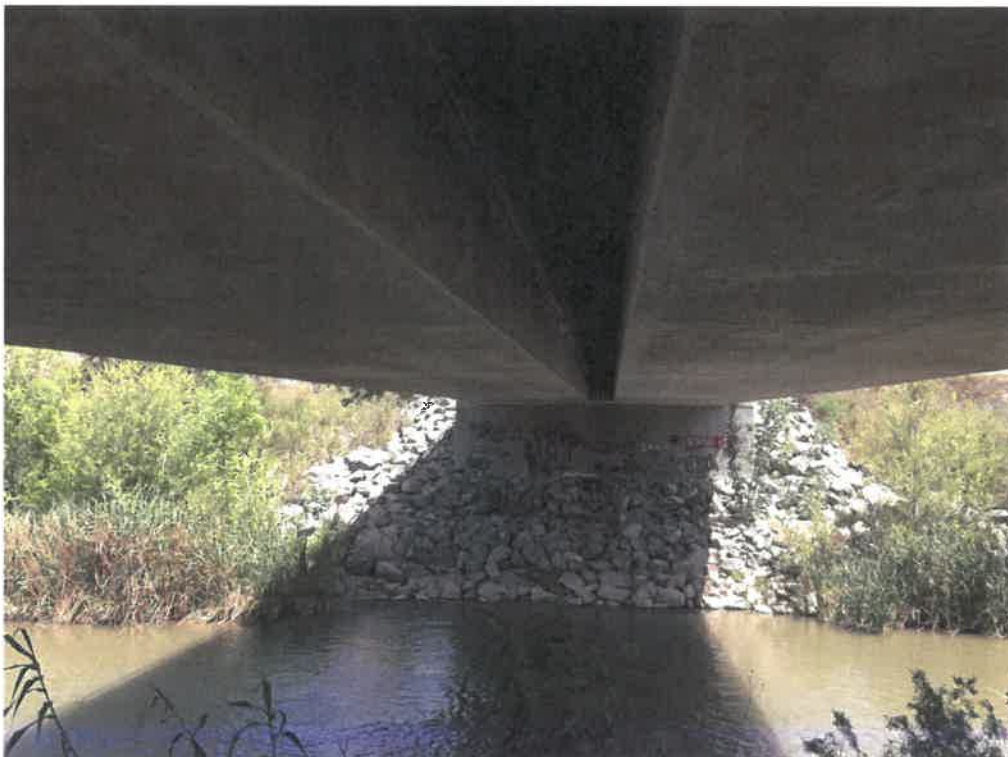
**Photo No. 3**

**Looking easterly toward Abutment 2 standing in front of Abutment 1.**
