Orange County Bridge Review Summary

Bridge Number: 55C0017

Bridge Name: Santa Ana River Channel

Facility Carried: Lincoln Avenue

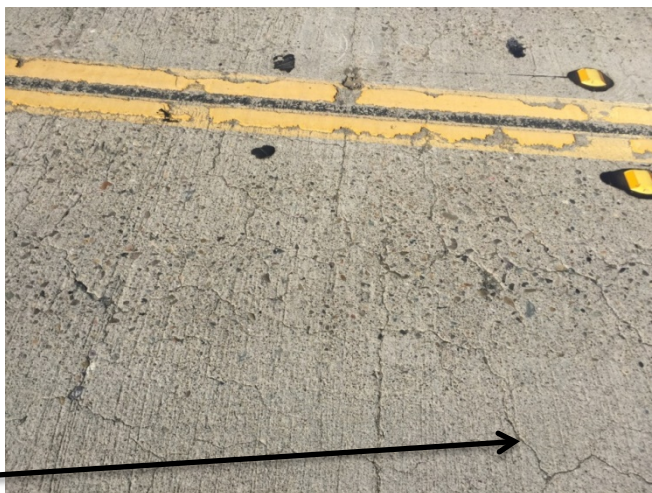
Photo 2:

Deck Cracks

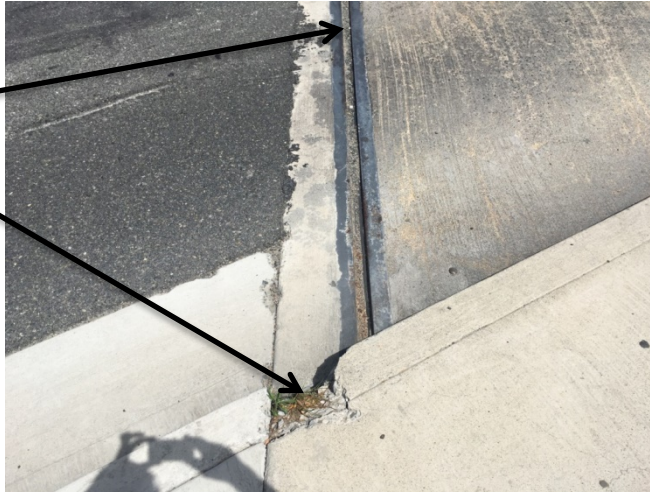
Joint Seal

Spalled Concrete on
Sidewalk

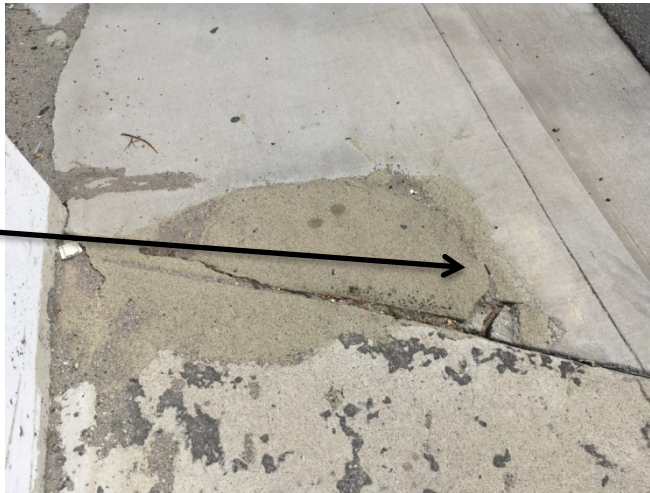
Spalled Concrete

- Monitor existing spalls. Currently very minor, no action needed at this time.

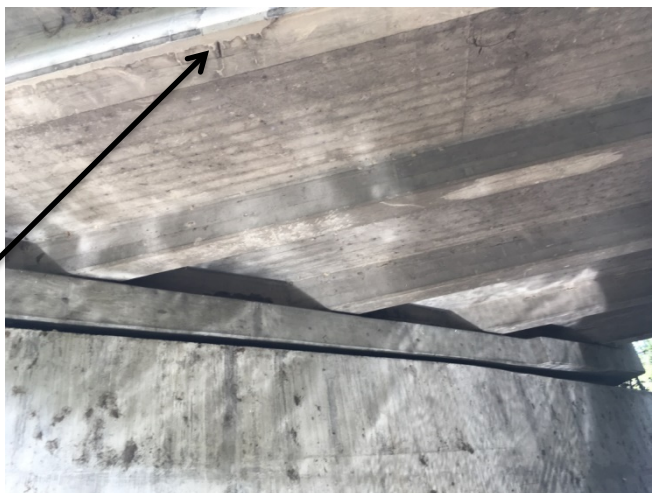
Photo 2: Barrier

Eroded Rebar

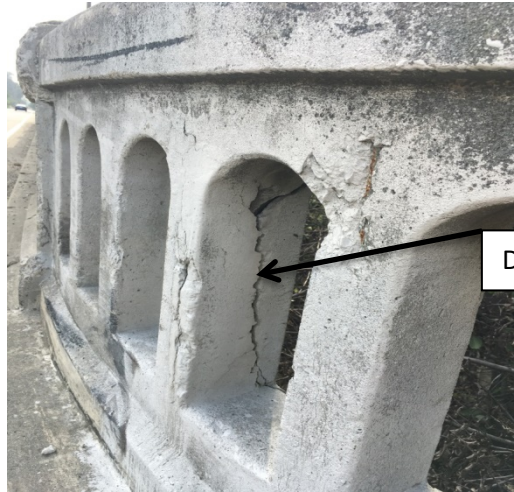
Photo 1: Barrier

Damaged Barrier

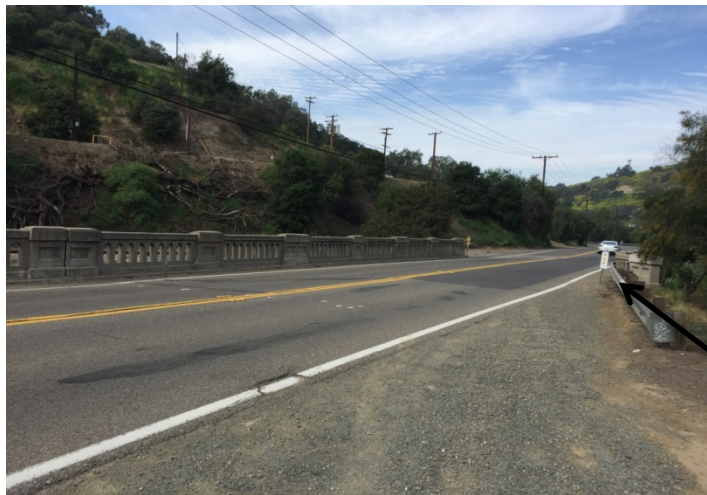
Photo 2: Bridge

Missing P-marker

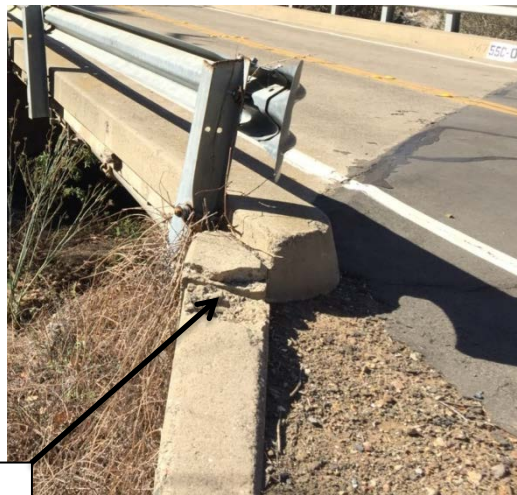
Spalled Concrete

Photo 5: Concrete spalling on wingwall

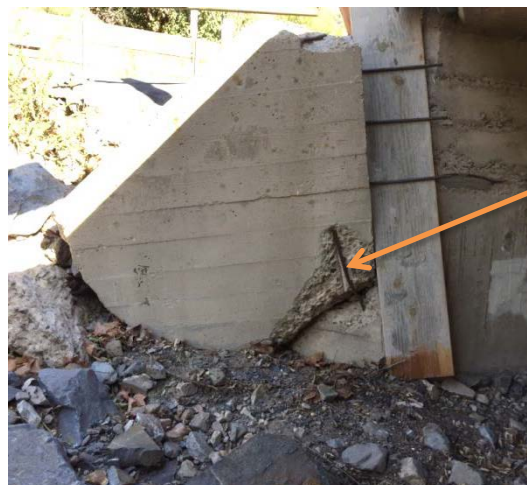
Damaged Wingwall

Photo 6: Broken Wingwall

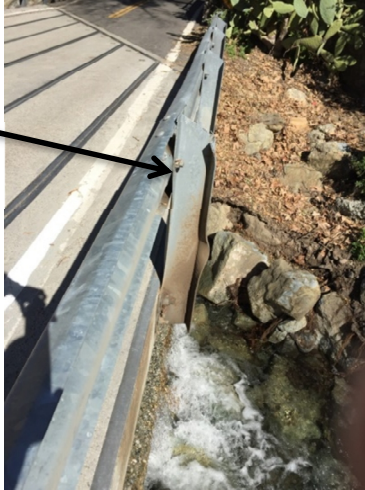
Photo 4: Railing

Damaged Post

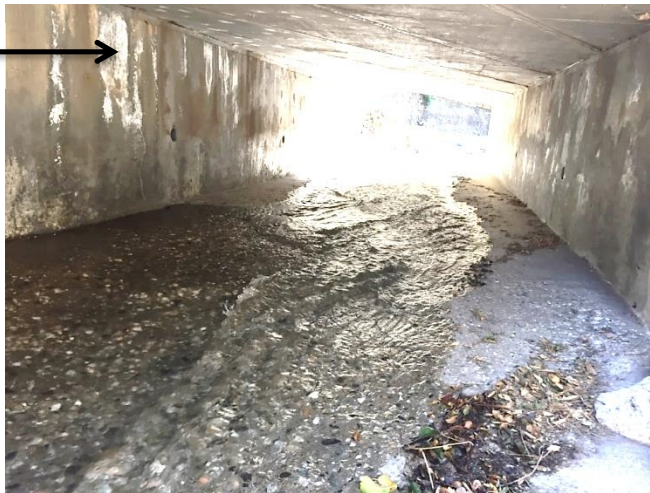
Photo 5:

Water Stains

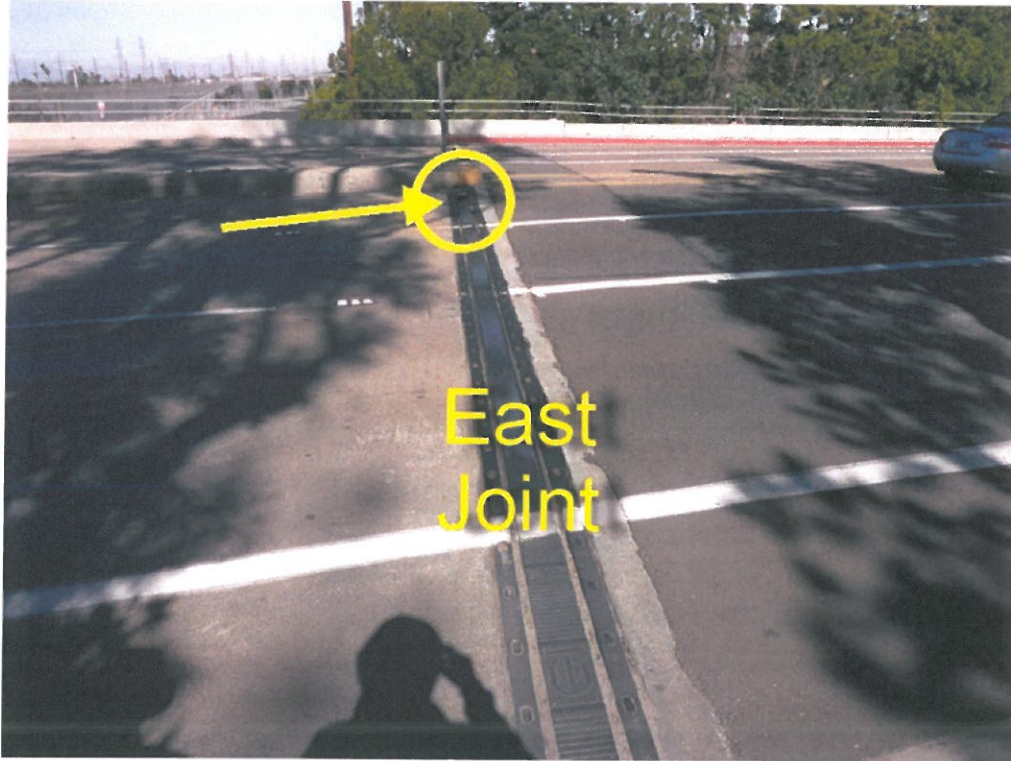
Photo No. 5

East joint is missing 2 feet section at EB lane 1.

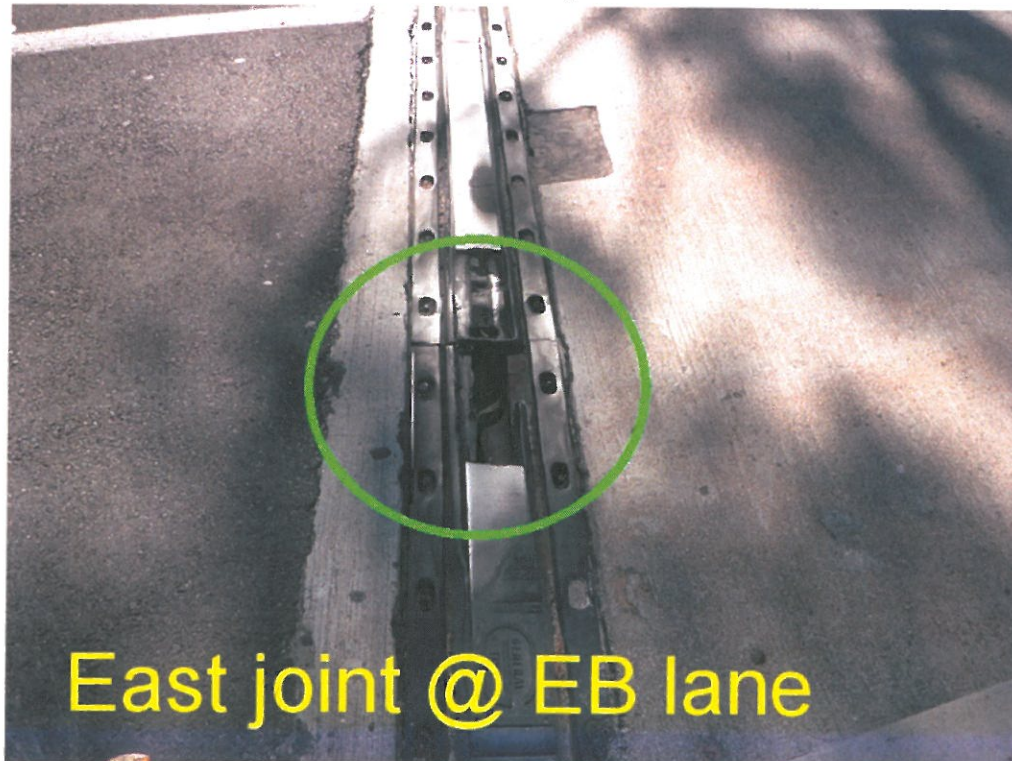
Photo No. 6

East joint is missing 2 feet section at EB lane 1.

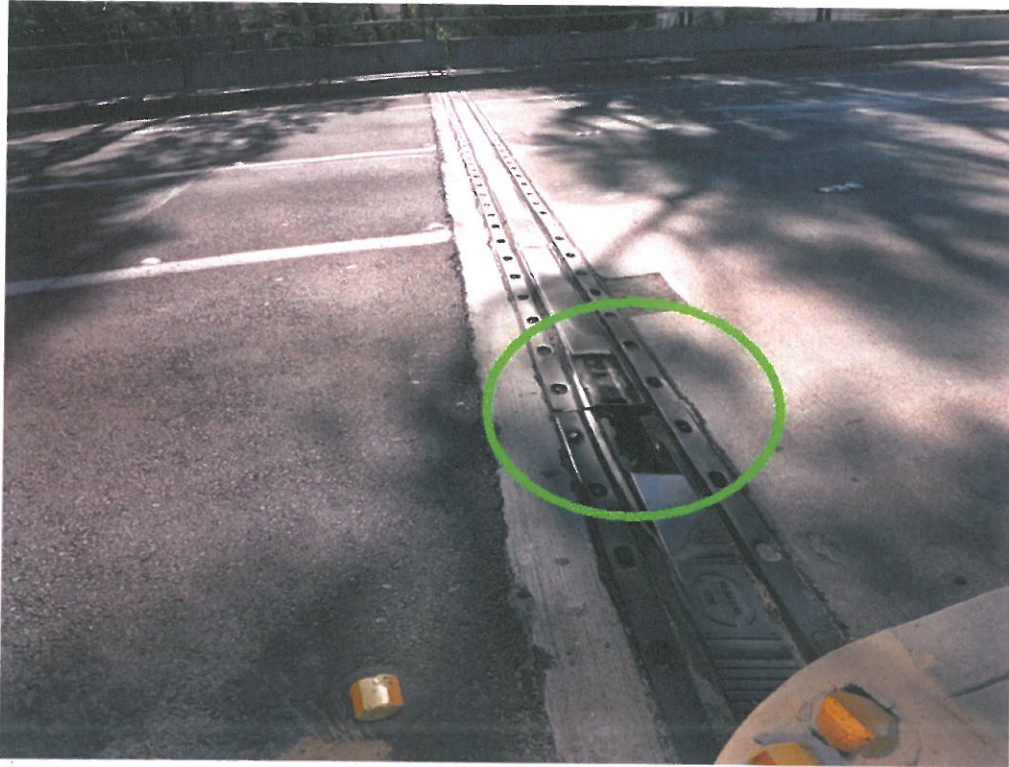
Photo No. 7

East joint is missing 2 feet section at EB lane 1.

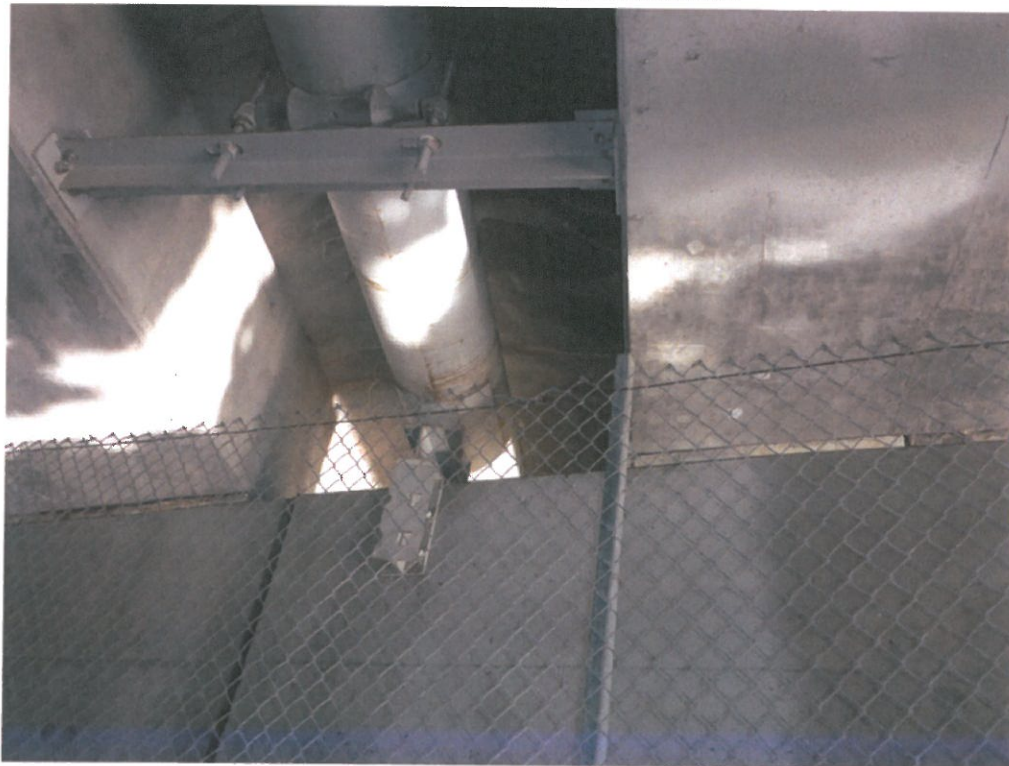
Photo No. 8

Soffit between the 2 box girders has transvrs cracks with white efflorescence at span 4.

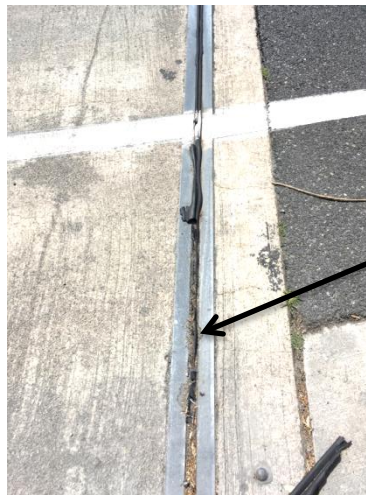
Failed Joint Seal

Photo 5: Failed Joint Seal

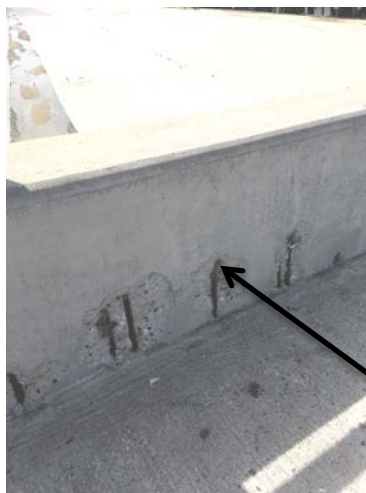
Photo 6: Barrier

Exposed Rebar

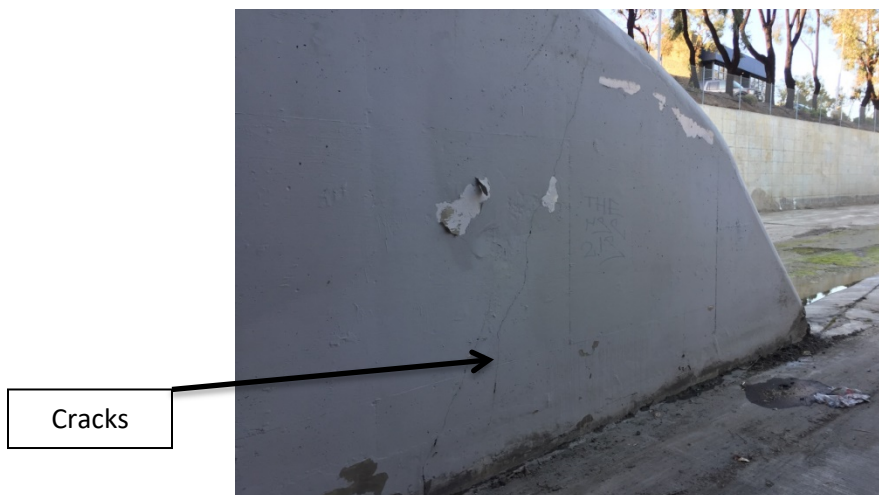
Photo 6:

Cracks

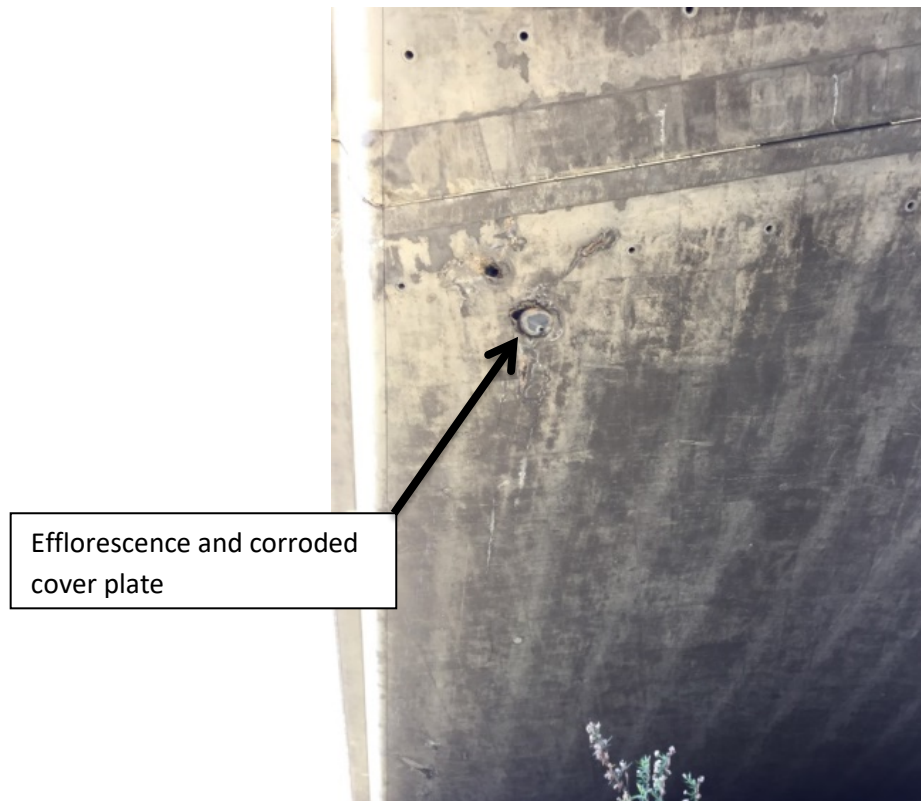
Photo 4: Bridge Soffit showing efflorescence and corroded cover plate

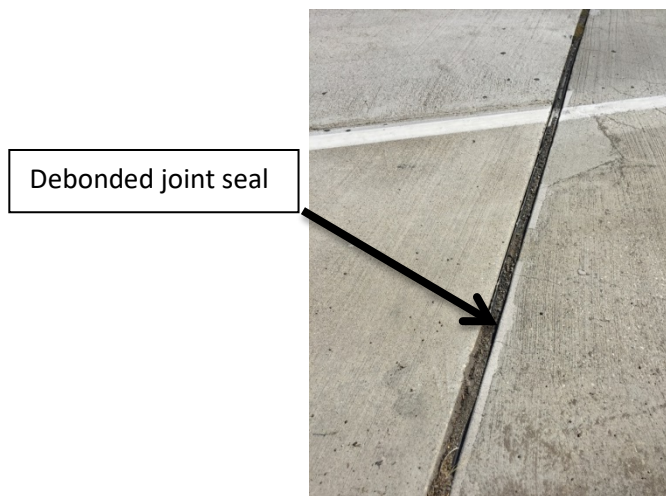
Photo 5: Detached joint seal at north end of bridge
