## **Orange County Bridge Review Summary**

**Bridge Number:** 55C0049

**Bridge Name:** Santiago Creek

**Facility Carried:** Santiago Canyon Road

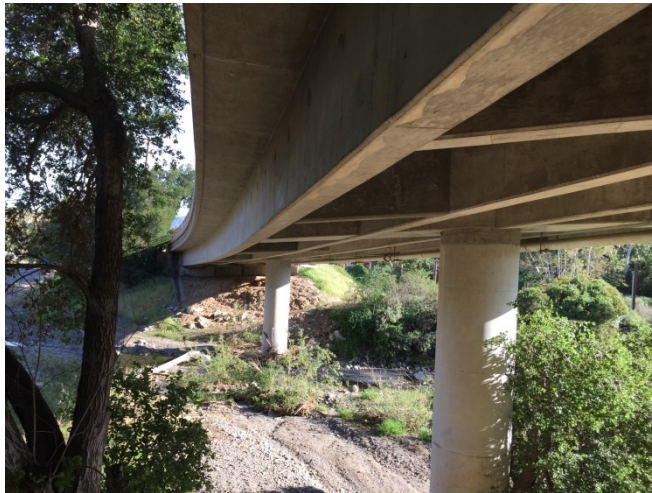
Photo 2:

- Efflorescence is visible on the bridge soffit (photo 3). No immediate action is required but the bridge soffit should continue to be monitored to determine if water is continuing to seep through the bridge deck.
- Confirmed joint seal is in need of replacement. Portions of the joint seal are missing (photo 5).
- No approach slab. It appears there is some AC settlement behind the abutments (photo 2). No immediate action is required but the approach should continue to be monitored.

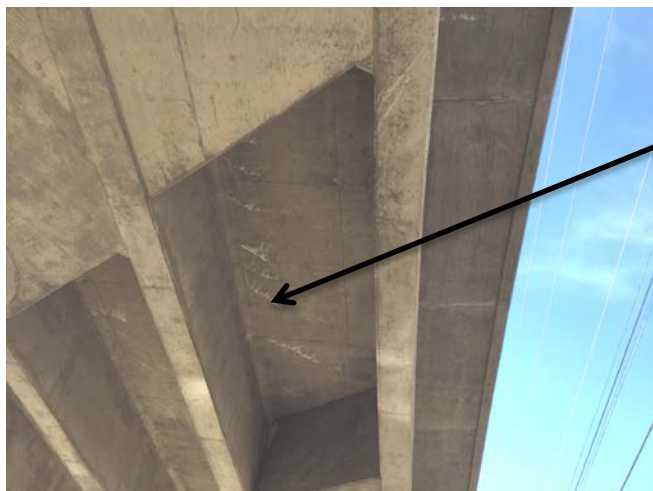
Photo 3: Bridge Soffit

Efflorescence

There are short transverse crack in the soffit 0.5 mm wide by 2 ft long and longitudinal hairline cracks 3ft long with white efflorescence.

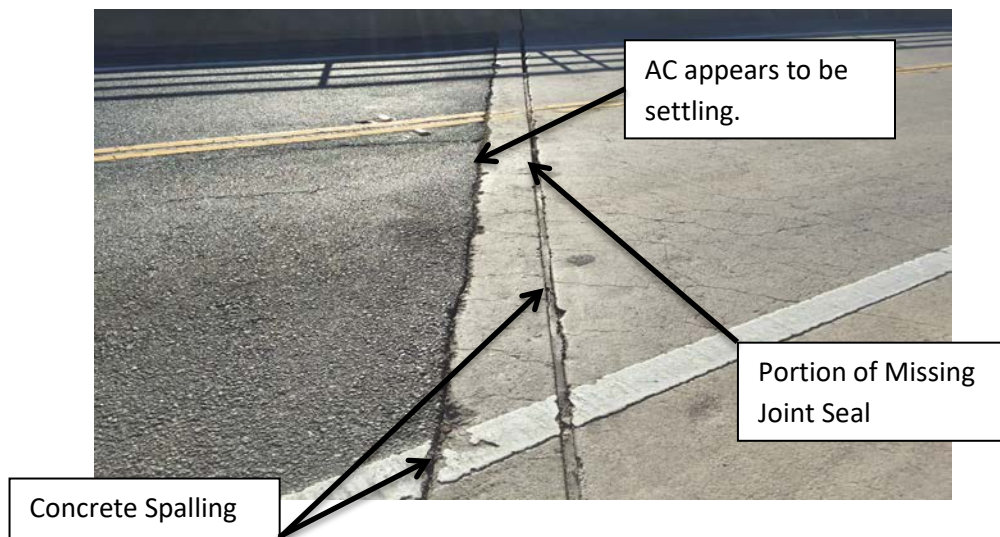
Photo 5: Joint Seal

There are water stain at the abutment wall #4 (north)

There are missing dry and section of the seal

- Repair Abutment 4 joint seal. This is a pourable seal so less extensive work than other joint seal systems.

Replace the joint seal at Abutment 4  
 (north) which is dry and 3 m is missing.
