Orange County Bridge Review Summary

Bridge Number: 55C0059

Bridge Name: William Canyon Creek Year Built: 1970

Facility Carried: Santiago Canyon Road

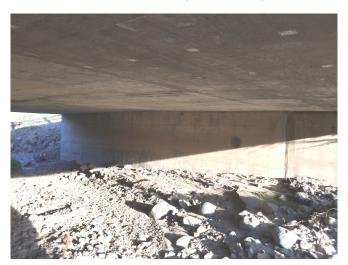
- Little to no efflorescence in bridge soffit (photo 2).
- Deep rutting in deck (photo 3).
- Erosion of embankment by the wing walls (photo 4).

Photo 2: Bridge Soffit

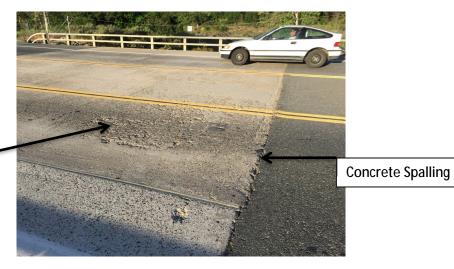
Photo 3: Bridge Deck

Rutting

ELEME	NT INSPECT	ION RATINGS AND NOTES							
	Defect Defe /Prot	ect Element Description	Env	Total Qty	Units		each Co		
38		Slab-RC	2	160	sq.m	80	80	0	0
	1190	Abrasion (PS Conc./RC)	2	80		0	80	0	0
(38-1190)									
There	are wearing	surface of the deck around the tires	line						
215		Abutment-RC	2	48	m	47	0	1	0
	6000	Scour	2	1		0	0	1	0
(215)						1110			
There	were no sig	nificant defects noted.							
(215-6	000)								
There is gully erosion at the southeast wing wall caused by runoff water. The water caused sinkhole $5' \times 4' \times 3'$ at the end of the wing wall in the roadway.									
330		Railing-Metal	2	20	m	20	0	0	0
(330)									
There	were no sig	nificant defects noted.

- Deep rutting in deck may be eligible for deck treatment, such as polyester concrete, since classified as condition state 2.
- Address erosion with fill material and divert water to suitable collection system.

- Polyester Concrete Overlay Estimated Total Construction Cost ≈ \$40,000 (with engineering, traffic control, mobilization and contingency)
- Address erosion ≈ \$6,000

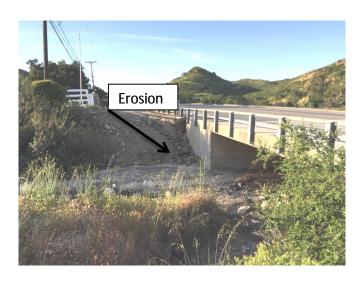
Photo 4: Abutment walls

RecDate: 05/13/2011 EstCost: Provide suitable material at the Action: Drainage Issue StrTarget: 2 YEARS southeast slope next to the winwall to Work By: LOCAL AGENCY DistTarget: prevent future degradation from runoff
