Orange County Bridge Review Summary

Bridge Number: 55C0065

Bridge Name: Limestone Canyon

Facility Carried: Santiago Canyon Road

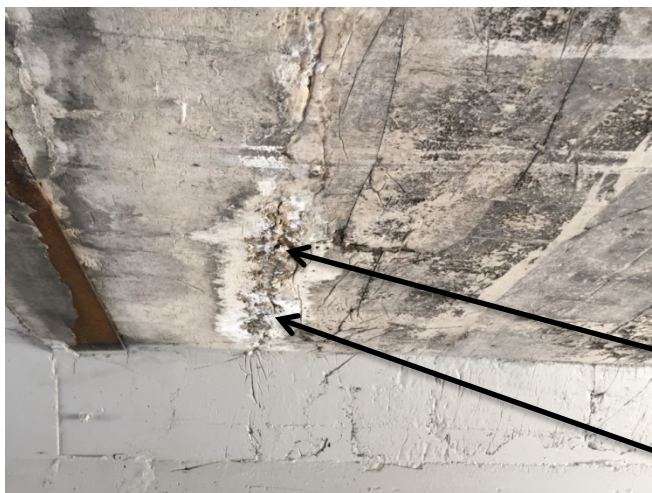
Photo 3: Bridge Soffit

- Cracks and efflorescence visible on soffit (photo 3).
- There appears to be excessive AC overly. Recommend no addition AC lifts on structure.
- Culvert walls appear to be painted (photo 4).
- Confirmed wingwall has separated from structure (photo 6).

- Monitor gap between wingwall and structure. If increases, initiate repair.
- Efflorescence likely from water penetrating through deck. May become more significant over time. To repair will require deck AC removal, deck treatment, and grinding approach AC to conform to lower deck elevation.
- No additional AC should be applied to the deck.

Efflorescence

Soffit Crack

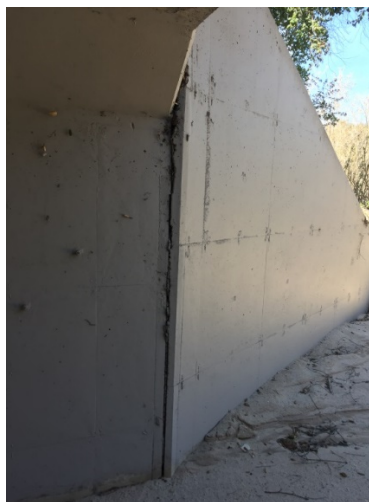
Photo 6:

The northeast wingwall is separated from structure, horizontal movement of 6" at the top and 2" at the bottom, it caused erosion behind the culvert wall and depression in the

- Reconnect Wingwall ≈\$30,000 (includes engineering, mobilization and contingency)
