Orange County Bridge Review Summary

Bridge Number: 55C0097

Bridge Name: Santa Ana River Channel Year Built: 1983

Facility Carried: Talbert/MacArthur

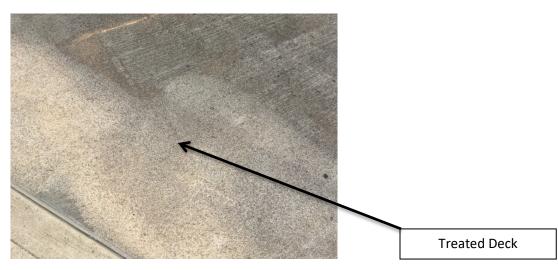
Photo 3: Bridge Deck

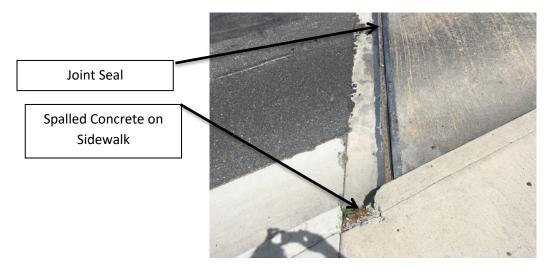
Photo 4: Bridge Deck

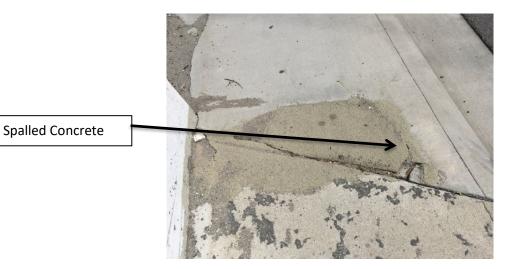
- Very minor spall on concrete railing, exposing rebar, and spalled sidewalk concrete (photos 1 & 5).
- Bridge deck appears to be treated (photo 2).

Photo 5: Sidewalk

Monitor existing spalls. Currently very minor, no action needed at this time.
