Orange County Bridge Review Summary

Bridge Number: 55C0119

Bridge Name: Brea Canyon Channel

Facility Carried: Tonner Canyon Road

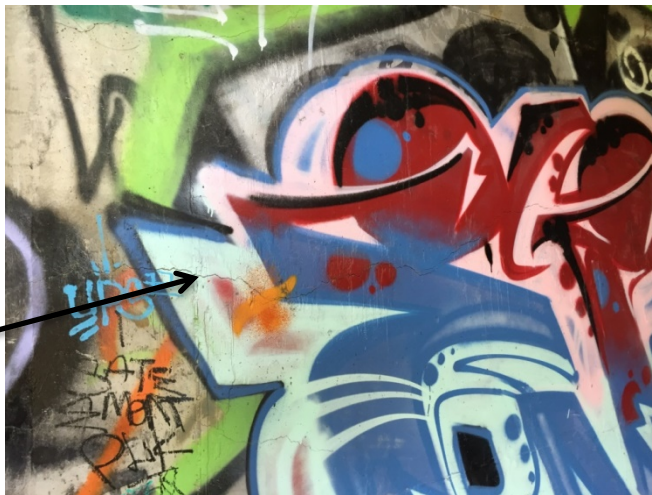
Photo 2: Culvert Wall

- Horizontal cracks on culvert walls. (photo 2)
- Confirmed that the channel bed is over grown with vegetation. (photo 3) Recommend clearing and grubbing channel bed to allow water to flow properly.

Culvert Wall Cracks

There is horizontal crack 2 mm wide 6 ft long at the south end of wall #1.

- Recommend monitoring cracks on culvert walls. Seal if further deterioration is observed.
Existing cracks do not currently pose major maintenance issue.

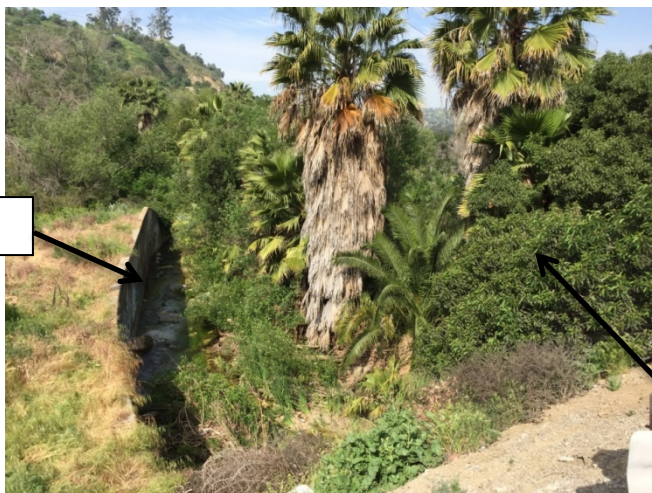
Photo 3: Brea Canyon Channel

Culvert headwall

Overgrown Vegetation

Remove the bushes and trees from the channel bed within 30 meters of the bridge to allow the water to flow properly.
It is growing back.
