## **Orange County Bridge Review Summary**

**Bridge Number:** 55C0121

**Bridge Name:** Brea Canyon Channel

**Facility Carried:** Brea Canyon BLVD

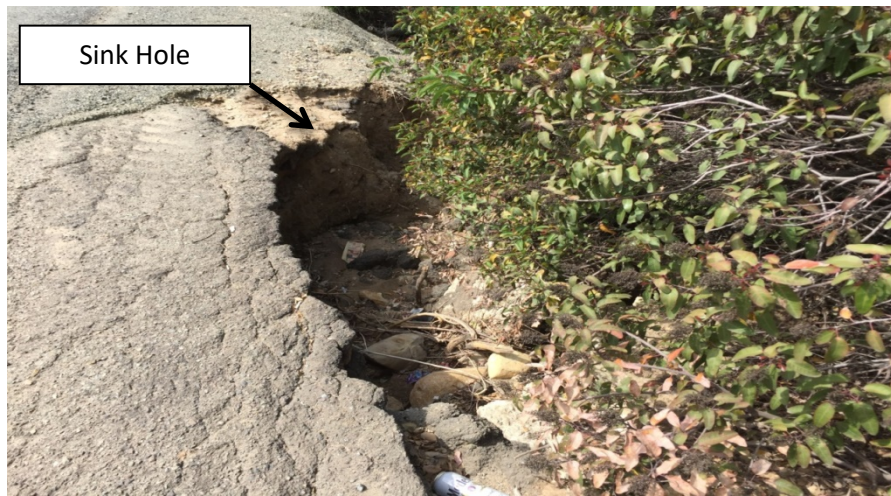
Photo 1: Edge of Pavement

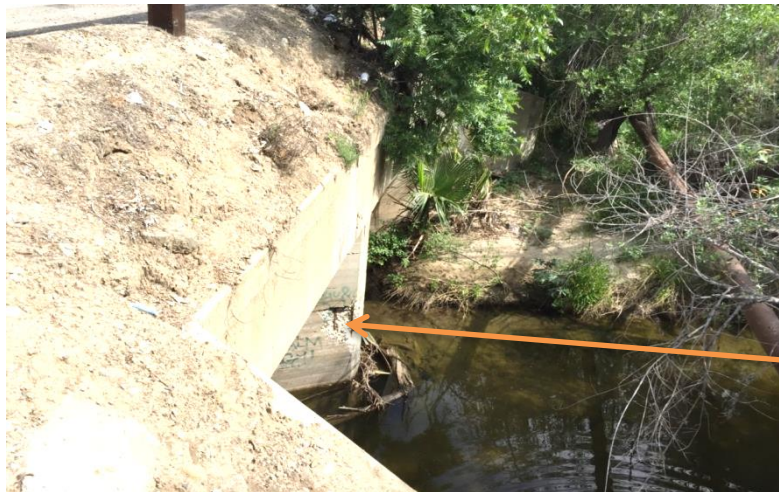
- There was limited access to the substructure.
- Exposed rebar on pier wall (photo 2).
- Confirmed vegetation overgrowth in channel. Recommend clearing and grubbing the channel.
- Portion of road is being undermined. Recommend removing portion of AC and filling and reconstructing the eroded slope. Investigate if roadside drainage pattern is causing erosion.
- Rutting at power pole. Recommend filling eroded slope. (photo 3)

Photo 2: Bridge Pier

| Elem No. | Defect /Prot | Defect | Element Description | Env | Total Qty | Units | Qty in each State | Condition | State |
|---|---|---|---|---|---|---|---|---|---|
| There is 10' x 2' x 2" spall in the west side at the north end with exposed rebars and delamination in the east side of the northend of the peirwall #2 | | | | | | | | | |

- Repair spalled pier wall. This should be performed soon to prevent additional corrosion of reinforcement.

- Recommend patching spalled concrete on pier wall.

Repair the spall and delamination at the north side of the pier wall west face of the wall 3 m x 0.6 m x 50 mm spall and at the east face of the wall the delamination area 3 m x 0.5 m.

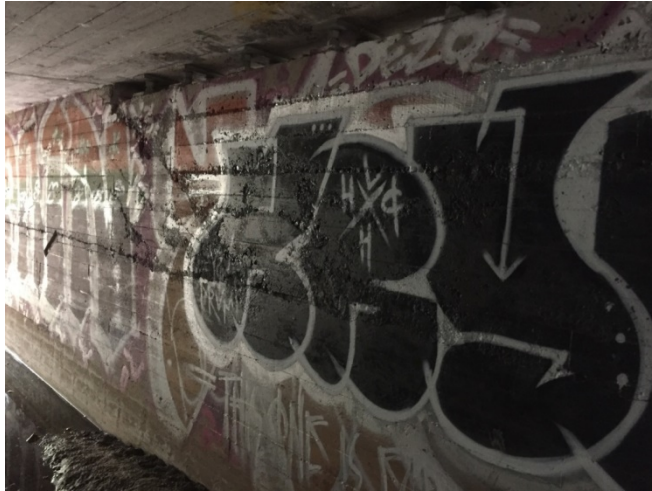
Photo 4: Pier Wall
