## **Orange County Bridge Review Summary**

**Bridge Number:** 55C0122

**Bridge Name:** Brea Canyon Channel

**Facility Carried:** Brea Canyon BLVD

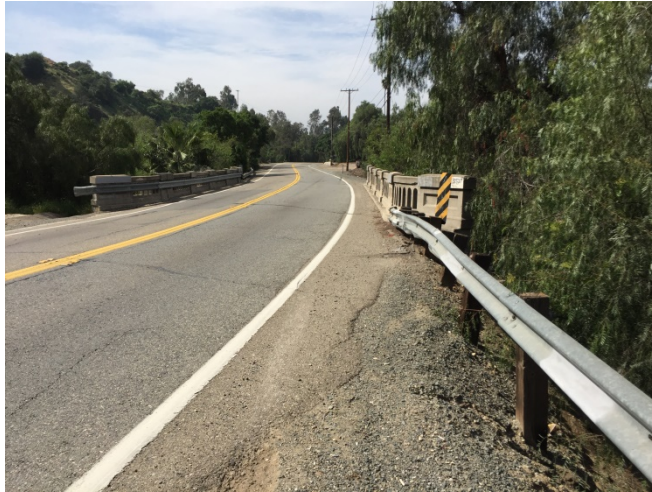
Photo 1:

- Confirmed that the concrete railing has been damaged (photo 1).
- Soffit efflorescence visible. This is indicative of water seepage through deck cracks (photo 2).
- Excessive AC on deck, which will reduce load capacity and long-term bridge health. Recommend no additional AC overlay, and County may consider removing some of the AC.
- Exposed rebar on girder soffit (photo 2).
- Vegetation overgrowth in channel and on Pier 2.
- Bird nests visible on bridge overhang (photo 3 and 4). Work may need to take place outside the bird-nesting season.

Damaged Railing

Most rail balusters have been cracked or spalled in both rail side. the end concrete rail post at the northwest quadrant is broken.

RecDate: 05/30/2007	EstCost:	Repair the damaged rail.
Action : Railing-Repair	StrTarget: 2 YEARS	The west end post of north is damaged;
Work By: LOCAL AGENCY	DistTarget:	there was 1" wide vertical cracks from
Status : PROPOSED	EA:	top to the bottom of footing. It may
		cause by vehicular hit.
		There are about 56 cracks or spalls in
		the concrete baluster railings.

- Recommend patching spalls in concrete baluster railings.
- Efflorescence likely from water penetrating through deck. Recommend sealing deck. Not significant problem at this time. To repair will require deck AC removal, deck treatment, and grinding approach AC to conform to lower deck elevation.
- Recommend patching spalled concrete for exposed rebar on girder soffit.
- Recommend clearing and grubbing overgrown vegetation in channel and Pier 2.

- Bridge barrier repair likely not eligible for BPMP funding since the repair work will not bring railing up to current standards. Cost to repair delaminated barrier and soffit concrete and patch ≈\$35,000 (includes engineering, traffic control, mobilization and contingency)
- Clearing and Grubbing
- Deck sealing not critical at this time.

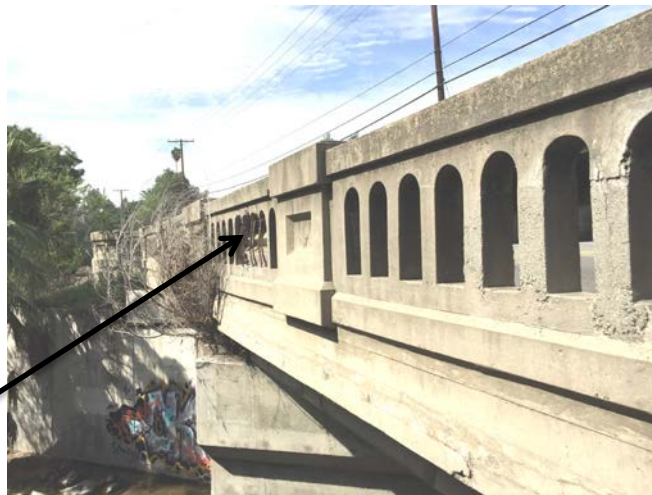
Photo 2: Barrier

Eroded Rebar
