## **Orange County Bridge Review Summary**

**Bridge Number:** 55C0168

**Bridge Name:** Handy Creek

**Facility Carried:** Amapola Avenue

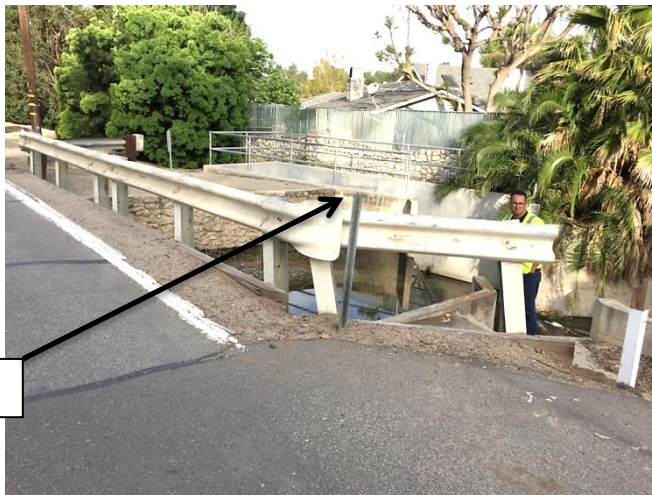
Missing P-marker

Photo 2: Bridge

- Replace P-marker

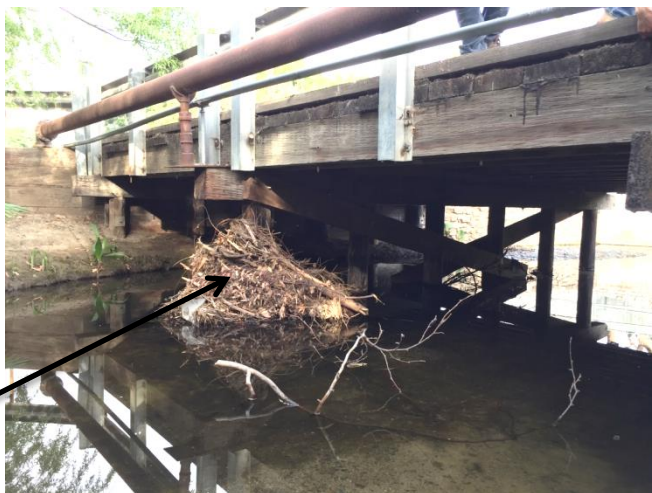
Debris build up

Photo 3: Debris build up on timber columns
