## **Orange County Bridge Review Summary**

**Bridge Number:** 55C0173

**Bridge Name:** Santiago Creek

**Facility Carried:** Modjeska Canyon Rd

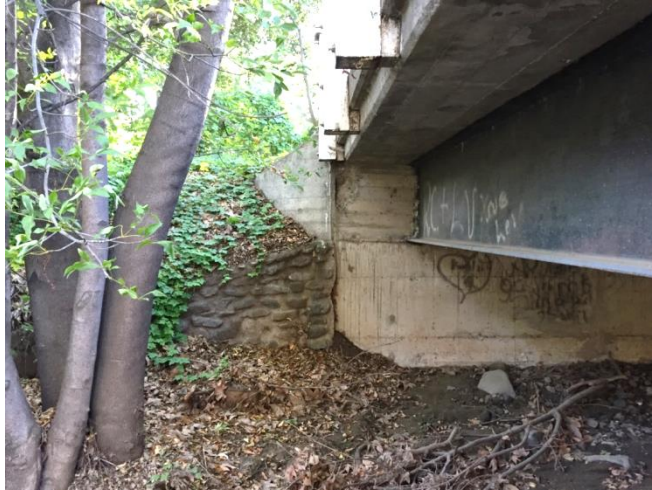
- Chained deck to check for delamination. Minor delamination found, recommend repairing.
- Light rust (mill scale) on girders. Recommend monitoring. No work necessary at this time.
- Drainage from the southeast house by the bridge is causing erosion issues. Recommend relocating drain.
- Concrete spall at abutment

Photo 4: Abutment View

- Repair spalled concrete
- Estimated Total deck treatment Construction Cost ≈ \$30,000 (with engineering, traffic control, mobilization and contingency)

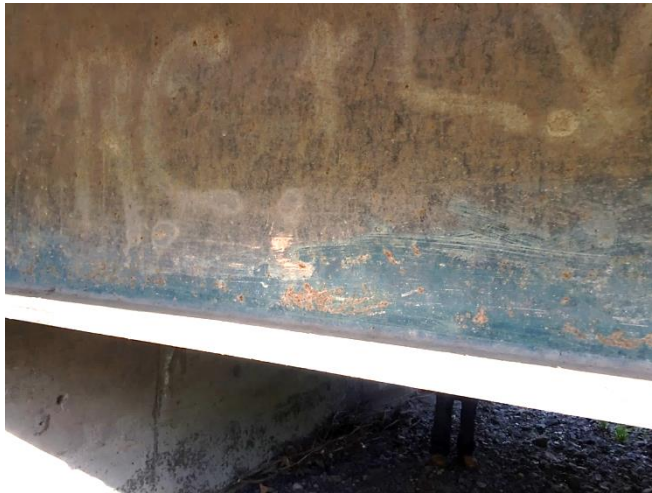
Photo 5: Bridge Girder

The paints are chalking and lost pigments at the edges.

- Monitor rust on girders. Not a critical issue in foreseeable future.
