## **Orange County Bridge Review Summary**

**Bridge Number:** 55C0176

**Bridge Name:** Silverado Canyon Creek

**Facility Carried:** Kitterman Drive

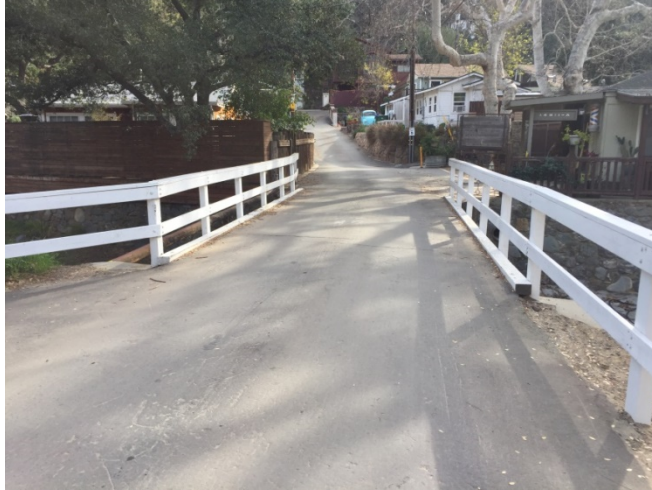
Photo 1: AC Deck

AC exhibits transverse cracks full width and 1" wide.

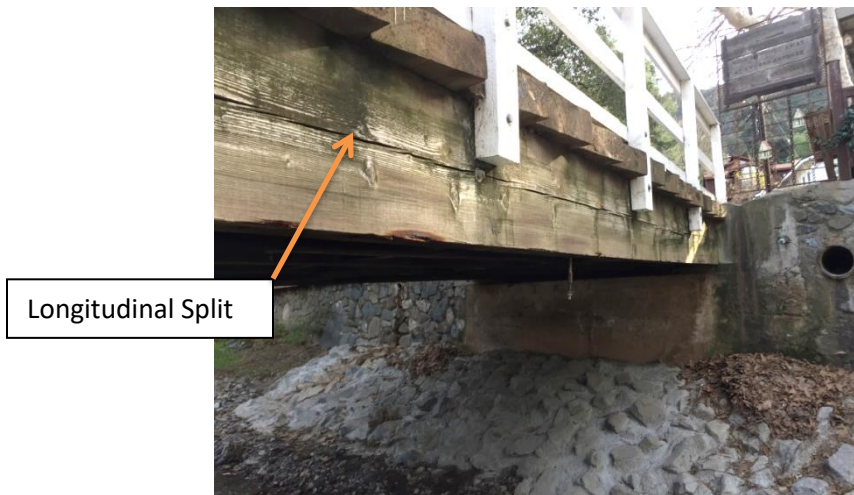
Photo 2: Exterior Stringer with longitudinal split

There is a longitudinal horizontal split up to 3 mm wide in the westerly face of the west exterior girder.
