Orange County Bridge Review Summary

Bridge Number: 55C0179

Bridge Name: Silverado Canyon Creek

Facility Carried: Silverado Canyon Road

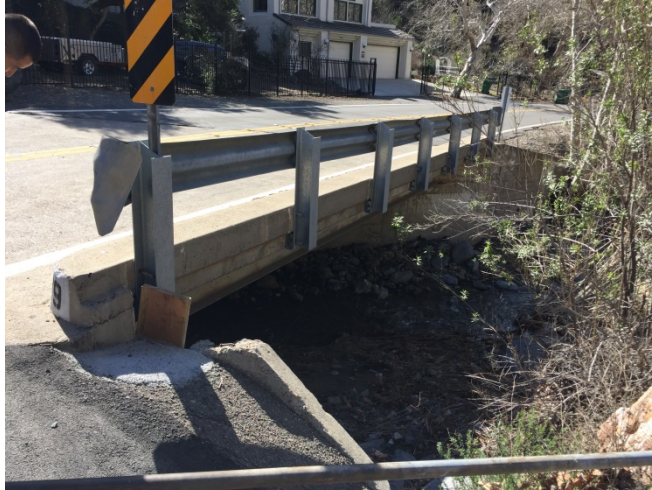
Photo 1: Silverado Canyon Creek Bridge

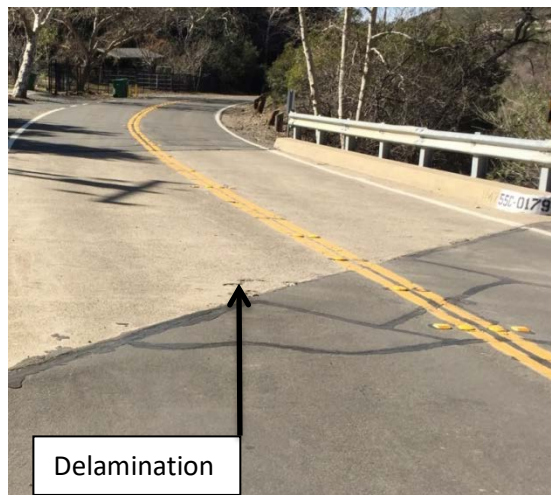
Photo 2: Concrete Delamination on bridge deck

- * 90% light scaling due to weather and aging.
- * two areas of unsound concrete +/- 1 ft X 1 ft at the north shoulder at 10 ft and 20 ft from the east end.
- * few transverse cracks up to 1.5 mm wide and up to 10 ft long in both lanes.

- Deck cracking condition is coded condition state 1, so deck treatment not eligible for BPMP funding.
- Repair damaged barrier posts.
- Remove and patch delaminated concrete at bridge north end. Considered low priority, and patch spalled concrete at the southeast wingwall.

- Remove delaminated concrete and patch ≈ \$15,000.
- Repair broken wingwall ≈ \$25,000.
- Spot Paint girders ≈ \$25,000. Possibly much higher if existing paint contains lead.

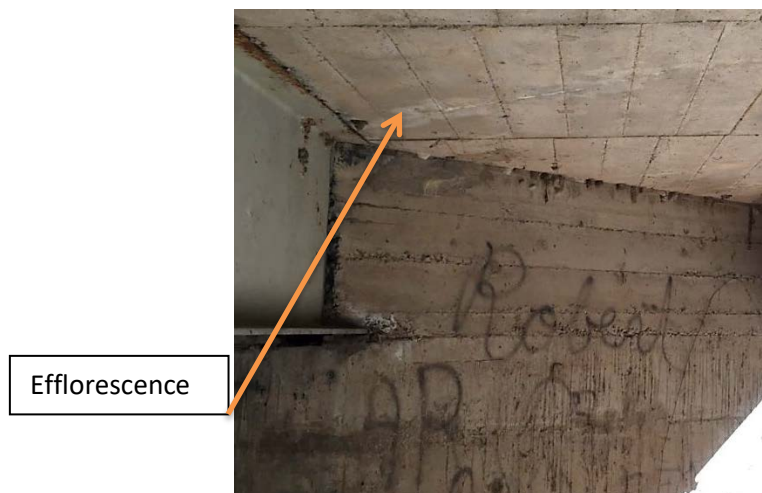
Photo 3: Efflorescence on Bridge Soffit

There were transverse cracks with white efflorescence, 2 cracks in every bay of the soffit.

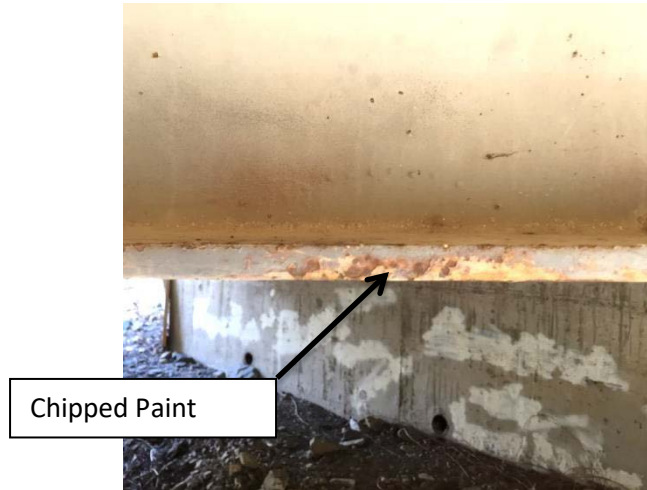
Photo 4: Paint chipping on grinder flange

Freckled rust is forming on the steel girders without corrosion.

- Because bridge railing does not meet current standards it is not eligible for funding. Caltrans can be contacted to determine if barrier upgrade can be performed, though typically also not eligible.
- Though not specifically covered in BPMP, petition Caltrans to fund broken wingwall repair.
- Spot paint steel girders.

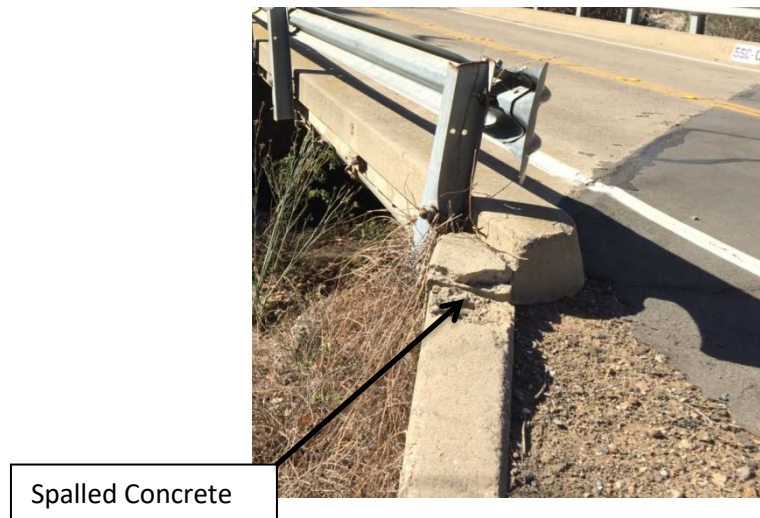
Photo 5: Concrete spalling on wingwall

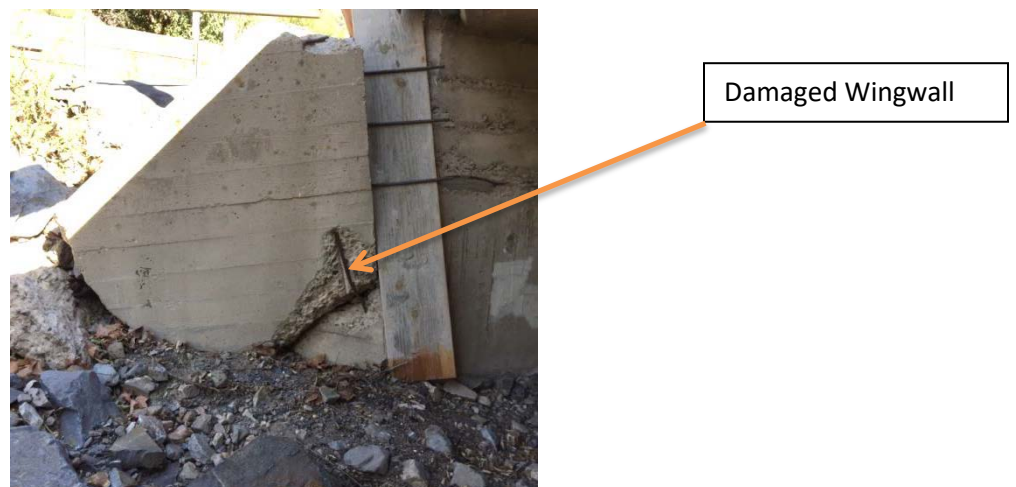
Photo 6: Broken Wingwall

The wing wall adjacent to the north end of the east abutment has broken off at the base and tilted, this condition is old condition and does not appear to have any effect on the structure.

Remove the broken wing wall at the north east corner and replace it within kind.

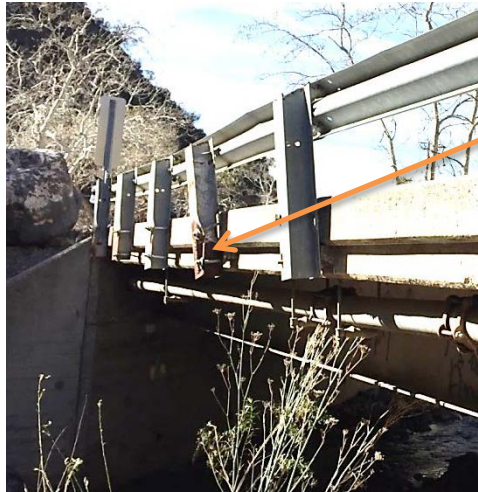
Damaged Post

Photo 7: Damaged Metal Post

There is missing a metal post and two damaged metal posts in the southerly bridge railing.

- Repair Damaged Railing ≈ \$15,000.

Replace the missing metal post and the
two damaged metal posts in the southerly
bridge railing.

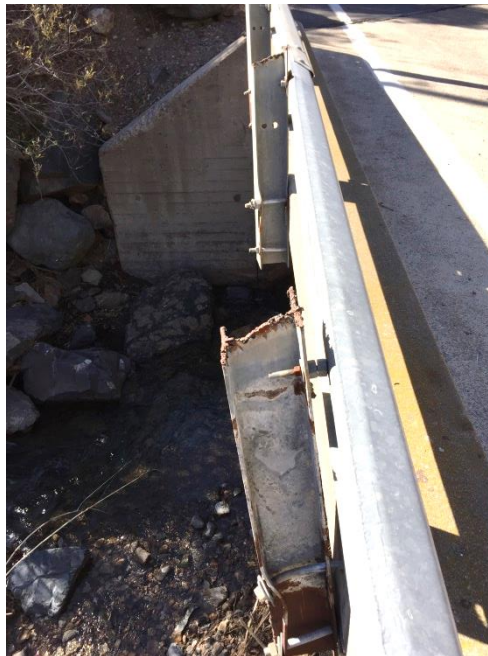
Photo 8: Broken Post
