Orange County Bridge Review Summary

Bridge Number: 55C0181

Bridge Name: Silverado Canyon Creek

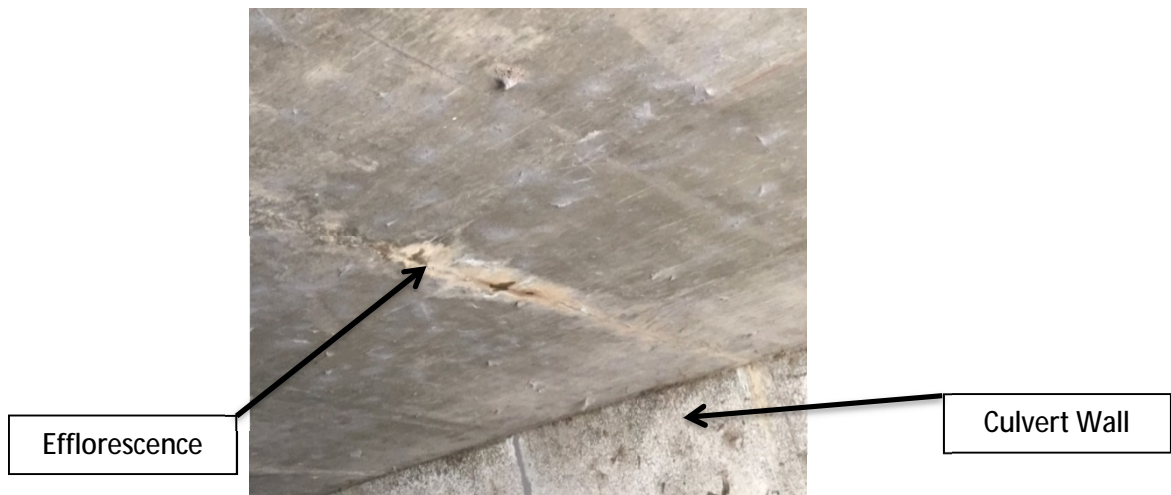
- Minor efflorescence visible on soffit, this is indicative of water seepage through deck cracks (photo 2). There were no visible deck cracks. The deck has a few inches of AC overlay.
- Exposed retaining wall and bridge footing (photo 3). Caltrans BIR indicates the scour is not an issue and scour mediation not needed.
- There are several railing timber post missing (photo 4). Top of timber posts appear to be rotting. Recommend replacing the missing posts. Note that this work is not eligible for BPMP reimbursement since the barrier does not meet current barrier rail standards.

Photo 2: Bridge Soffit

The soffit exhibits 5 longitudinal cracks full length from abutment to abutment with white and brown efflorescence.

- Replace railing timber posts.
- Efflorescence likely from water penetrating through deck. Not significant problem at this time. Condition must worsen to be eligible for BPMP funding. To repair will require deck AC removal, deck treatment, and grinding approach AC to conform to lower deck elevation.

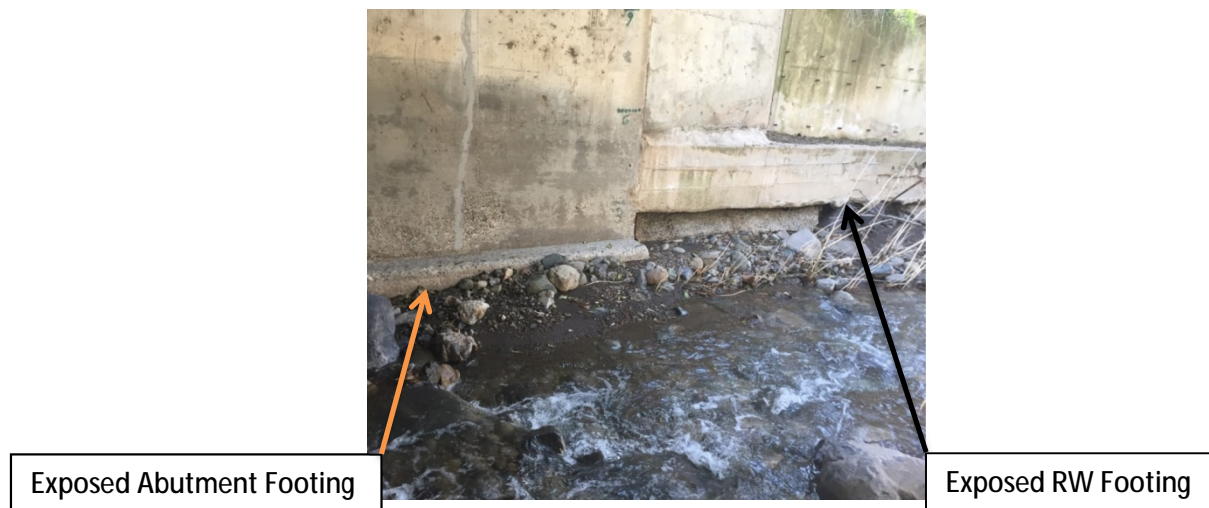
Photo 3: Exposed footing

The bottom of the westerly spread footing is exposed at its northerly terminus.

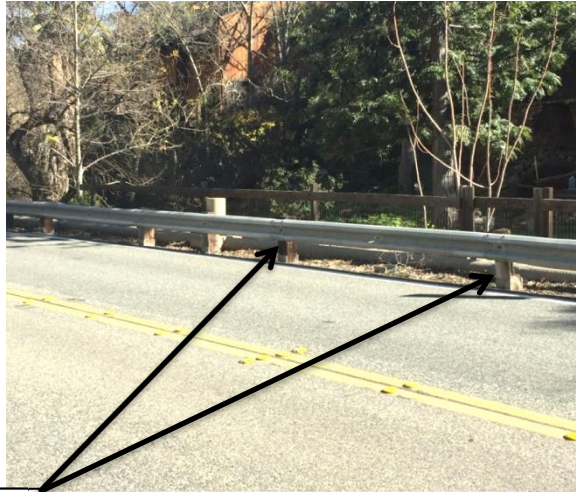
Missing Posts

Photo 4: Missing post

South rail is missing two timber posts #3 and #7 (counting from west); and post #8 (from west) has decay and section loss.

- Replace Railing Timber Posts Repair Spalls < \$10,000 (includes engineering, traffic control, mobilization and contingency)

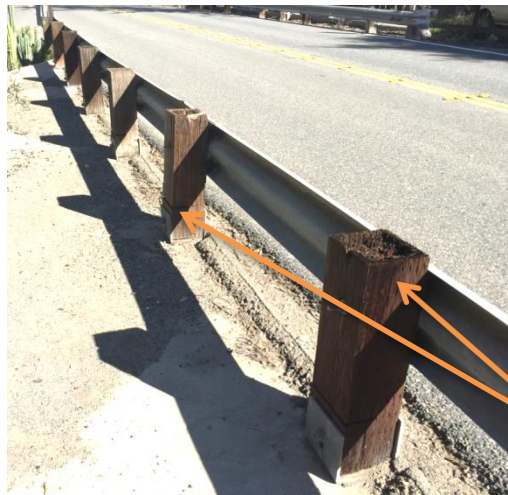
Rotting Posts

Photo 5: Rotting post

At north rail, posts 3,4,6 and 7 (counting from west) are decayed from to the top.
