Orange County Bridge Review Summary

Bridge Number: 55C0182

Bridge Name: Silverado Canyon Creek

Field Inspection Observations

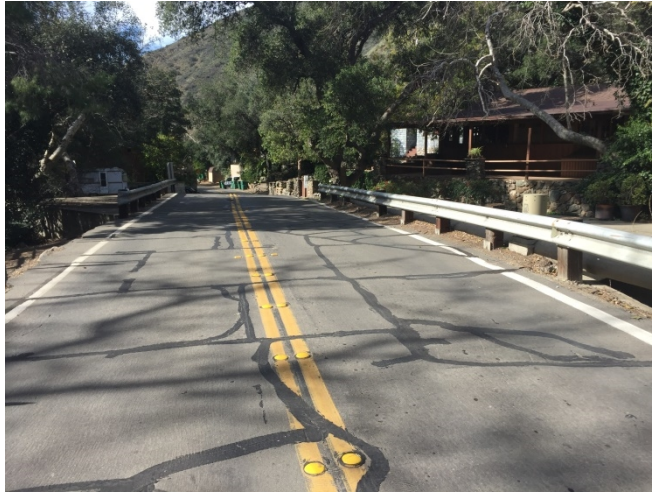
Photo 1: Silverado Canyon Creek Road Bridge

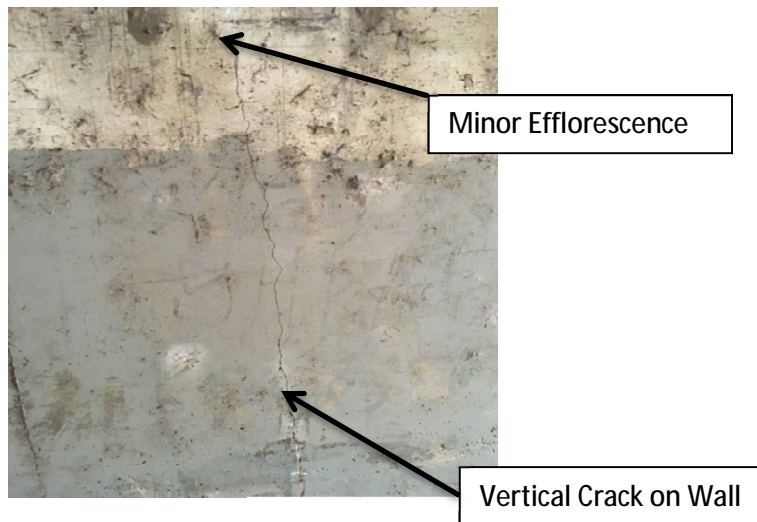
Photo 2:

- Bottom of retaining wall is exposed due to erosion and lower portion of wingwall is broken (photo 4 and 5).
- Minor efflorescence visible on vertical cracks along walls (photo 2) and soffit.
- Rock pocket above wall drain (photo 6). Recommend Patching
- Confirmed missing timber posts. Top of railing post are rotting. Recommend replacing missing and rotting posts. Note this work is not eligible for BPMP reimbursement.

- Replace railing timber posts.
- Efflorescence likely from water penetrating through deck. Not significant problem at this time. Condition must worsen to be eligible for BPMP funding. To repair will require deck AC removal, deck treatment, and grinding approach AC to conform to lower deck elevation.
