Orange County Bridge Review Summary

Bridge Number: 55C0188

Bridge Name: Silverado Canyon Creek

Facility Carried: Thisa Way

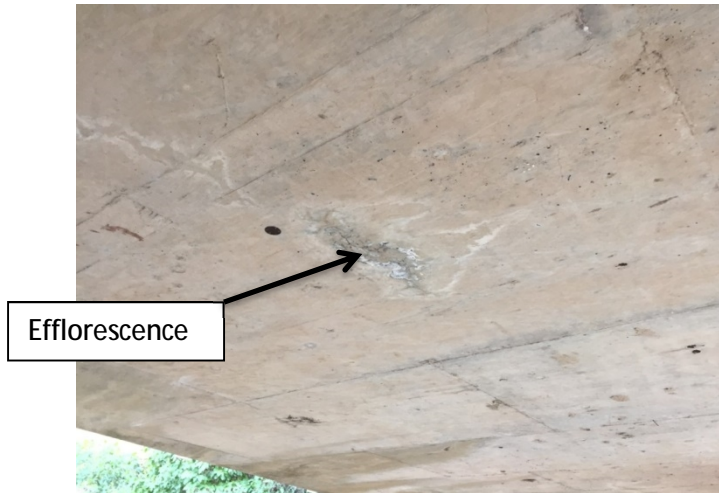
- Retaining walls at the southwest end of bridge have been undermined. Rip rap is fully grouted and is failing. The northeast embankment is eroding. Recommend repairing erosions measures. (photo 5 and 6).
- Minor efflorescence visible on soffit (photo 4).
- Vegetation growth at abutments (photo 7).

- Efflorescence likely from water penetrating through deck. Not significant problem at this time. Condition must worsen to be eligible for BPMP funding. To repair will require deck AC removal, deck treatment, and grinding approach AC to conform to lower deck elevation.

Photo 4: Bridge Soffit

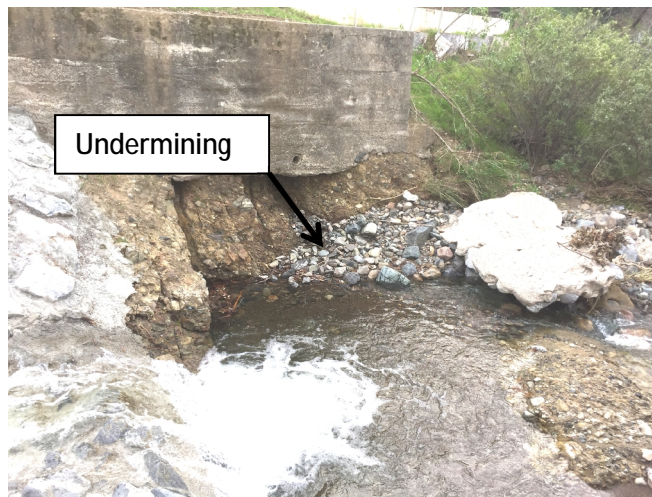
Photo 5:

The streambed has degraded 6 ft immediately downstream of the concrete culvert cut off wall at the thalweg. The cut off wall is protected at the downstream banks with grouted rock rip rap. The grouted rock rip rap at the northwesterly quadrant has been undermined up to 3 ft at its downstream terminus. It seems there is no change in the downstream condition since 1999

- Repair scour countermeasures.

- Repair scour mitigation measure ≈ \$50,000 (with engineering, mobilization and contingency)

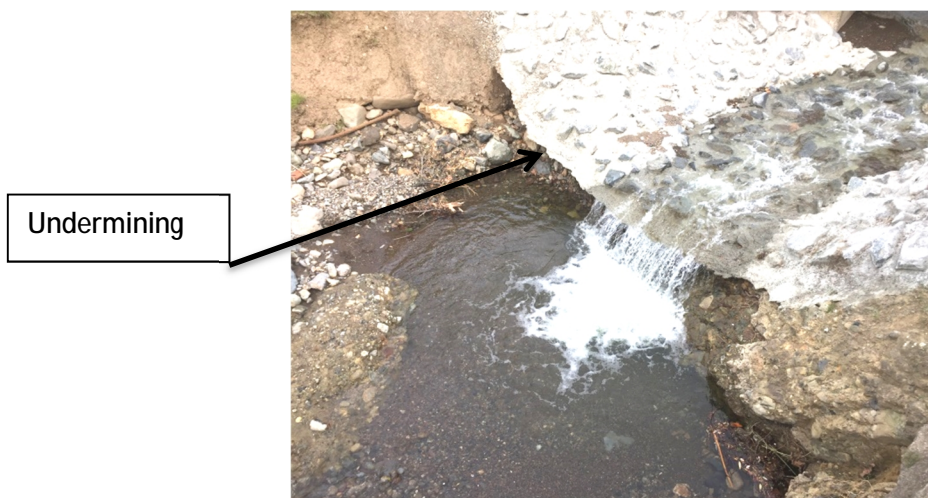
Photo 6: Slope Protection

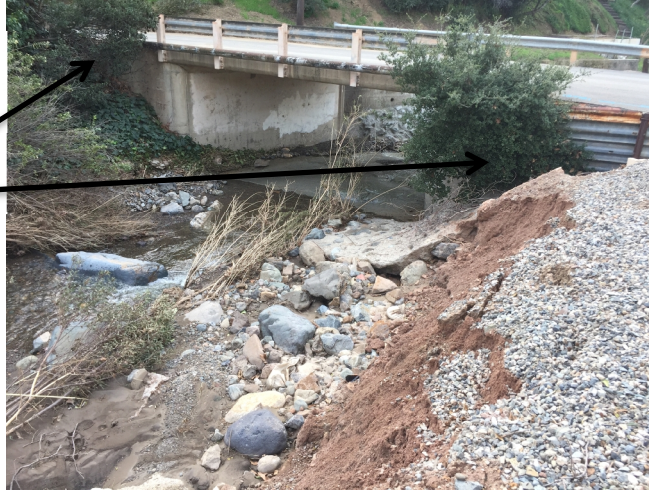
Vegetation growth
at abutment

Photo 7: Embankment Erosion
