Orange County Bridge Review Summary

Bridge Number: 55C0205

Bridge Name: Santa Ana Delhi Channel

Facility Carried: Santa Ana Avenue

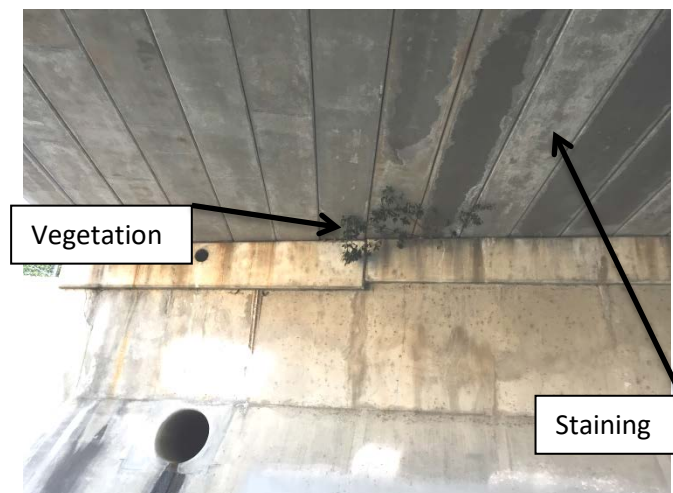
Photo 3: Abut 1

- Efflorescence and water stains are visible on bridge soffit. The bridge deck has several inches of AC therefore the condition of the bridge deck cannot be assessed.
- Confirmed that there is vegetation growing at abutment 1 (photo 3).
- There appears to be 8-10" of asphalt concrete. Recommend that no additional AC be placed on the bridge deck, and consider removing some of existing AC.
- Concrete spalling on exterior girder (photo 4).
- There is exposed sheathing at abut face (photo 5).

There is a tree growing at the seat of Abutment 1 under slab unit 9 (counting from east).

- Remove vegetation at abutment 1.

Remove the small tree that are growing in
Abutment 1 seat.
