Orange County Bridge Review Summary

Bridge Number: 55C0344

Bridge Name: Santa Ana River (Adams Ave)

Bridge Inspection Report

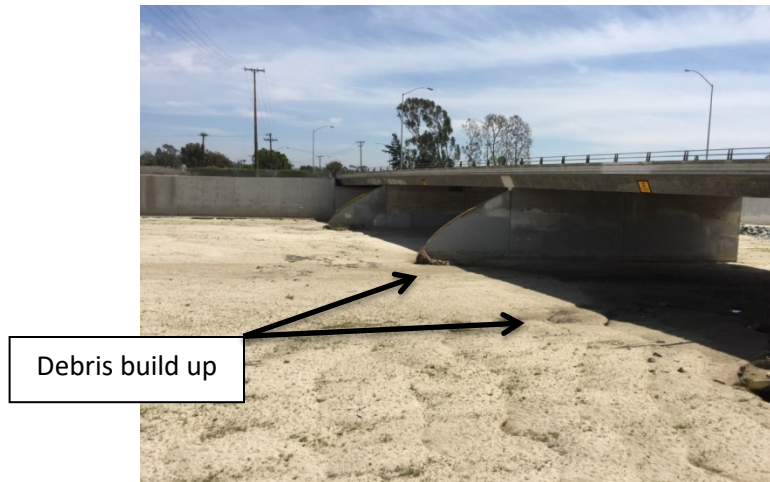
Photo 1: Elevation View

- There was no access to the substructure. The piers were visually inspected from the access road (photo 1).
- Bridge deck appears to have been treated.
- Exposed reinforcement in concrete barrier.
- Debris build up on pier nosing.

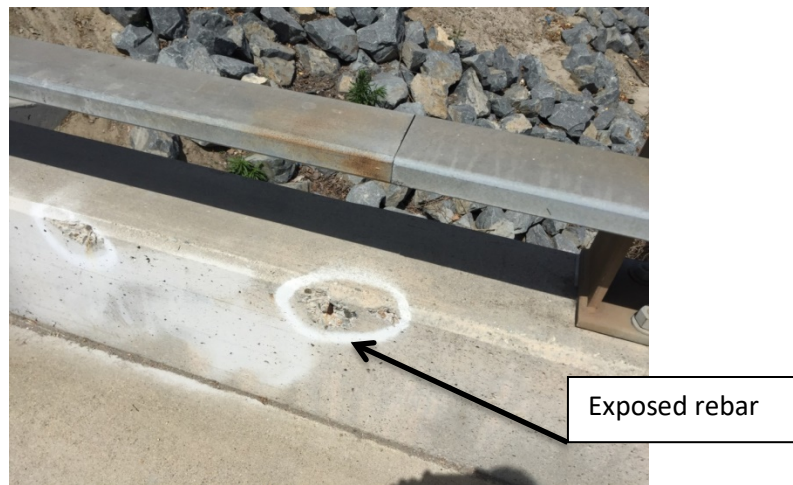
Photo 2: Barrier

- Small spall around reinforcement bar on barrier. Not structural and no action needed at this time.

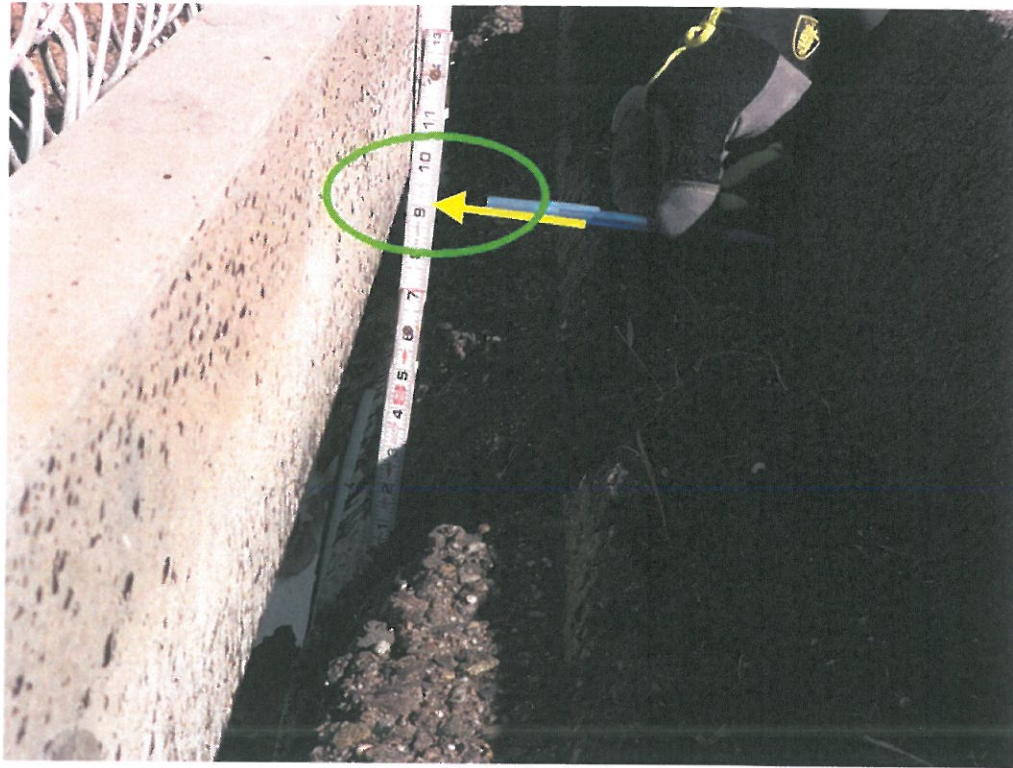
Photo No. 1

Ac thickness at the west side is almost 9 inches.

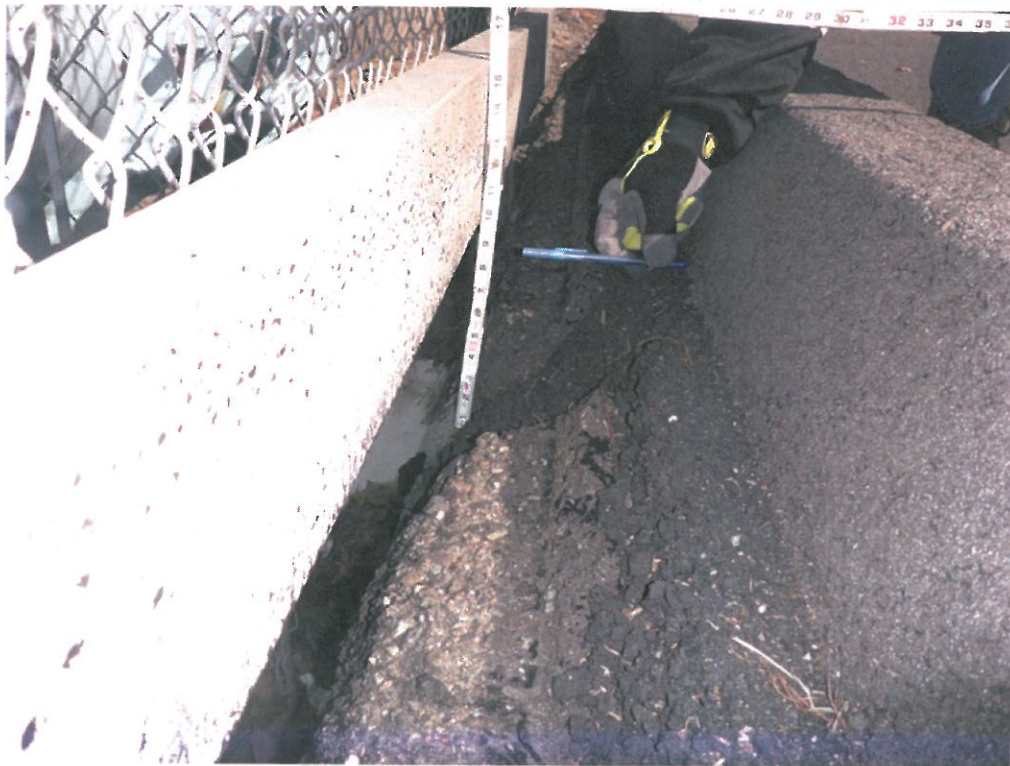
Photo No. 2

Ac thickness at the west side is almost 9 inches.

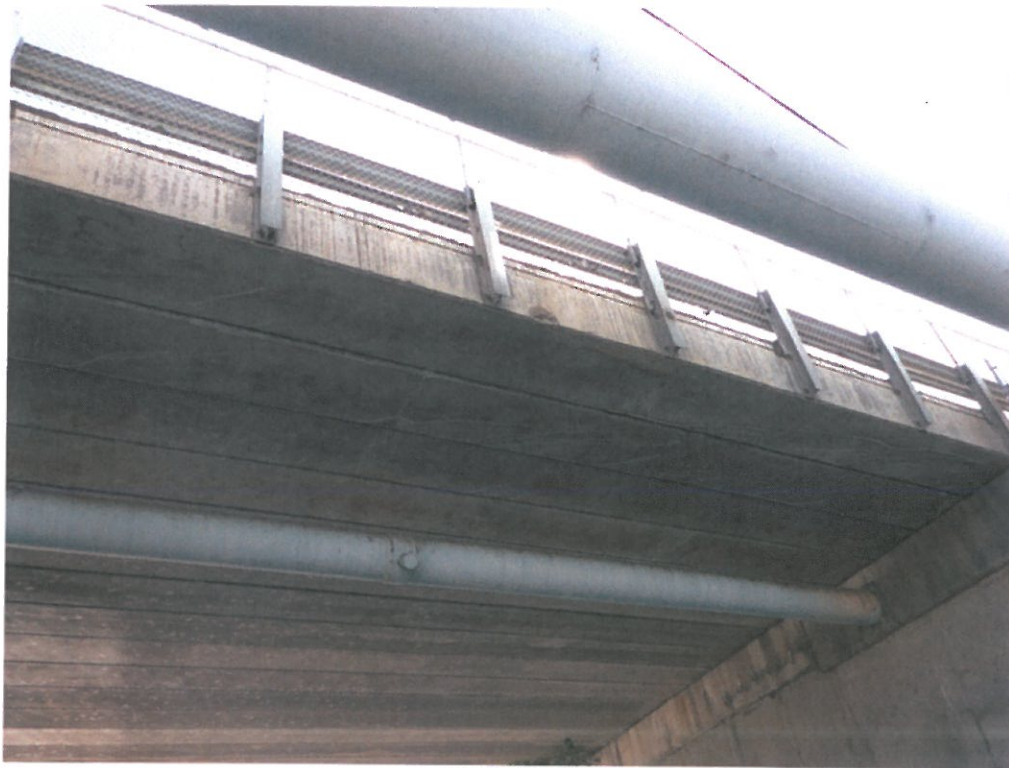
Photo No. 3

Spall 12" X8" X 1.5 at teh west face of the bog girder at mid-span.

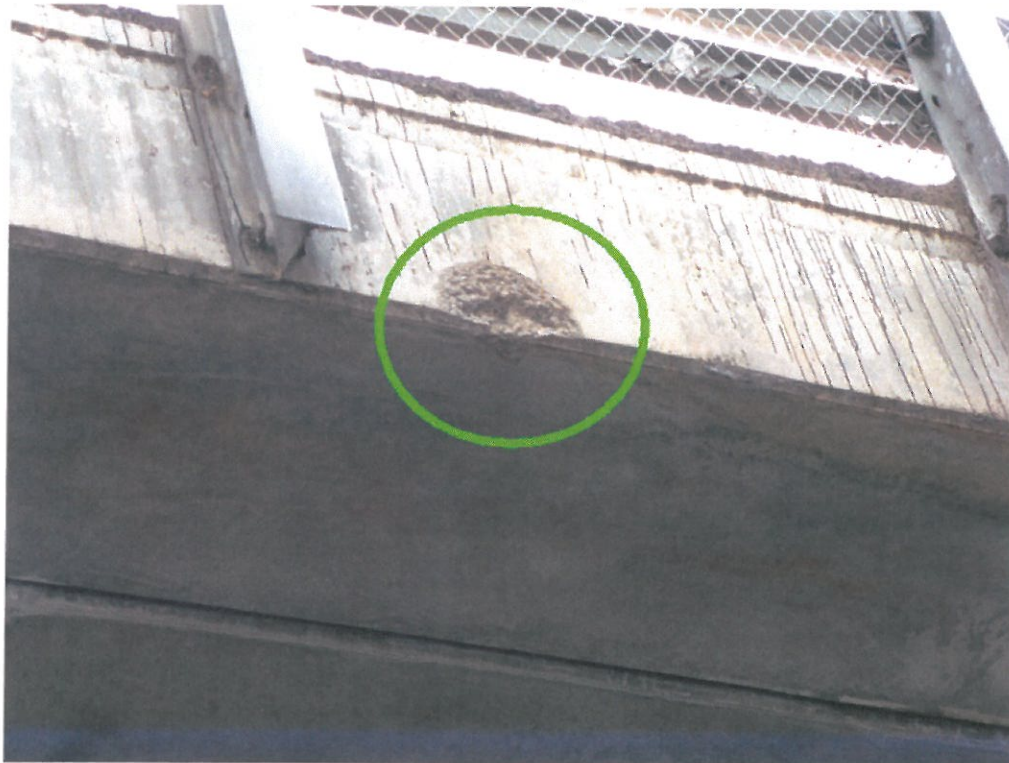
Photo No. 4

Spall 12" X8" X 1.5 at teh west face of the bog girder at mid-span.

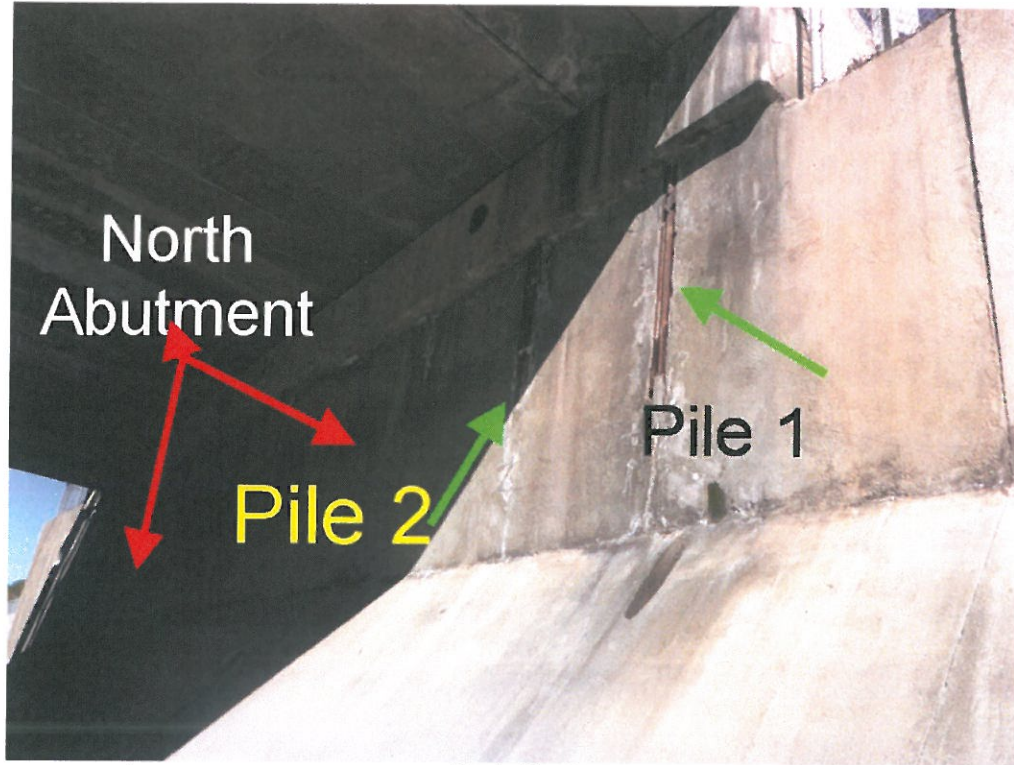
Photo No. 9

North Abutment has two piles are visible at the east side.

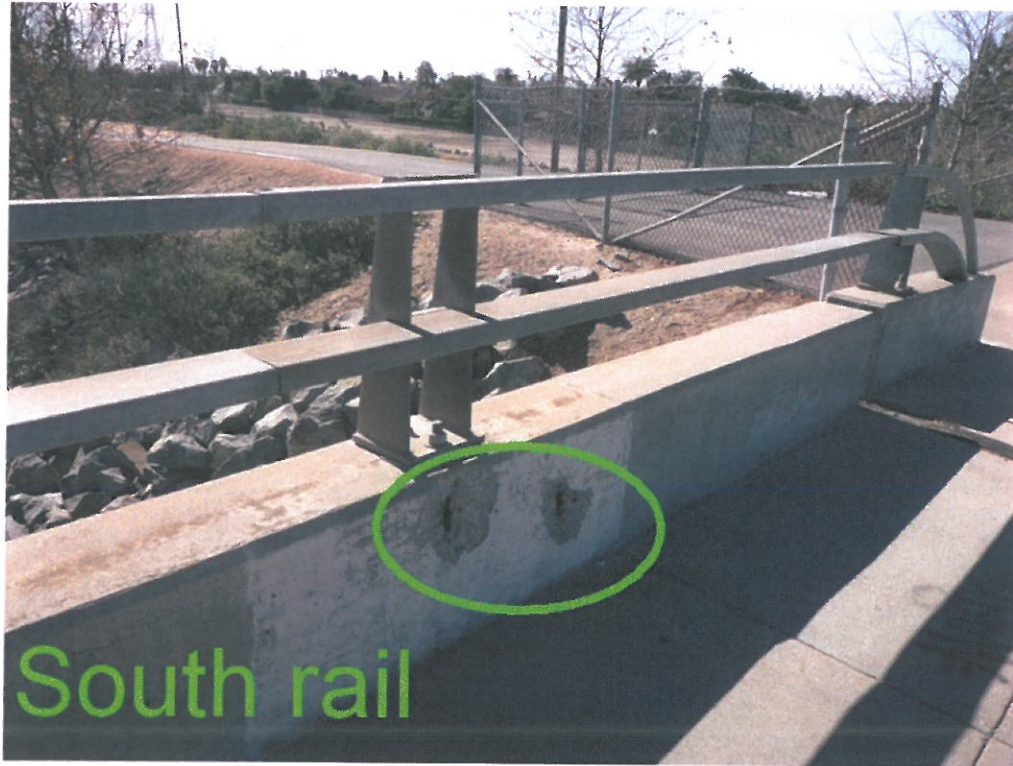
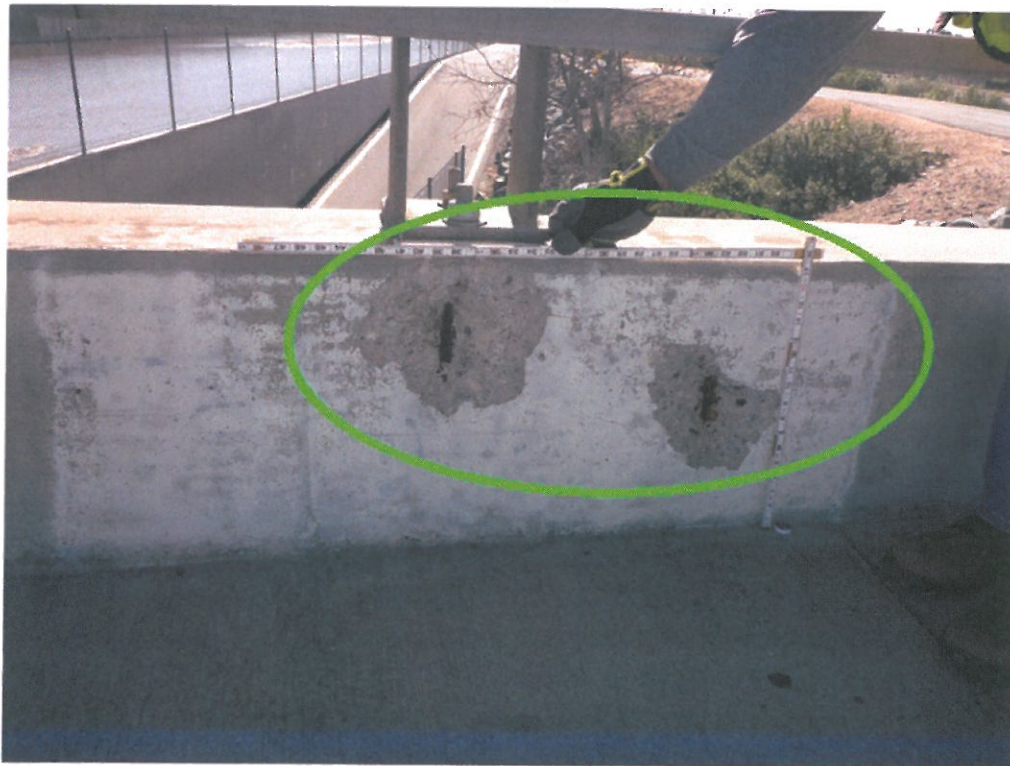
The curb of the southerly sidewalk exhibits few spalls with eba exposed and rusted

South rail has 2 spalls 12"X10"X 1.5 at 10 ft from the west end.

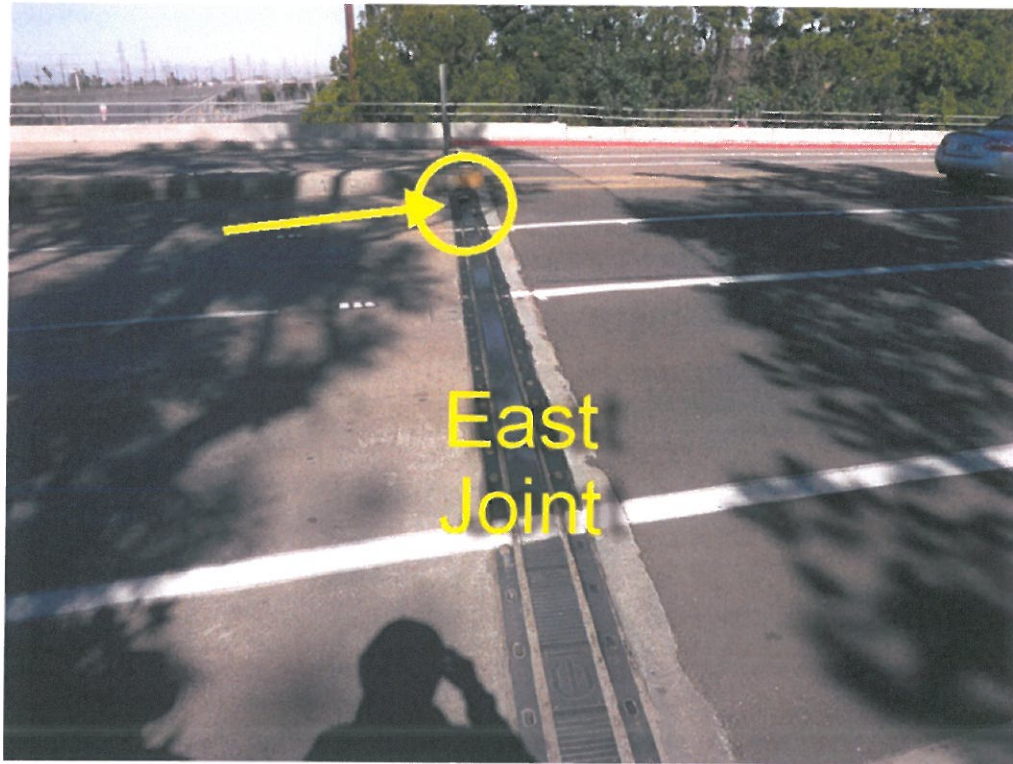
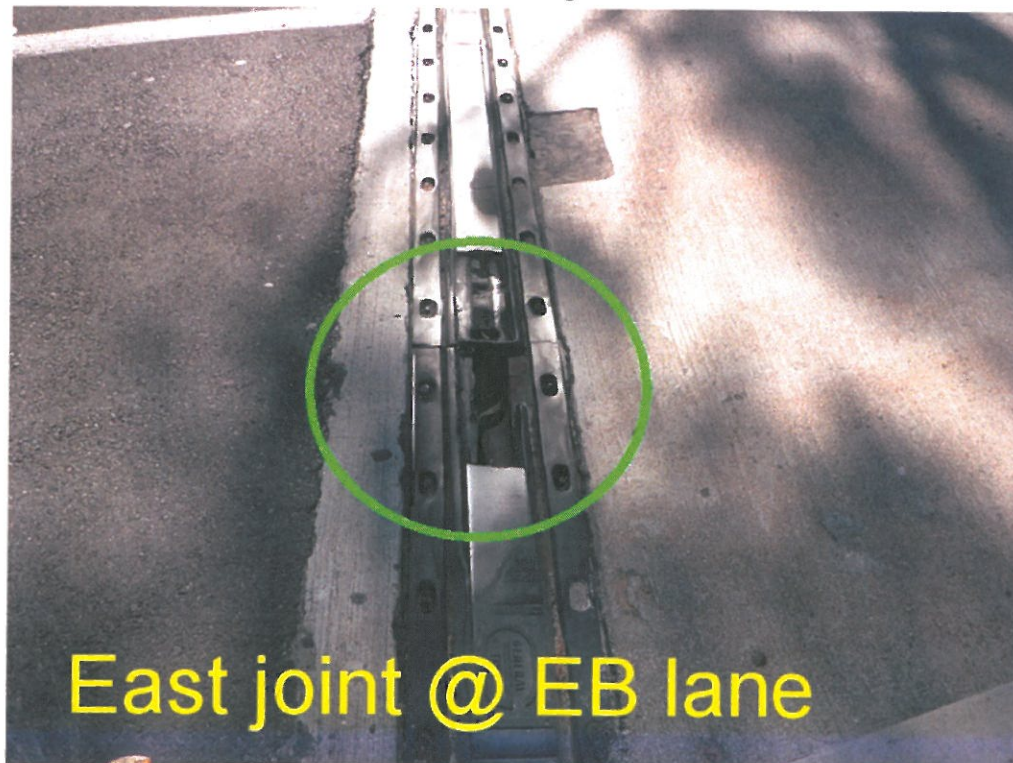
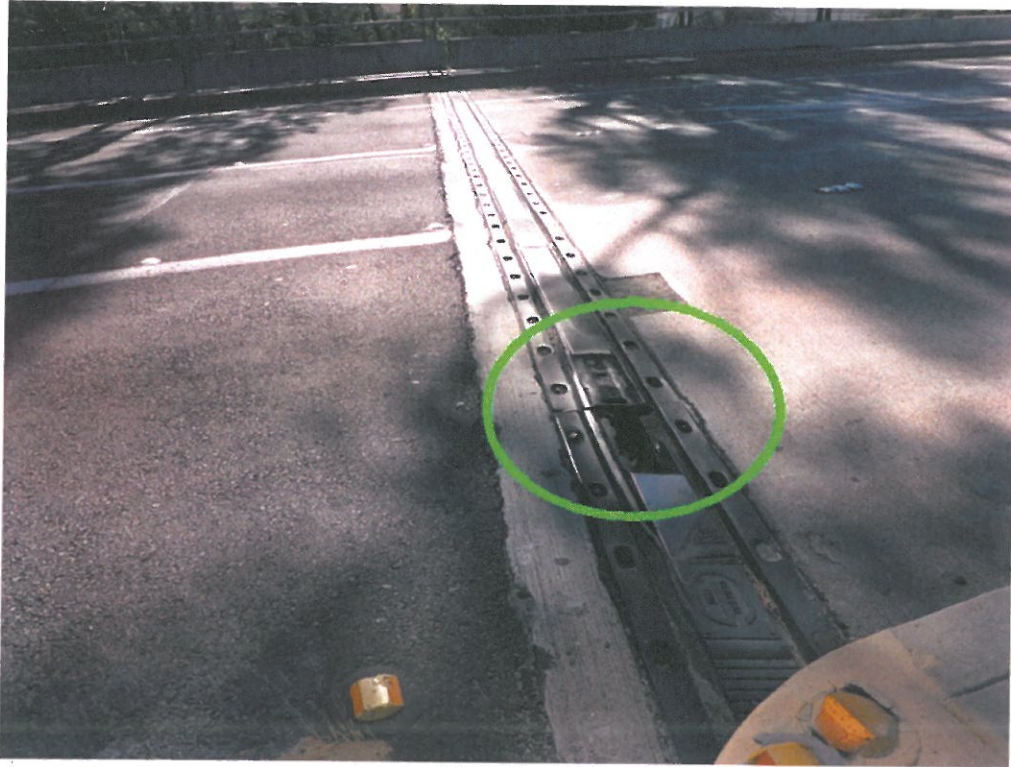
The east joint at eastbound lane 1 is missing a section 2 feet long and 3 inches wide.

East joint is missing 2 feet section at EB lane 1.

Action : Joints-Repair/Clean

StrTarget: 1 YEAR

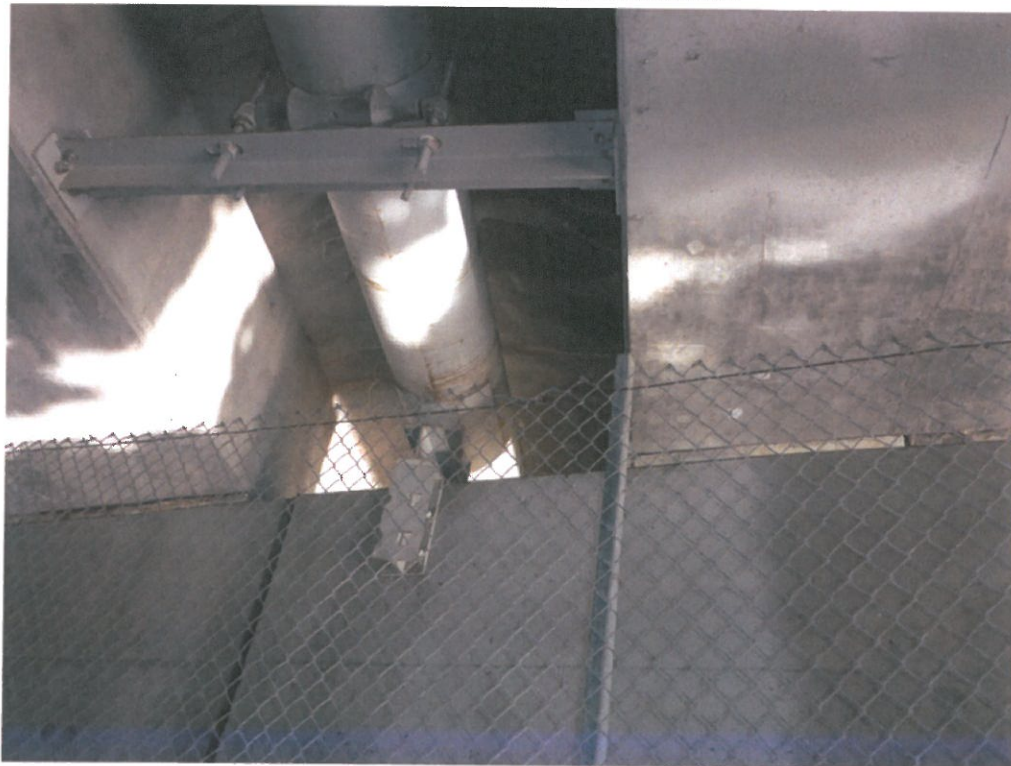
Photo No. 8

The soffit at the closure pour between the two box girders exhibits few transverse cracks with white efflorescence at span 4.

Soffit between the 2 box girders has transvsre cracks with white efflorescence at span 4.

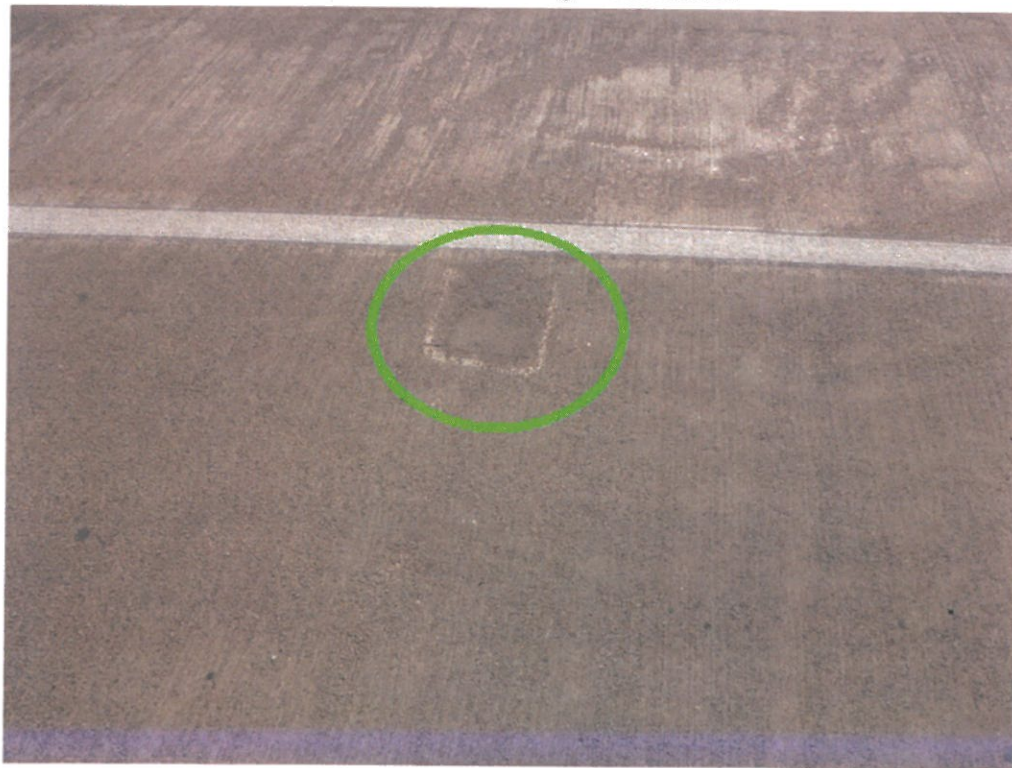
Photo No. 10

There are few scattered sound patched areas 1 foot X 1 foot in many locations.

Sound patched spalls 1 ft X 1 ft in many locations.

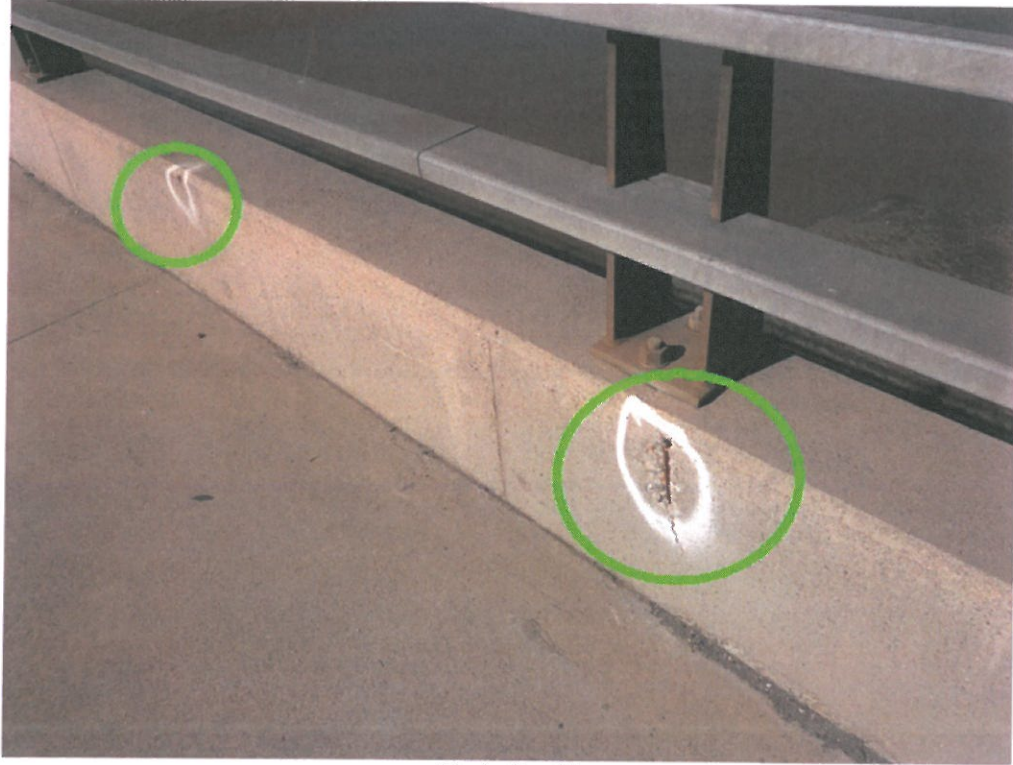
Photo No. 11

The north rail exhibits few spalls 5 inches 5 inches X 1 inches in many locations.
