Orange County Bridge Review Summary

Bridge Number: 55C0477

Bridge Name: Sand Canyon Wash

Facility Carried: Mason Regional Parkway

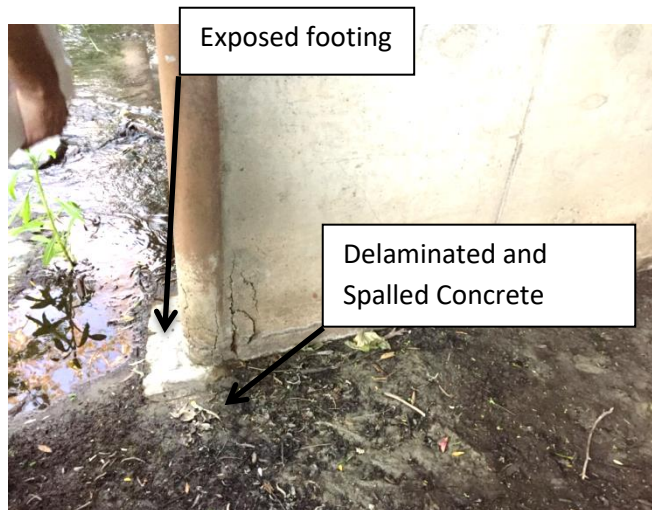
Photo 4: Culvert Wall

- Minor Spalling on pier nose (photo 4). Recommend repairing spalled surface area.
- Exposed footing (photo 4).
- Diagonal and vertical cracks on culvert walls (photo 4).
- Overgrown vegetation. (photo 5)

There are vertical cracks up to 1 mm wide in the culvert walls as follow 5 cracks in wall #1, 6 cracks in walls #2 & #3, and 3 cracks in wall #4.

- Repair spall and cracks on pier nose.
- Remove vegetation.

- Repair Pier nose cracks and Spalls ≈ \$15,000 (includes engineering, mobilization and contingency)
- Remove vegetation.

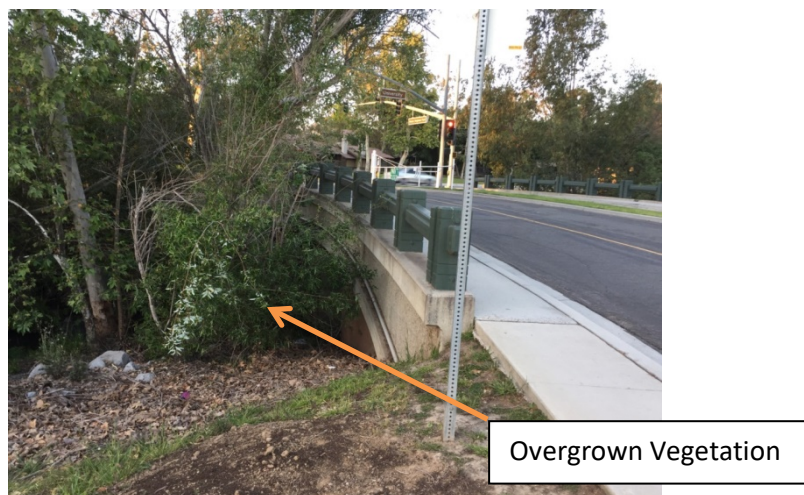
Photo 5: Channel Vegetation

The downstream live trees accumulated 300 mm dirt and water inside the barrels #1 and #3.

Remove and clean the downstream channel

Action : Remove Vegetation
