Orange County Bridge Review Summary

Bridge Number: 55C0550

Bridge Name: Aliso Creek

Facility Carried: Aliso Creek Road

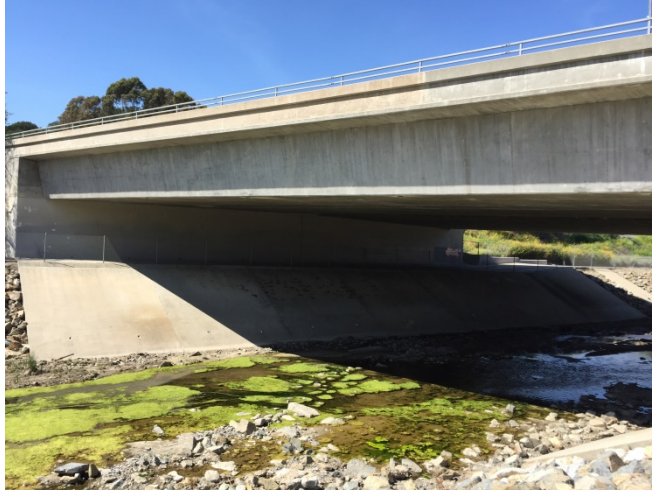
Photo 1:

- Due to traffic, there was limited deck access. Efflorescence visible on bridge soffit (photo 1), this may be a result of a leaking utility. Recommend determining if there are utilities through bridge that may be leaking, since moisture must be present in bridge cells to cause the efflorescence.
- Some down drains are clogged (photo 2). Note this is not eligible for BPMP funds.
