Orange County Bridge Review Summary

Bridge Number: 55C0561

Bridge Name: Dana Point Harbor

Field Inspection Observations

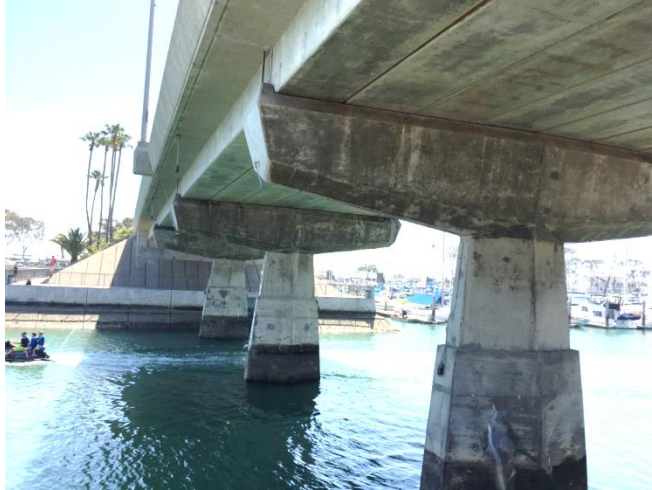
Photo 1:

- Minor spalling on walkway
- There was minimal access to the substructure (photo 1 and 2). Overall this bridge appears to be in good condition.
- Joint seals filled with debris. (photo 3) No immediate action required.

- Recommend patching spalled concrete. No immediate actions required since not a high priority.

- Repair Spalls ≈ \$30,000, complicated by water access and wet conditions (includes engineering, mobilization and contingency)

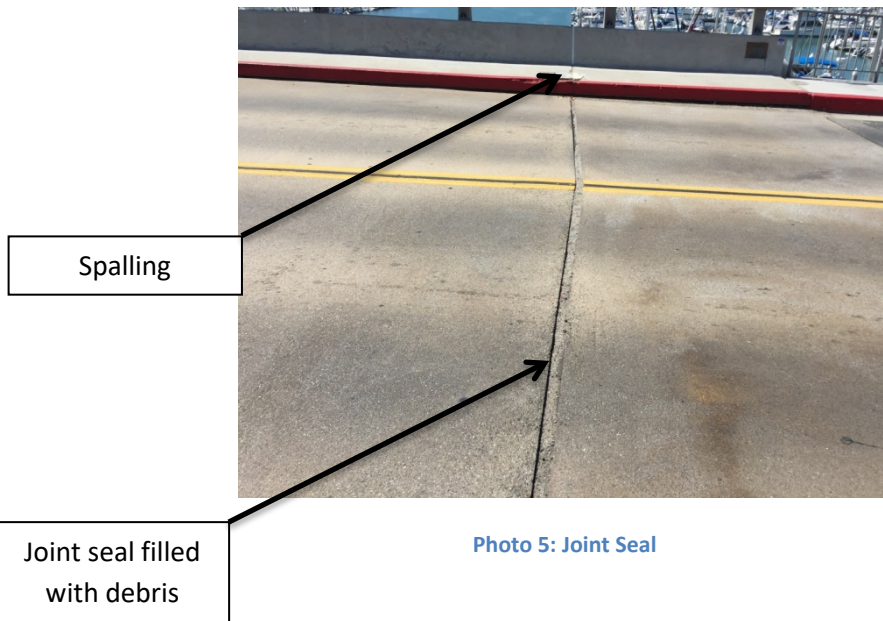
Photo 5: Joint Seal
