## **Orange County Bridge Review Summary**

**Bridge Number:** 55C0574

**Bridge Name:** Redhill Channel

**Facility Carried:** Bent Twig Lane

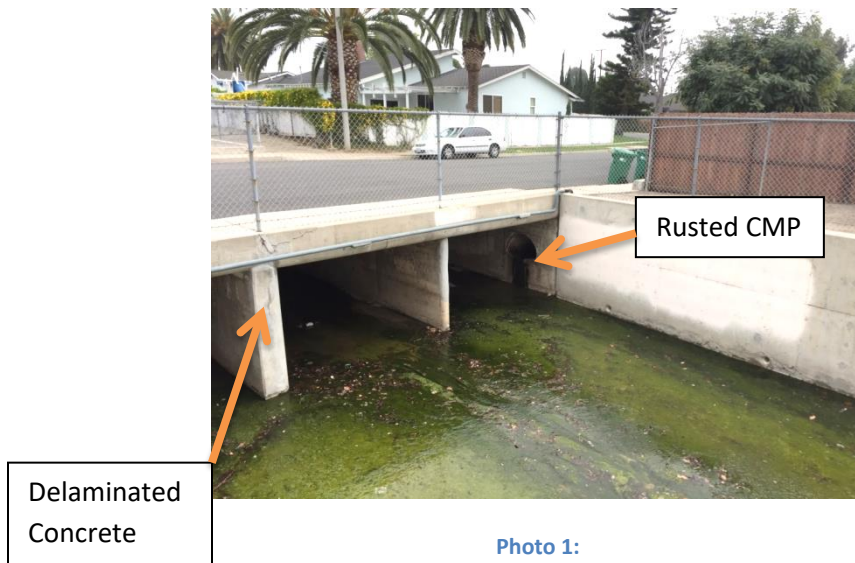
- There was no access to the culvert. The culvert was visually inspected from the access roads.
- Spalling and delaminated concrete around post pockets (photo 1 & 3).
- Rusted galvanized fence post likely cause of spall (photo 3).

- Replace fence post and repair post pocket spalls. If fence post not replaced, spall will reoccur.

- Repair spalled concrete and replace fence post < \$15,000 (includes engineering, mobilization and contingency).
