Orange County Bridge Review Summary

Bridge Number: 55C0606

Bridge Name: Arroyo Trabuco

Facility Carried: Oso Parkway

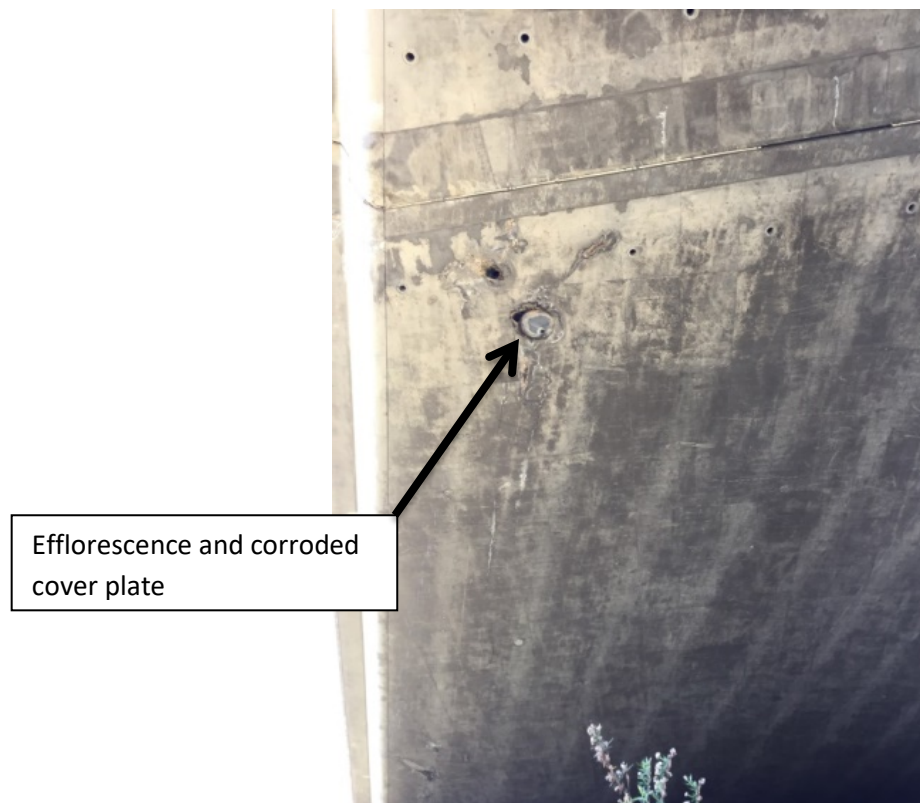
- Efflorescence near each wetted area indicating water is seeping through soffit slab. Water dripping in span 1, this appears to be from a utility line in the bridge. Recommend contacting utility and have utility owner correct problem before significant damage, such as corrosion, occurs to soffit. Note, if the leaking utility is sewer water then much more corrosive. Soffit opening cover appears to be corroding (Photo 4). Note this work is not eligible for BPMP funds.

Photo 4: Bridge Soffit showing efflorescence and corroded cover plate

- Clean out down drains.
- Deck cracks are condition state 1, so are not considered significant and are not eligible for BPMP funding.
- Have utility owner stop leaks.

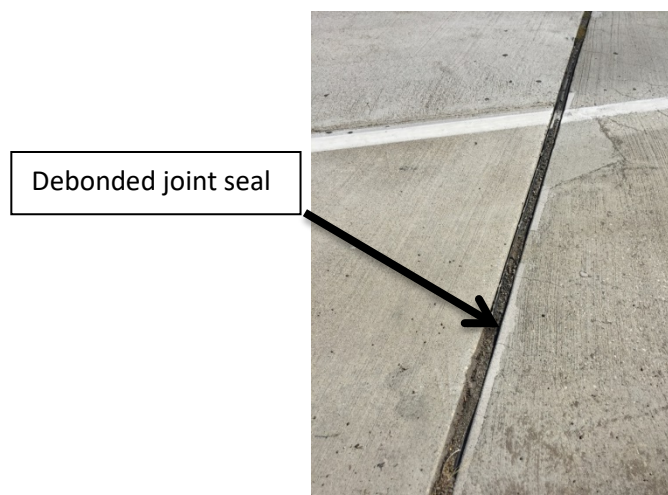
- Joint seal detached at north end. (photo 5)
- Significant bank erosion. It is unclear if the water is from weep hole drainage system or detached joint seal. Since there does not appear to be water coming from the seat, it is assumed it is from the weep holes system. Investigate source of water and repair leak before condition worsens. Note this is not eligible for BPMP funds. (Photo 6 & 7)

Photo 5: Detached joint seal at north end of bridge

- Repair joint seals.
- Identify water source causing bank erosion and repair problem.

- Joint Seal = 104 ft * \$150/LF ≈ \$16,000
- Traffic Control ≈ \$15,000
- Bank erosion ≈ \$20,000. Difficult to estimate until water source identified
- Estimated Total Construction Cost (with engineering, mobilization and contingency) ≈ \$65,000

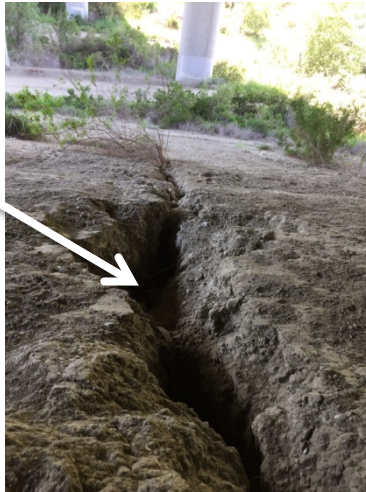
Deep Rutting

Photo 6: Rutting at abutment

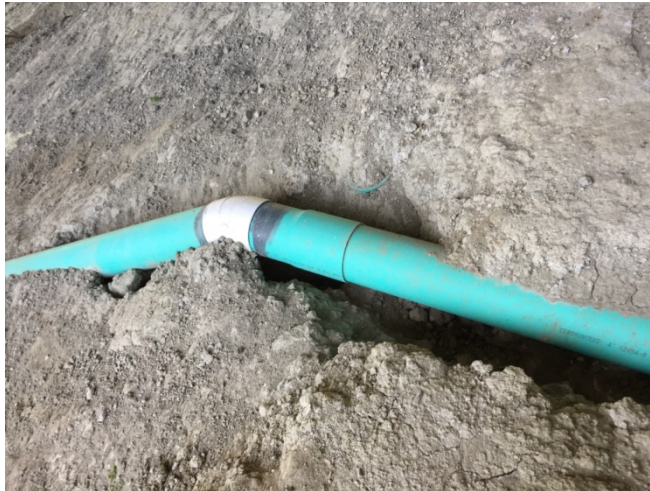
Photo 7: Erosion at abutment weep hole drainage system
